Technical Service Bulletin

91 Bluetooth phone cannot be paired to vehicle

91 13 04 2013422/10 September 11, 2013. Supersedes Technical Service Bulletin Group 91 number 12-49 dated July 31, 2012 for reasons listed below.

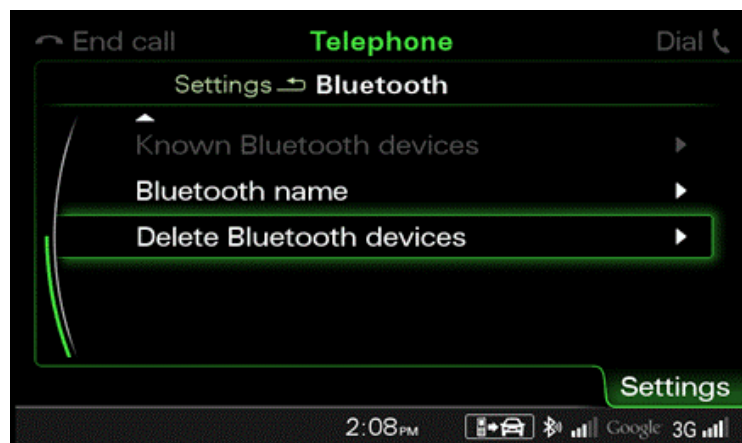
Figure 1. Select "Delete Bluetooth devices".

3. If the phone still will not connect in MMI3G+, delete all Bluetooth devices in the MMI menu (Figure 1 and Figure 2).

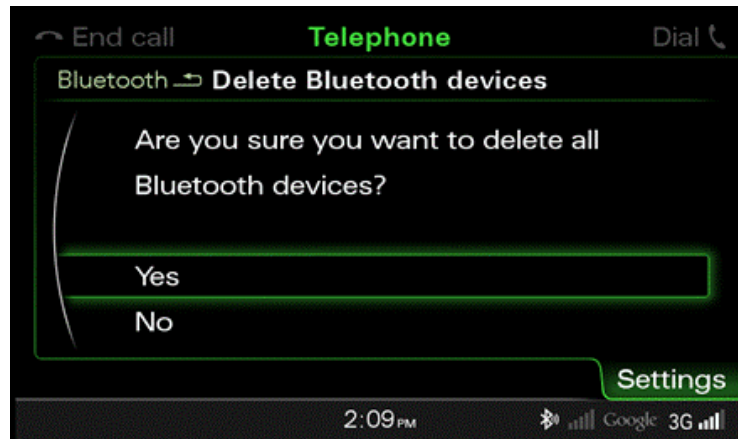
Figure 2. Confirm deletion of Bluetooth devices.

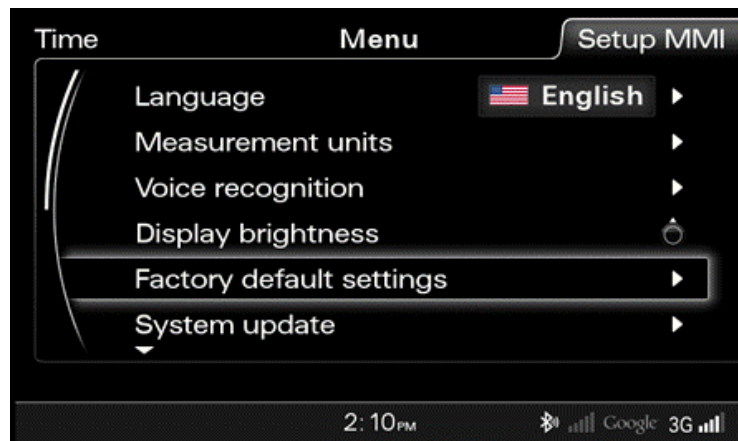
Figure 3. Open default settings menu.

4. Reset phone and Bluetooth settings in the MMI menu to default (Figure 3 - Figure 6).

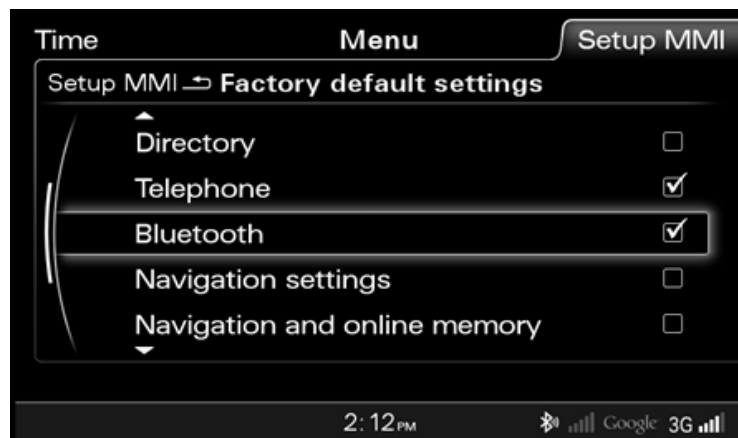
Figure 4. Select Telephone and Bluetooth options for factory defaults.

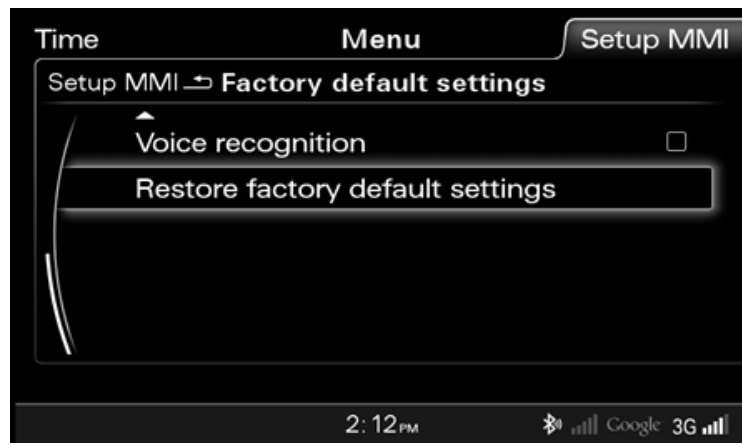
Figure 5. Restore factory default settings.

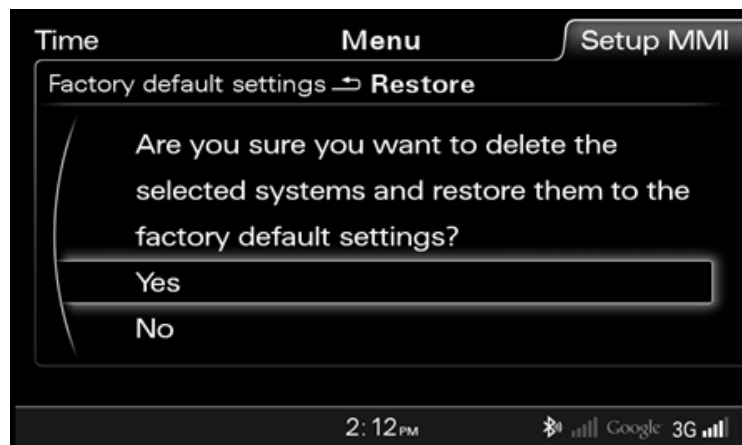
Figure 6. Confirm restoration of factory default settings.
