Technical Service Bulletin

69 Airbag lamp on; upper limit of side airbag exceeded

69 13 27 2010144/4 December 10, 2013. Supersedes Technical Service Bulletin Group 69 number 08-11 dated December 10, 2008 for reasons listed below.

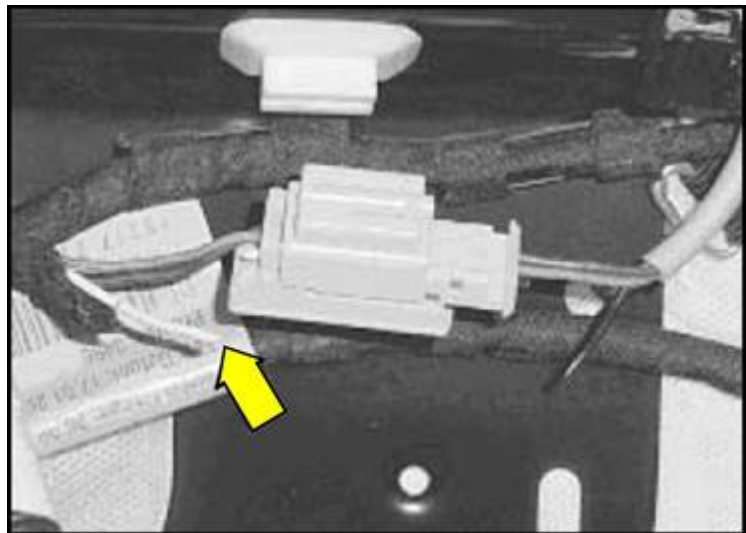
Figure 3. Igniter wire 1 on seat harness side.

5. Cut igniter wire 1 (on seat harness side) next to airbag connector (Figure 3).

6. Using VAS 1978A wiring repair kit (including crimping tool VAS 1978/1 with VAS 1978/24 insert): Strip wires and splice using a 4-inch section of repair wire (000979010) and 2 butt connectors (111971941A). This allows the harness additional slack.

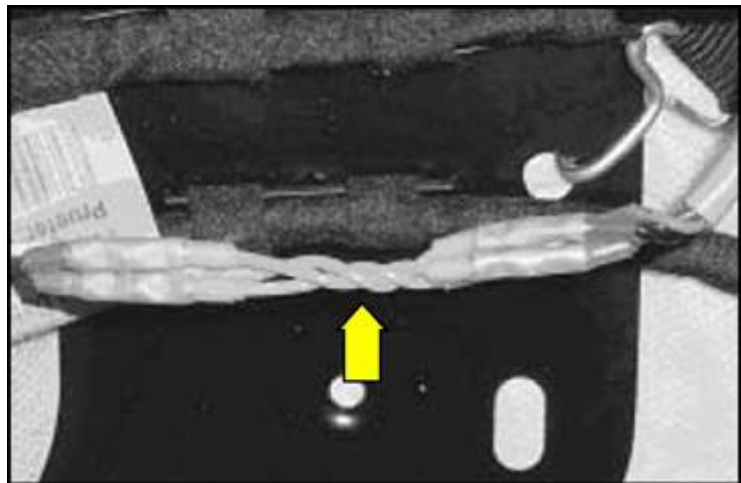
Figure 5. Repaired wires that have been twisted.

- Discard connector.
- Twist repaired wires (Figure 5).
