Technical Service Bulletin

94 Heavy condensation in headlights

94 13 29 2035920/1 December 5, 2013.

Model(s)	Year	VIN Range	Vehicle-Specific Equipment
TT	2007 - 2013	All	Not Applicable

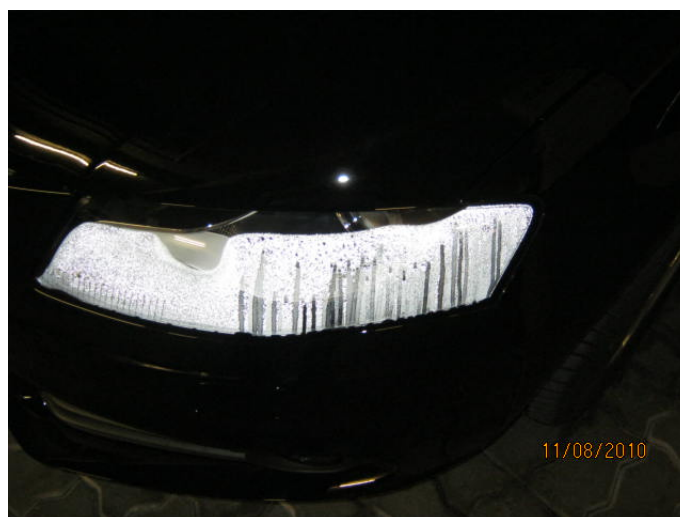
- Heavy condensation has built up in the headlight (Figure 1).
- Condensation only dissipates after the car is driven with the headlights on for at least ten minutes.

Figure 1. Heavy condensation.

Humid outside air (such as during rain) can enter into the headlights through the ventilation hose.

1. Use compressed air (less than 30 PSI) to clear the headlight lens.
2. Replace the ventilation hose (Figure 2) of the affected headlight with part number **8J0941717B** (left) and/or **8J0941718** (right) to reduce the humidity ingress. Hose should be fitted so that the filter element hangs freely behind the cross-member (Figure 3).

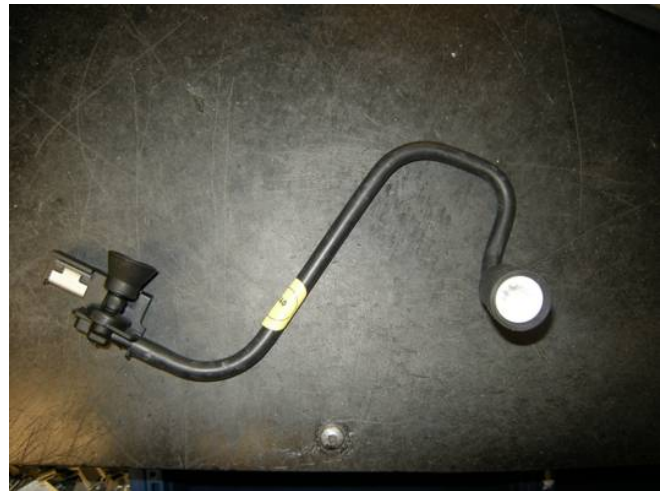
Figure 2. Revised ventilation hose.

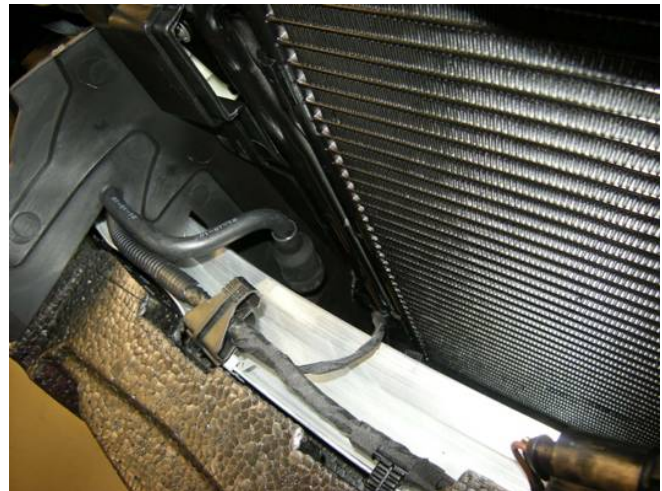
Figure 3. Filter element hanging freely behind cross-member.
