Technical Service Bulletin

96 False warning by lane change assistant (Audi Side Assist)

96 13 80 2030583/4 December 5, 2013. Supersedes Technical Service Bulletin Group 96 number 13-76 dated September 23, 2013 for reasons listed below.

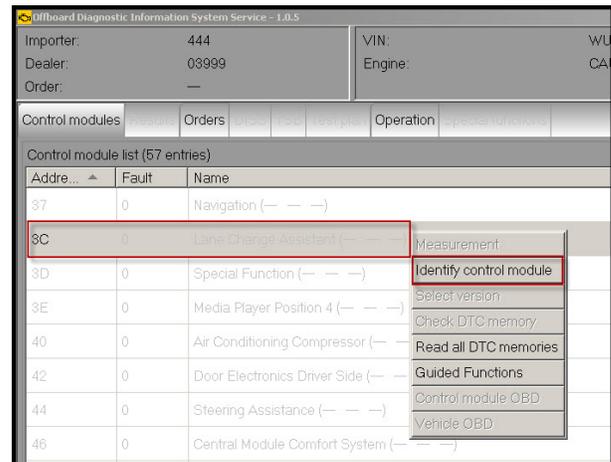
Figure 1. 3C Lane Change Assistant is greyed out until "Identify control module" is selected

Start Diagnosis -> Fill out Engine Information from drop down menu -> Uncheck option for "Guided Fault Finding" --> Select Tab "Control module list" --> Scroll down list to "3C Lane Change Assistant" (ECU option will be greyed out) -> Right click on "3C Lane Change Assistant" and select "Identify control module" (Figure 1).

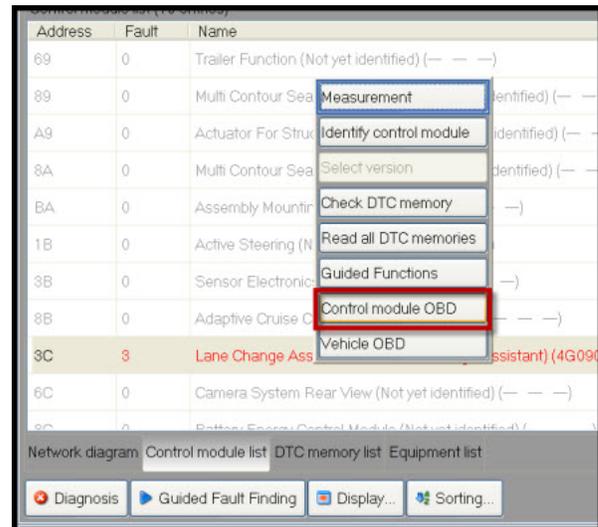
Figure 2. Software part number is identified as “VW/Audi part number” using ODIS

Once the information has populated, right-click on “3C Lane Change Assistant” and select “Control Module ODB” (Figure 2).

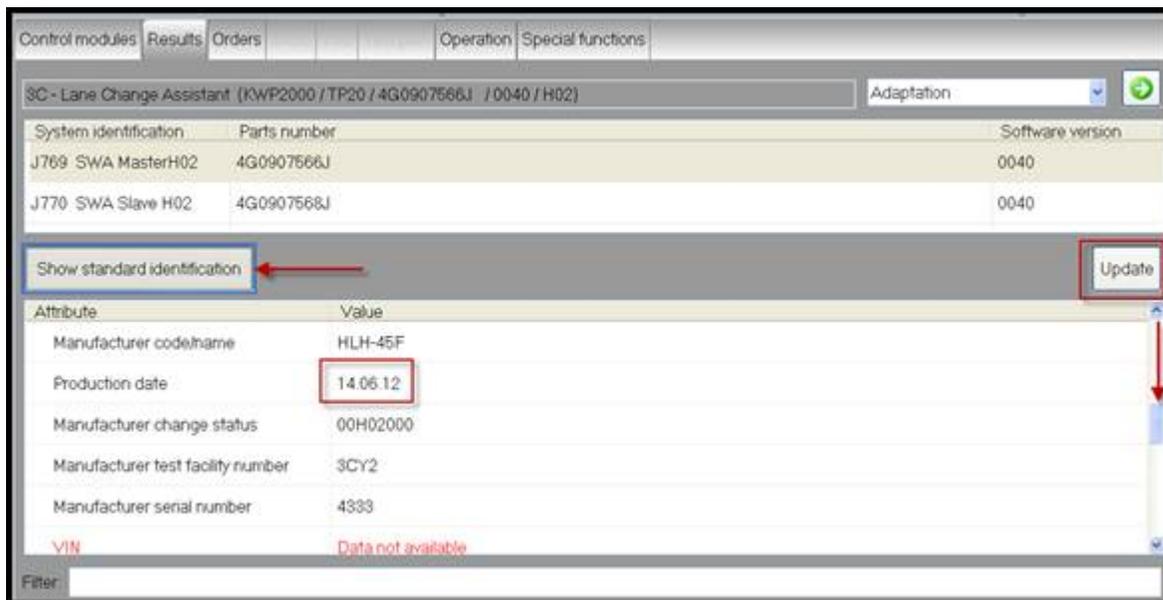
Figure 3. Control Module OBD screen showing part information and production date.

Under the Results tab, click on the button “Show Advanced Identification” (Figure 3), and then select the “Update” button on the right.
