Technical Service Bulletin

91 CD/DVD cannot be ejected

91 13 14 2013790/8 November 6, 2013. Supersedes Technical Service Bulletin Group 91 number 11-25 dated November 29, 2011 for reasons listed below.

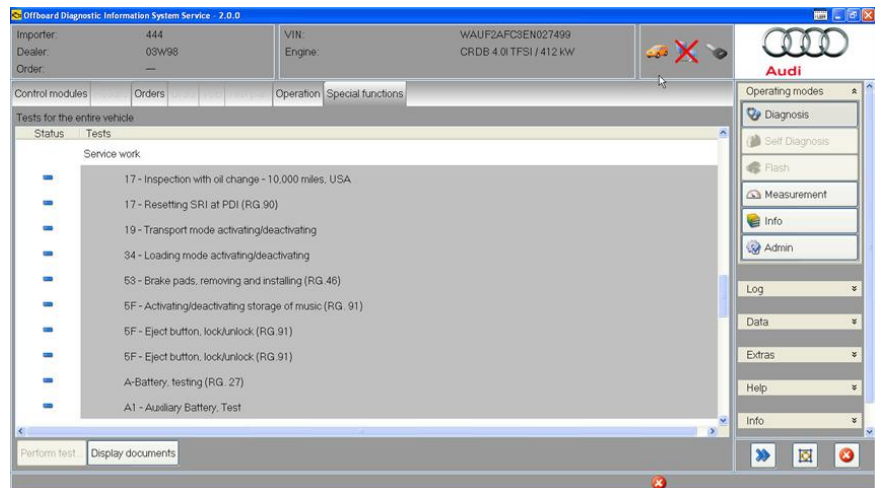
Figure 1. Test plan for MMI 3G / 3G+.

Through GFF, perform the test plan to enable the eject button through *Special Functions >> Service Work >> 5F – Eject Button, lock/unlock* (Figure 1).

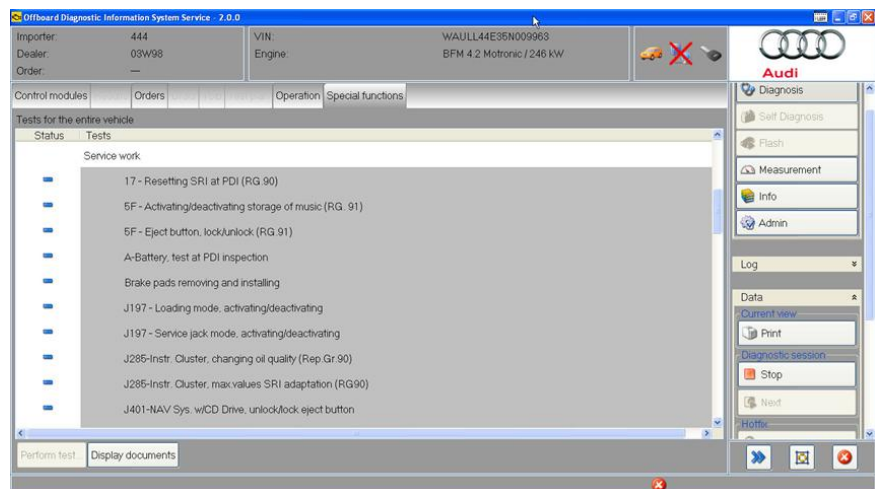
Figure 2. Test plan for MMI 2G.

Through GFF, perform the test plan to enable the eject button through *Special Functions >> Service Work >> 37 – Eject button, lock/unlock* (Figure 2).

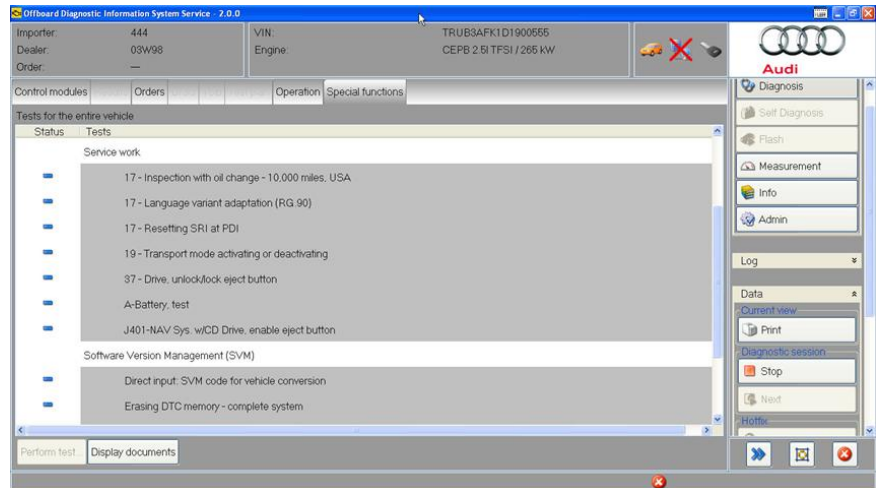
Figure 3. Test plan for RNS-E.

Through GFF, perform the test plan to enable the eject button through *Special Functions >> Service Work >> J401-NAV Sys. w/CD Drive, enable eject button* (Figure 3).
