NUMBER: 23-034-17

Clicking Noise When Opening/Closing Power Sliding Backlite

2017 (DS) RAM 1500 Pickup

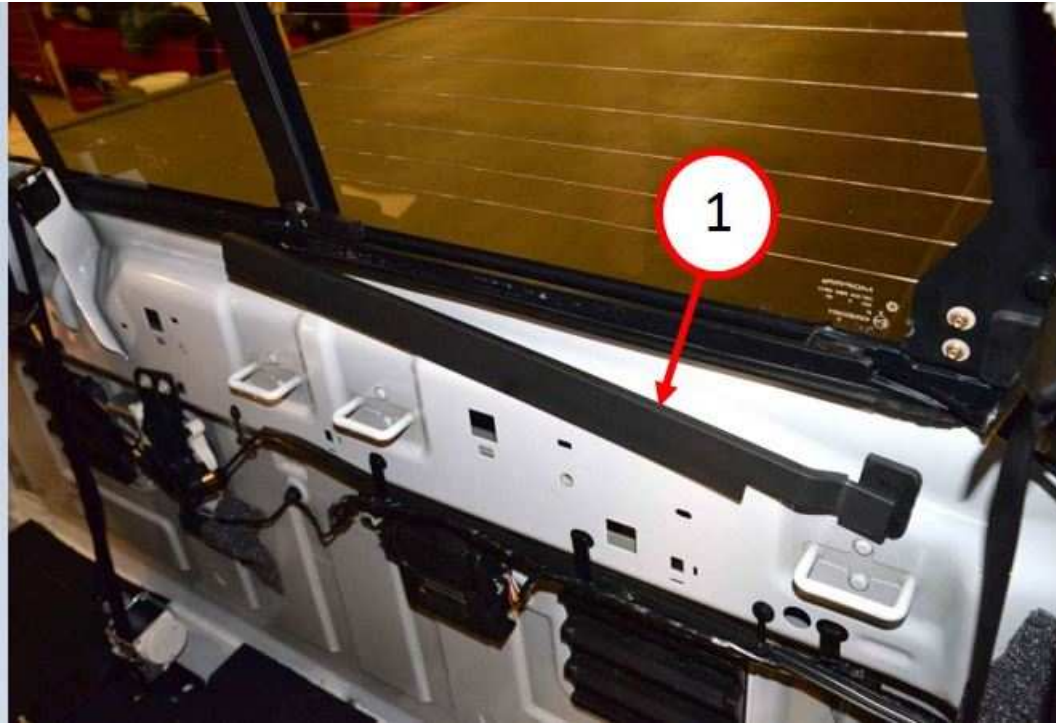
Fig. 2
Ribbon Cable Shield

1 - Support and Secure Ribbon Cable Shield After Removal

CAUTION! After removing ribbon cable shielding, position shield out of the way and secure with tape or equivalent to prevent stress and possible breakage of ribbon cable (Fig. 2) .
