October 27, 2017

06750 Version 1

Clicking from the Driver Power Seat While Using the Height or Tilt Adjustment

Year	Model	Trim	VIN Range
2013–17	Accord	All except LX	ALL

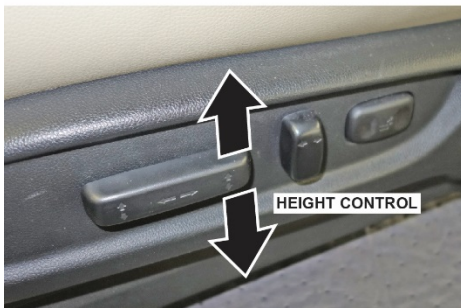
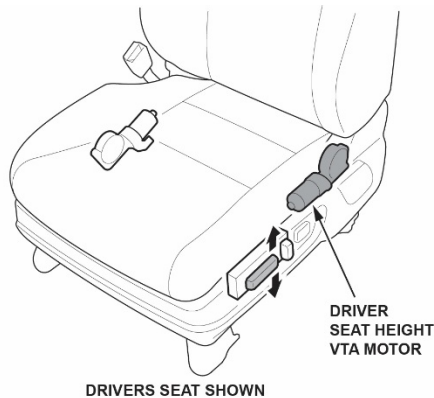
Height Adjust VTA

The vertical transmission assembly (VTA) unit has a stripped internal gear.

Adjust the seat height. If you hear a loud clicking or ratcheting from the seat height VTA unit and the travel of the height is minimal, go to REPAIR PROCEDURE A (HEIGHT ADJUST VTA REPLACEMENT).

Replace the height adjust VTA unit and/or tilt adjust VTA unit.

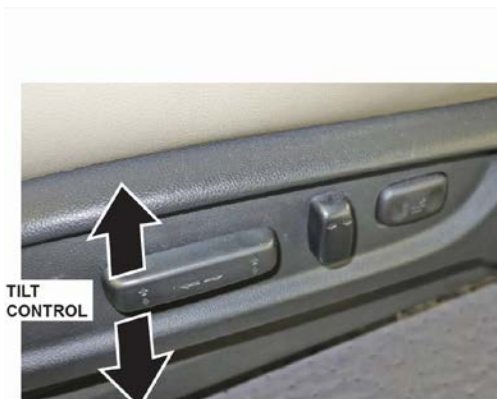
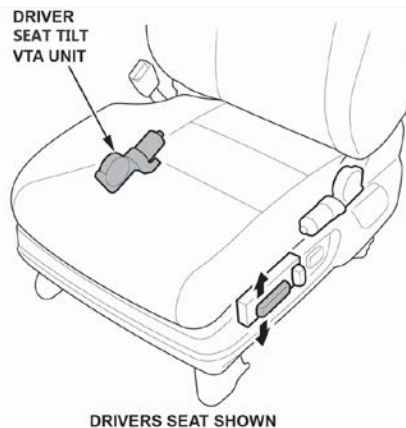
Tilt Adjust VTA

Adjust the seat tilt. If you hear a loud clicking or ratcheting from the seat tilt VTA unit and the travel of the tilt is minimal, go to REPAIR PROCEDURE B (TILT ADJUST VTA REPLACEMENT).
