# UPDATE Technical Bulletin

December 15, 2015

## 91N9 UPDATE – MIB2 MQB Modular Infotainment System Software Update (NVLW) – USA Only

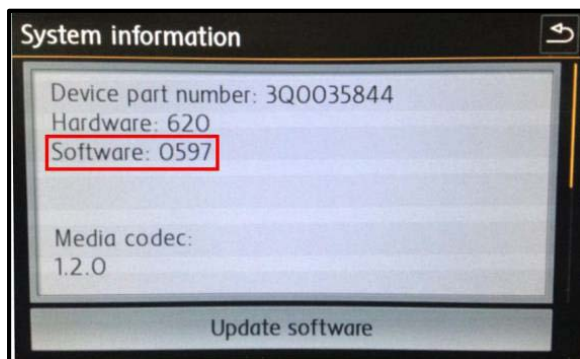
- If the currently installed software level is LOWER than **0613** <as shown>, proceed with these repair instructions.
- If the currently installed software level is GREATER than or EQUAL to **0613**, this work procedure does not apply.
