UPDATE Technical Bulletin

December 18, 2015

91N9 UPDATE – MIB2 MQB Modular Infotainment System Software Update (NVLW)

Model(s)	Year	Engine Code	Trans. Code
Golf, GTI, Golf Sportwagen	2016	All	All

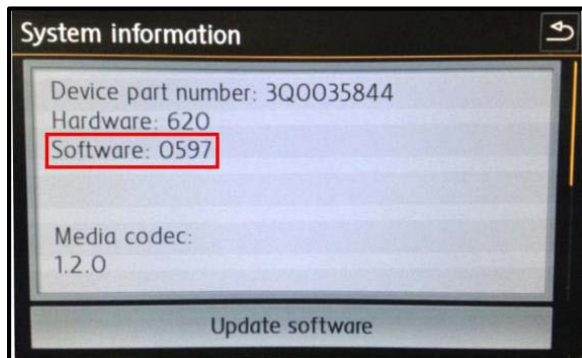
- If the currently installed software level is LOWER than **0613** <as shown>, proceed with these repair instructions.
- If the currently installed software level is GREATER than or EQUAL to **0613**, this work procedure does not apply.

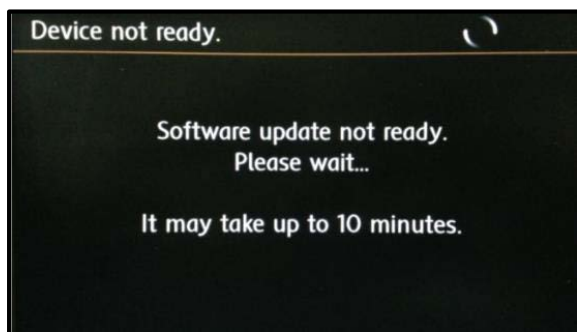
- The “Device not ready” screen will be displayed temporarily.
- After this screen is displayed, the Infotainment system will reboot and return to the normal operating mode.
- If the unit does not restart within 2 minutes, turn the unit ON using the ON/OFF button (volume knob).
