# Technical Service Bulletin

## 01 MIL on (DTC P2006(00) or P2007(00))

01 14 60 2033919/12 January 21, 2014. Supersedes Technical Service Bulletin Group 01 number 13-34 dated October 8, 2013 for reasons listed below.

Model(s)	Year	VIN Range	Vehicle-Specific Equipment
S4, S5, S5 Cabriolet, A6, A7, Q5, Q7	2013	All	3.0 FSI Engine

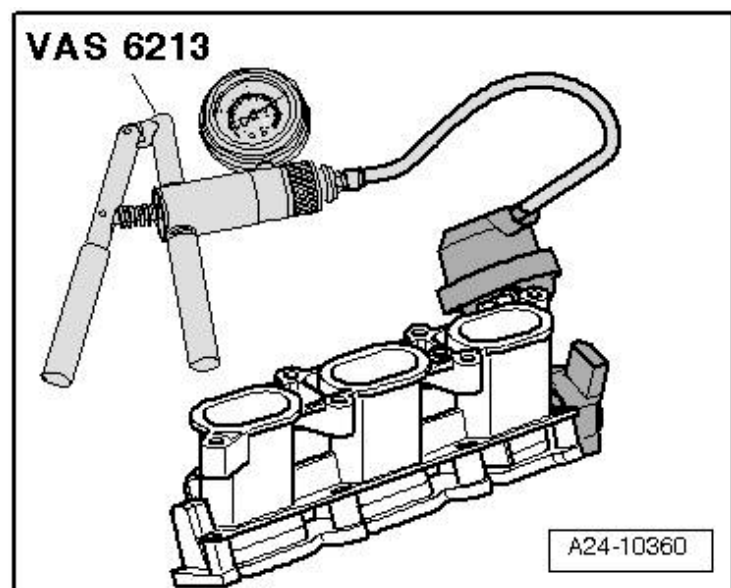
**Figure 1.** Vacuum pump VAS 6213

1. Ensure that the fault is not caused by a defective vacuum line by using the vacuum pump (Figure 1) to confirm there is no leak in the vacuum supply to the actuators.

The vacuum lines are working correctly if they are able to maintain vacuum while the actuators are disconnected and the lines are plugged up.

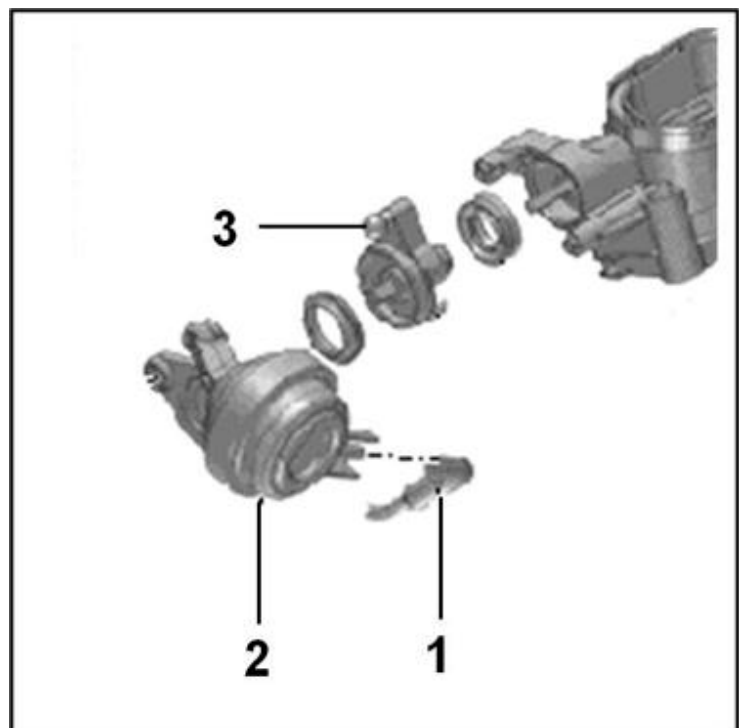
**Figure 5.** Vacuum hose (1), vacuum actuator (2), and ball head (3)

One of the vacuum actuators on intake runner bank 1 or bank 2 is defective. It is possible that the membrane on the vacuum actuator may tear. As a result, the intake manifold flaps do not function.

3. Disconnect the vacuum hose (Figure 5, 1), then pry the vacuum actuator (Figure 5, 2) off of the ball head (Figure 5, 3).

4. Reinstall the new actuator by following the above steps in reverse order.
