Technical Service Bulletin

57 Door handle touch sensors (Audi advanced key) inoperative

57 14 00 2027353/2 January 21, 2014. Supersedes Technical Service Bulletin Group 57 number 11-52 dated August 17, 2011 for reasons listed below.

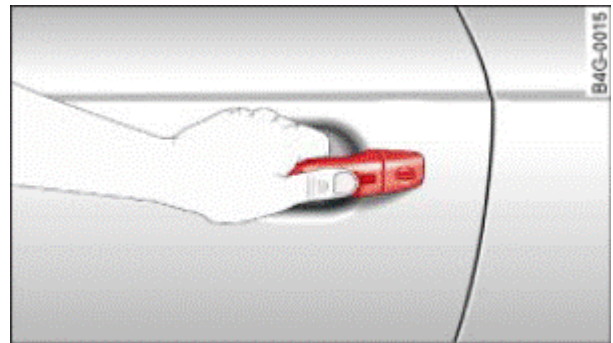
- Audi advanced key functions can be disabled by interference from nearby transmitters (such as cell phones, wireless headphones, other vehicle keys, etc.) that are using the same frequency range, as no positive identification is possible.
- If the customer attempts to lock the vehicle by touching the lock sensor on the outer side of the handle, but reaches into the door handle simultaneously (triggering the unlock sensor) the door will not lock (Figure 1). When lock and unlock signals are sent from the lock sensor and the unlock sensor at the same time, the unlock signal has a higher priority.

Figure 1. Reaching into door handle while touching the lock sensor.

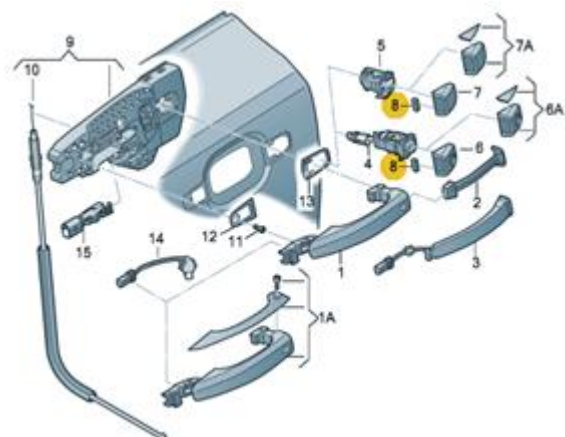
- The magnet under the cap of the door handle may not be installed.
- The system may be intermittently inoperative after water (from heavy rain or car wash) has entered the door handle touch sensor rubber sleeve.
- Incorrect touch sensors may be installed.

Figure 3. Magnet location in ETKA illustration.

1. Pull the affected door handle open and check if the magnet is installed (indicated as "Position 8" in ETKA illustrations) (Figures 3, Figure 4, and Figure 5).
2. If the magnet is missing, install the magnet.

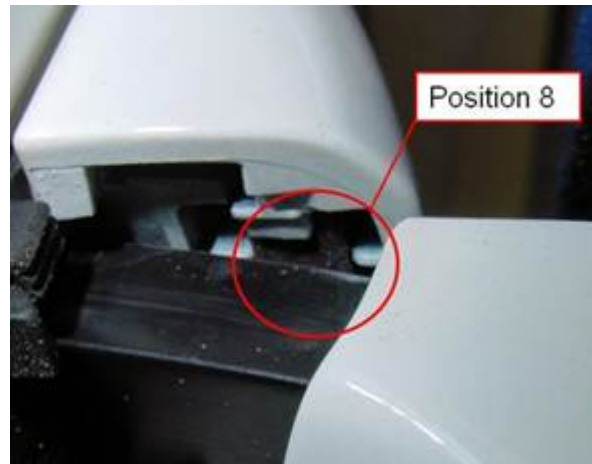
Figure 4. Door handle cap with an installed magnet.

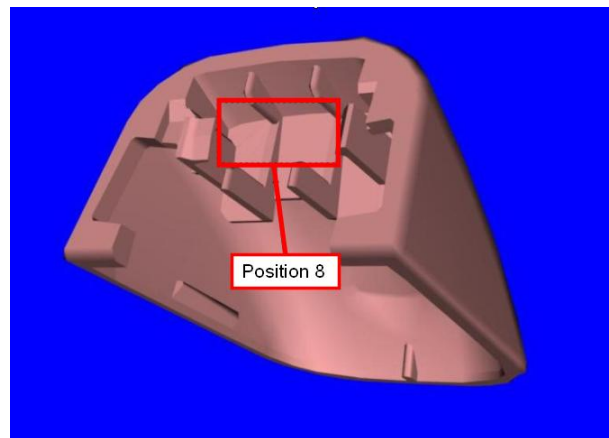
Figure 5. Location for magnet in door handle cap.

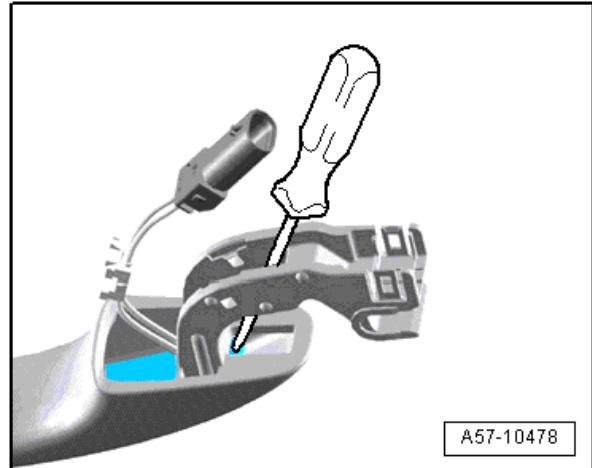
Figure 6. Removal of touch sensor.

1. Use Guided Fault Finding to check the wiring of each door handle for which a DTC is logged in the J393 control module.
2. If there are no problems with the wiring, check in Measured Value Block 43 the locking and unlocking function using Audi advanced key for every door handle.
3. If a door handle does not respond properly, remove the touch sensors (Figure 6) from the door handles to check the part number (Figure 7). During the removal make sure that the sensor is pried out using a screwdriver according to the repair manual.
4. Replace all door handle sensors with part number **8K0927753** or **8K0927753A**. Part numbers **8K0927753B**, **8K0927753C**, **4G8927753** and **4G8927753A** are optimized; do *not* replace them.

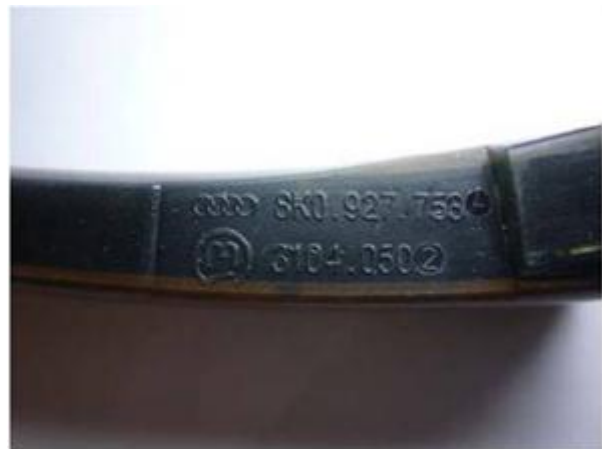
Figure 7. Door handle touch sensor part number.
