# Technical Service Bulletin

## 91 Bluetooth call quality issues for caller on other end of call

91 14 20 2027718/6 January 3, 2014. Supersedes Technical Service Bulletin Group 91 number 13-11 dated October 31, 2013 for reasons listed below.

Model(s)	Year	VIN Range	Vehicle-Specific Equipment
2011-2013	A6/A7	All	Bluetooth Hands-Free Calling
2011-2013	A5 CAB	All	Bluetooth Hands-Free Calling
2011-2013	TT	All	Bluetooth Hands-Free Calling

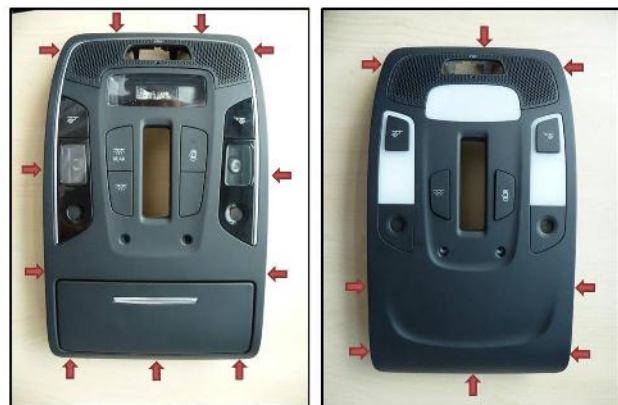
- Remove the decorative trim from the base plate with your fingers. If necessary, gently pry the trim with a trim stick or bone tool, then finish removing it with your fingers.
- There are a number of different clips holding the trim plate to the base plate depending on the trim level of the vehicle (Figure 1).

**Figure 1.** Clip location for A6/A7 high-line roof module (left) and for mid-line roof module (right)

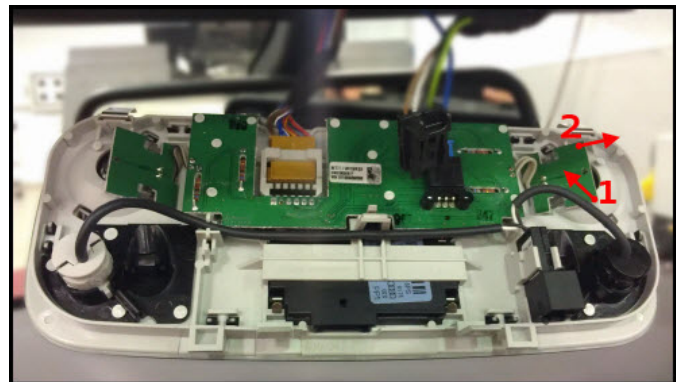
**Figure 2.** Prying the LED circuit-board of the jewel.

- To remove the LED circuit boards, first pry the top of the small circuit board away from the LED jewel, in the direction indicated by arrow 1 (Figure 2). It will only need to be lifted 1-2mm. Then, pull up on the circuit board in the direction indicated by arrow 2 (Figure 2) to release the circuit board from the LED jewel. There are three different attachment points of the LED circuit board and LED jewel (Figure 3).

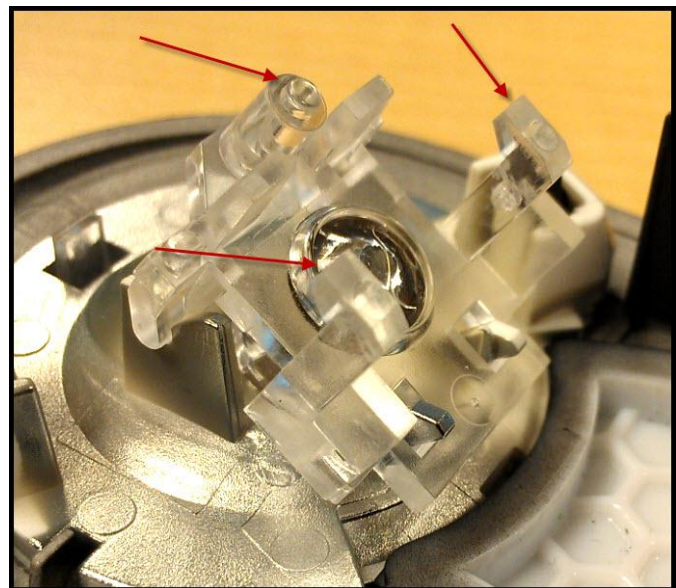
**Figure 3.** LED jewel attachment points.

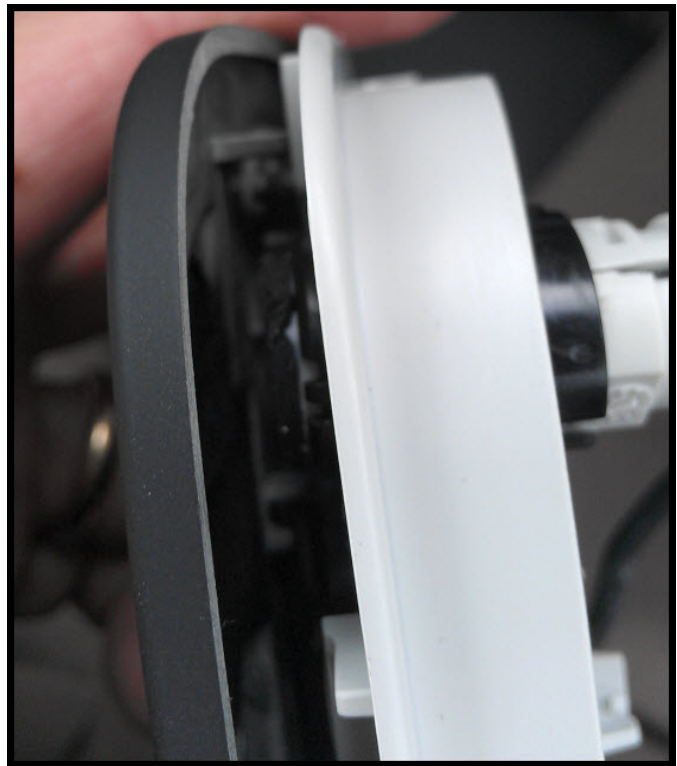
*Figure 4. Prying the trim plate from the base plate.*

- Repeat for the other side.
- Once the LED jewels are free from the circuit boards, the decorative trim plate can be detached from the base plate. Use your fingers to pry the two pieces apart. There are many clip points holding the two pieces together. Sliding your finger slowly around the perimeter is the most effective way to separate the two parts without damaging them (Figure 4).

The use of a bone tool or screw driver is not recommended for this roof module assembly because it can damage the soft touch paint on the edge of the trim, which can be visible once the part is reinstalled in the headliner.

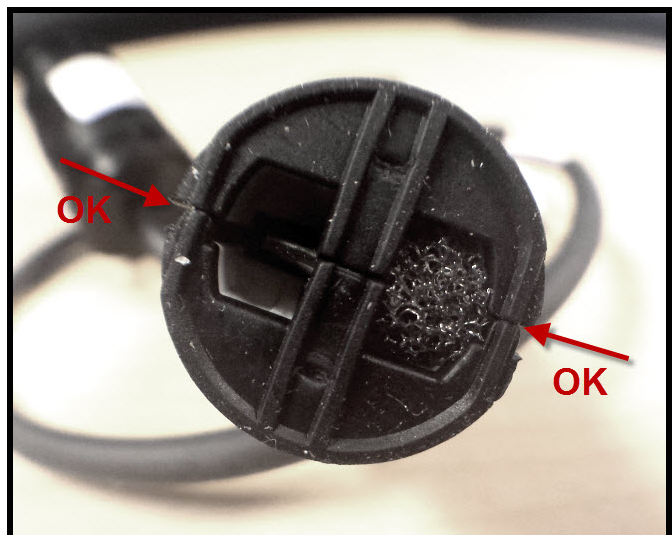
1. Inspect the seal of the microphone for damage:
  - There are two splits in the rubber seal. This is normal as long as the two halves of the seal are touching each other (Figure 5).

*Figure 5. Undamaged seal*

- Reinstall the microphones into the roof module. Ensure that the microphones are firmly seated. A loud snap can be heard and felt when the microphone is fully seated. Reinstall the roof module and retest for the complaint before proceeding with diagnosis. If the complaint cannot be reproduced, no additional action is necessary.

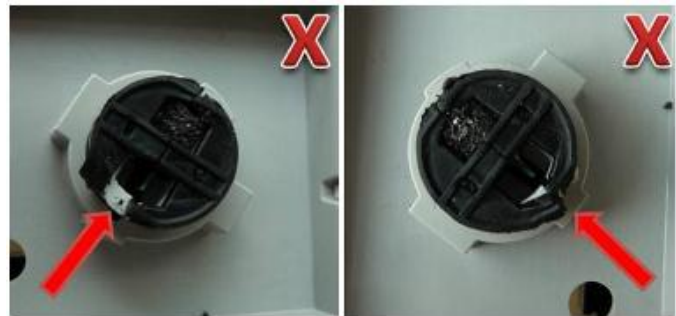
The microphone seal is damaged during installation into the roof module.

- If the two halves of the seal are loose and move freely, the seal is damaged (Figure 6).

Figure 6. Examples of damaged seals

- If the vehicle is a 2013+ A6/A7 built after VIN DN005481, contact TAC prior to proceeding with repairs for special instructions. When calling, please provide repair order number, as well as part numbers for microphones and interior light assembly.
- If the vehicle does not fall into the above range, replace the microphone set by installing the replacement microphone while the decorative trim is removed from the base plate. Take care when doing so to prevent damaging the new microphone's seal by slowly installing it perpendicular to the base plate (Figure 7). Do not install the microphone at an angle, as this may pinch the seal (Figures 8 and 9)

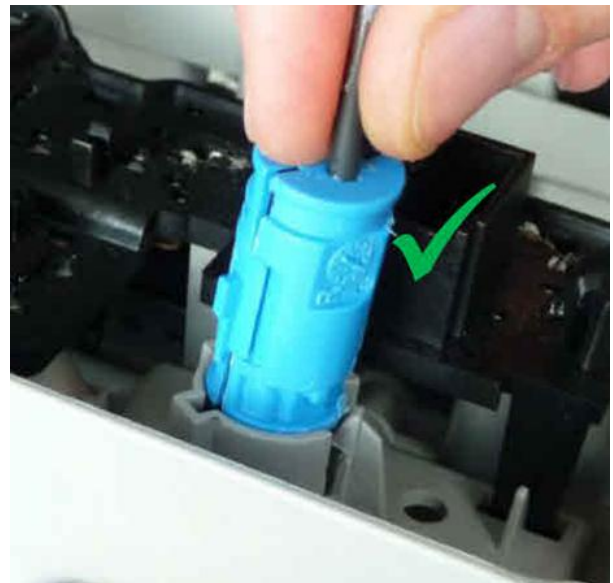
Figure 7. Proper installation.

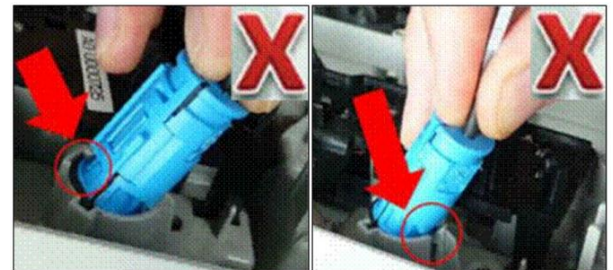
Figure 8. Incorrect installation at an angle, showing a pinched seal on the left.

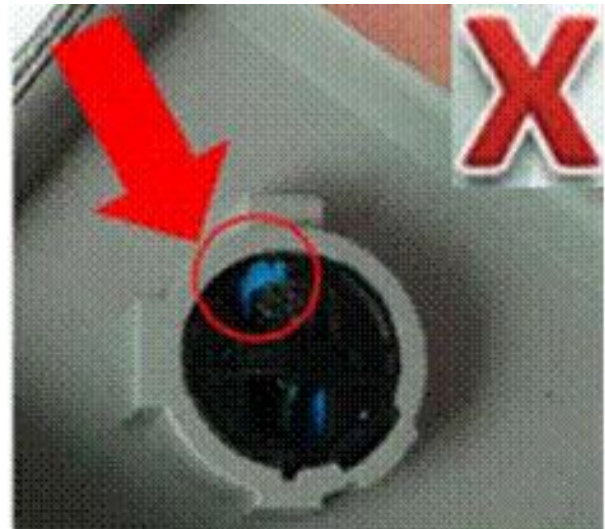
*Figure 9. Damage caused by a pinched seal.*

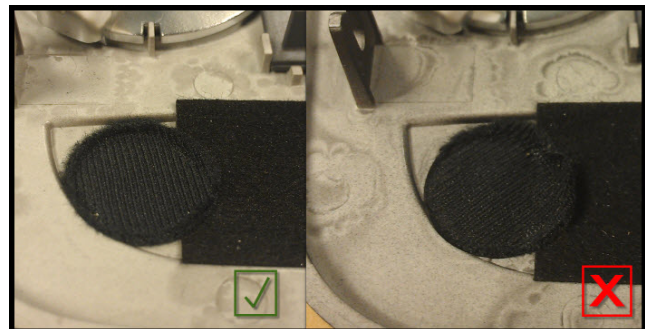
- Visually inspect the round felt material on the underside of the decorative trim (Figure 10). The felt material pushes against the microphone's rubber seal and forms a barrier. The decorative trim should be replaced (see ETKA) if the material is bunched up or not centered perfectly, as it can potentially affect the call quality.

*Figure 10. Felt on backside of decorative trim.*

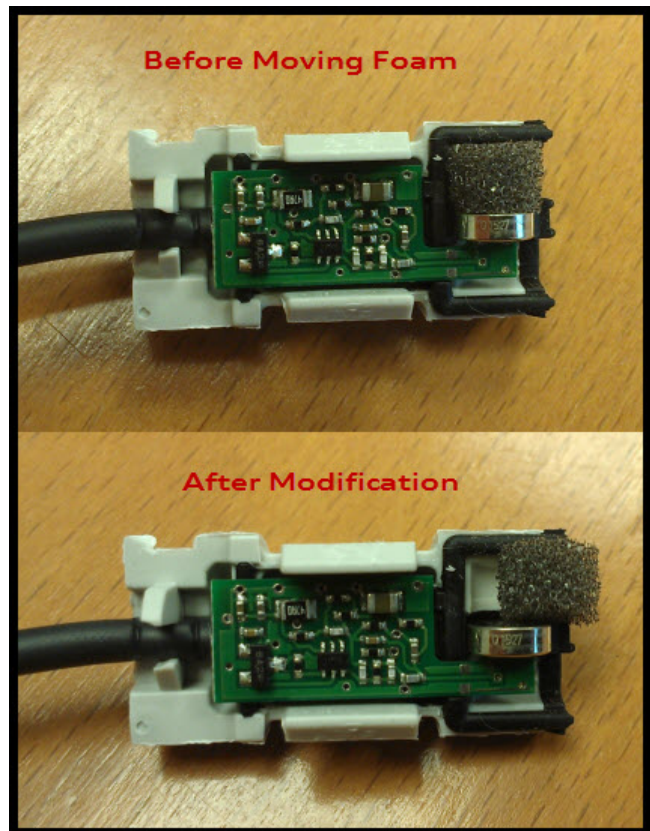
**Figure 11.** After modification, the foam should be partially pulled out of the microphone.

- Before installing the new microphone, partially pull out the foam that is inserted in the microphone to allow for a better seal against the felt material (Figures 11 and 12).

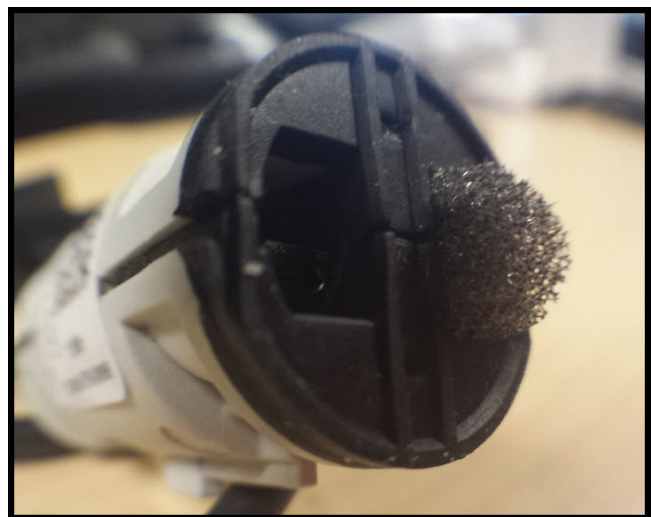
**Figure 12.** Foam is partially pulled out of the microphone.
