Technical Service Bulletin

91 MMI 3G Basic Sound system "popping" (K0250 Update)

91 14 21 2035232/2 January 9, 2014. Supersedes Technical Service Bulletin Group 91 number 13-09 dated September 25, 2013 for reasons listed below.

Model(s)	Year	VIN Range	Vehicle-Specific Equipment
A6, A7	2010 - 2011	All	Not Applicable
Q7	2010 - 2013	All	Not Applicable

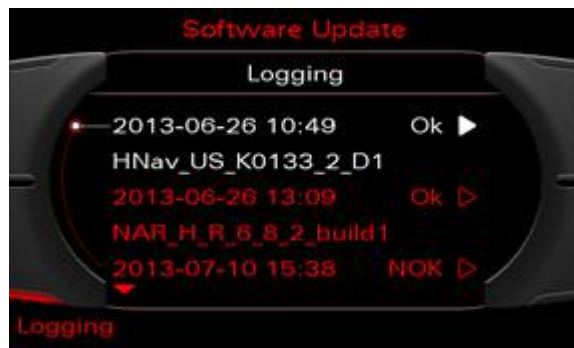
After a successful update, the screen will show the date on which the update was performed and the software that was installed (BBT_US_K0250_X_XX — The X characters will be one of several different numbers or letters). 'Ok' will be listed on the right. If K0250 does not have any rows with 'Ok', the update must be retried until it is successful.

Figure 1. Software update log showing a successful software installation. (MMI 3G High screenshot used as reference).

2. Verify that the software update has been completed successfully by accessing the Logging page (Figure 1). To access this screen, proceed to step 8 in TSB 2028141, and press the lower left softkey.

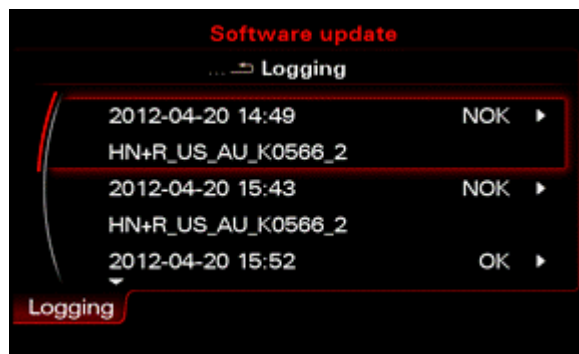
Figure 2. Software update log showing 2 failed attempts before a successful installation (MMI 3G+ screenshot used as reference).

Tip: If the update must be performed two or more times because the modules are not updating correctly, a screenshot of the software update log is required (Figure 2). This should be kept on-hand for warranty auditing purposes. To take a screenshot, insert an SD Card into slot 1 and press and hold the left and right arrow keys at the same time. All four softkeys will flash when the screenshot is taken. A screenshot should be taken of each page in the logging display.
