Technical Service Bulletin

69 Replaced airbag control unit cannot be coded

69 14 28 2023323/12 March 31, 2014. Supersedes Technical Service Bulletin Group 69 number 13-26 dated October 21, 2013 for reasons listed below.

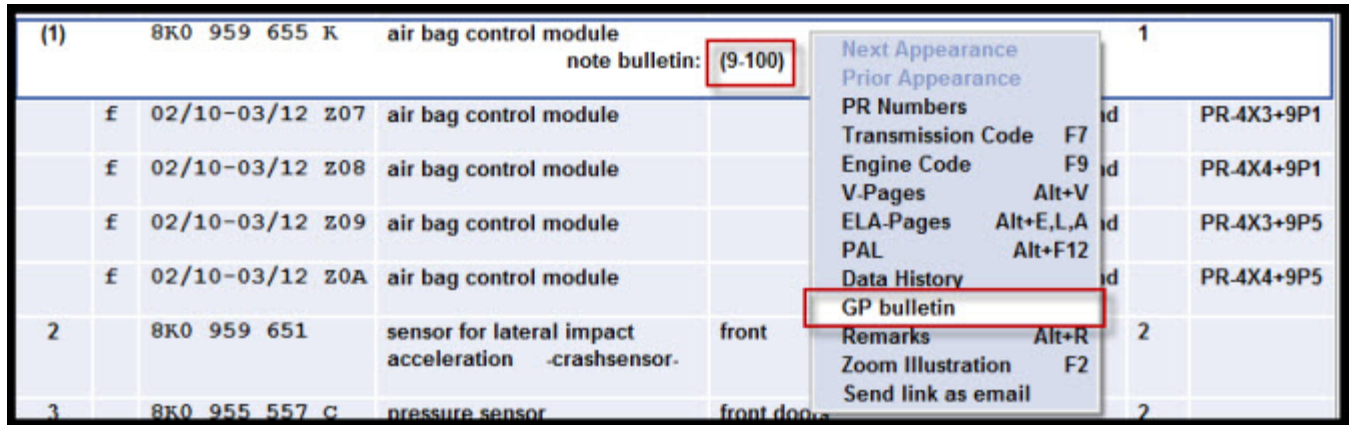
Figure 1. Selecting GP bulletin in ETKA.

1. Locate the part in ETKA. Use the FI search function (VIN filter) to determine if the correct control module (including color code) was ordered for the vehicle.
2. To open the GP bulletin, right-click the part number and select **GP Bulletin** from the drop-down menu (Figure 1).

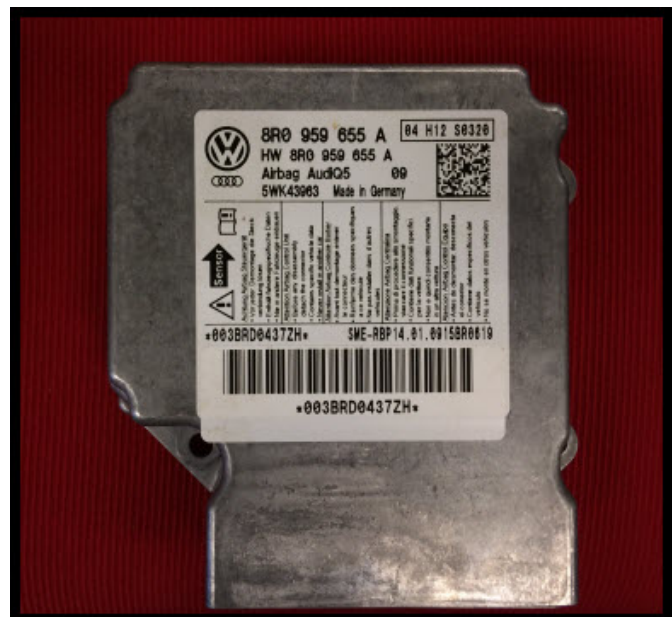
Figure 3. Production Control Unit

Tip: The color code indicates the ECU software that the control module must be programmed with to operate correctly in the North American Market. Only control modules to be used for service will have a color code. In addition, some service parts will have a secondary label placed over the original supplier label after the part has been programmed for the North American market (Figure 3 and Figure 4).

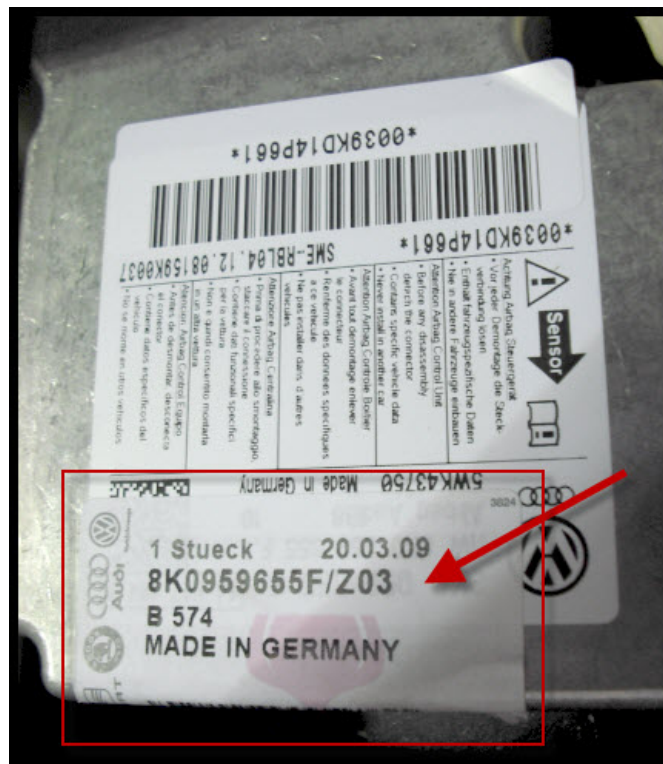
Figure 4. Service Part Control Unit
