Technical Service Bulletin

91 Bluetooth call quality issues for caller on other end of call (A5 Cabriolet, TT Roadster)

91 14 33 2036865/1 April 8, 2014.

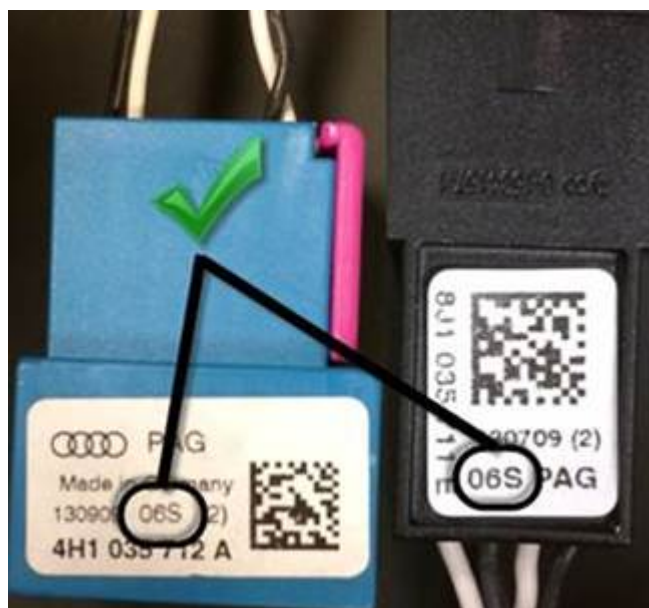
Improved microphone installation procedure and optimized the microphone seal, beginning with January 2012 vehicle production. Microphones with improved seals are at the 03S level or greater (Figure 1).

Figure 1. Microphones with improved seals.

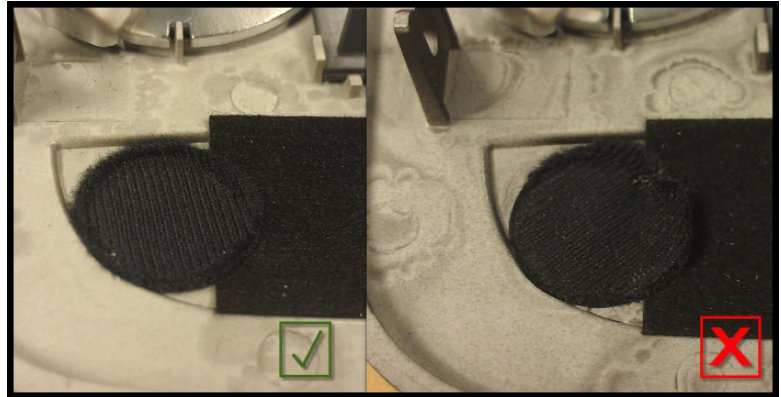
1. Visually inspect the round felt material on the underside of the decorative trim (Figure 5). The felt material pushes against the microphone's rubber seal and forms a barrier. The decorative trim should be replaced (see ETKA) if the material is bunched up or not centered perfectly, as it can potentially affect the call quality.

Figure 5. Felt on backside of decorative trim.

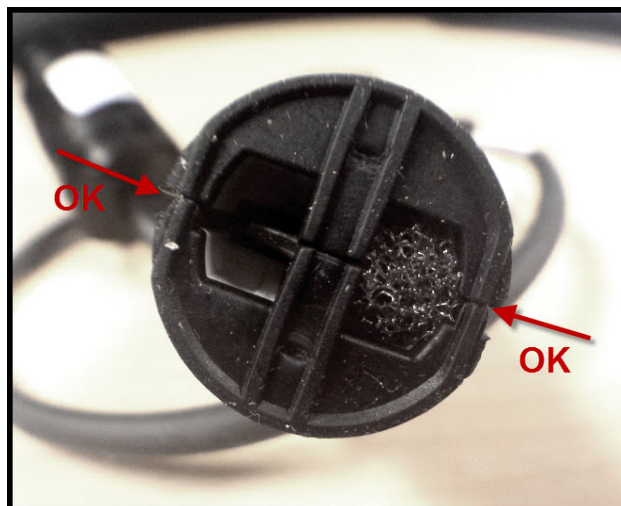
2. Inspect the seal of the microphone for damage:
 - There are two splits in the rubber seal. This is normal as long as the two halves of the seal are touching each other (Figure 6).
 - If the two halves of the seal are loose and move freely, the seal is damaged (Figure 7).

Figure 6. Undamaged seal.

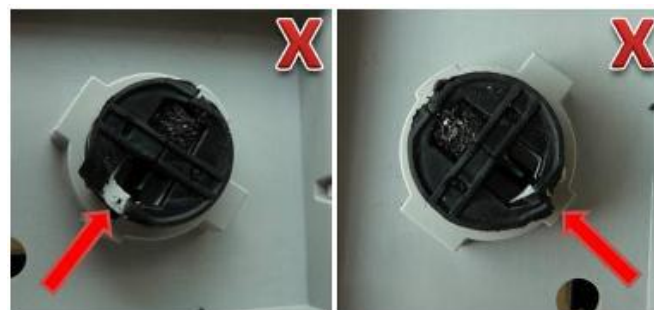
Figure 7. Examples of damaged seals

If any of the seals are damaged, install a replacement microphone:

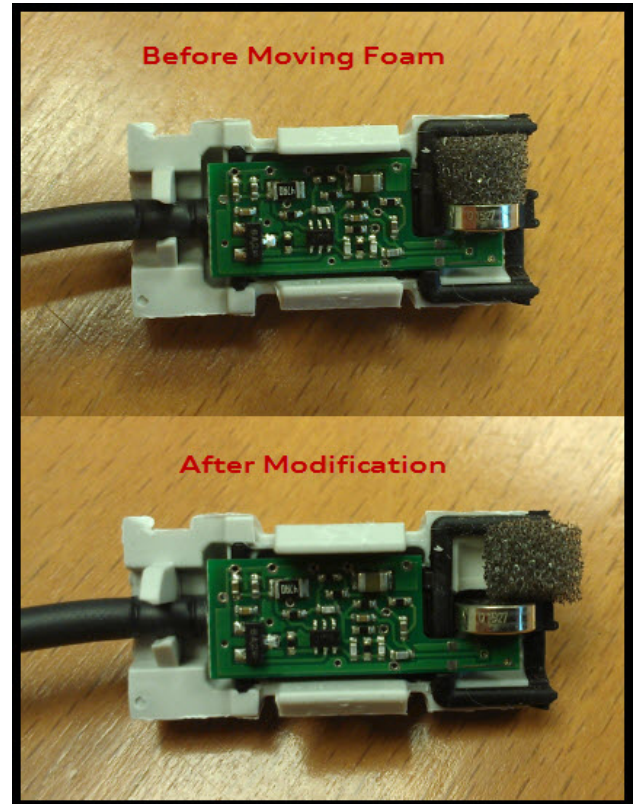
Figure 8. After modification, the foam should be partially pulled out of the microphone.

- Before installing the new microphone, partially pull out the foam that is inserted in the microphone to allow for a better seal against the felt material (Figures 8 and 9).
- In order to prevent damage to the microphone seal, install the microphone while the decorative trim is removed from the base plate. Slowly install the microphone perpendicular to the base plate (Figure 10). Do not install the microphone at an angle, as this may pinch the seal (Figures 11 and 12).
- Carefully inspect the new microphone seal after it has been snapped into place.

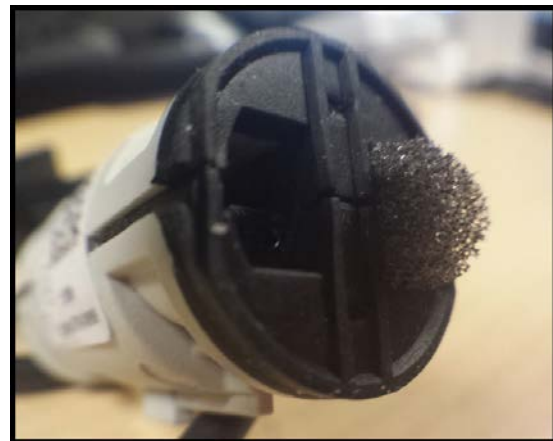
Figure 9. Foam is partially pulled out of the microphone.

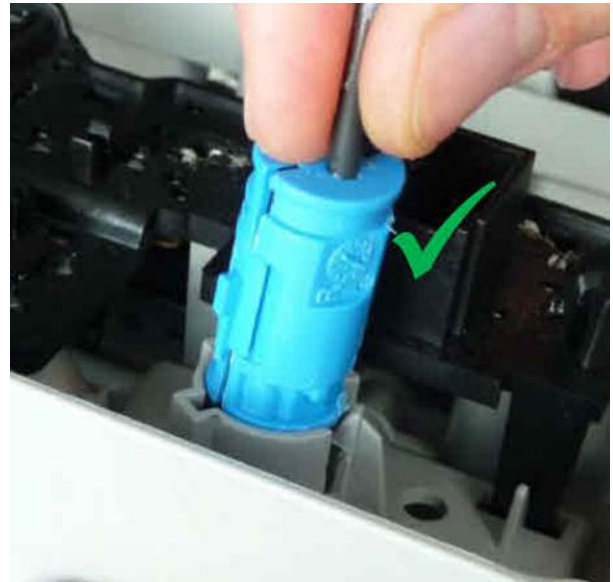
Figure 10. Proper installation.

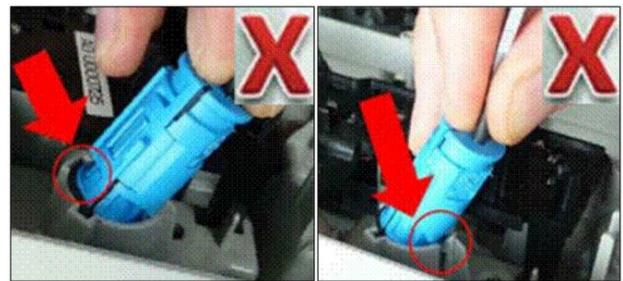
Figure 11. Incorrect installation at an angle, showing a pinched seal on the left.

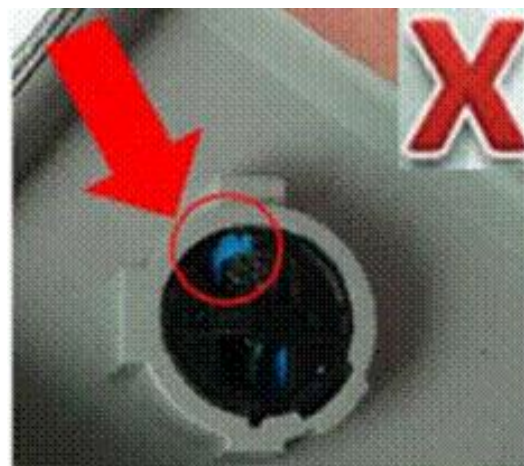
Figure 12. Damage caused by a pinched seal.
