Technical Service Bulletin

97 No start (DTC P068A00)

97 14 43 2036764/3 April 14, 2014. Supersedes Technical Service Bulletin Group 97 number 14-42 dated March 31, 2014 for reasons listed below.

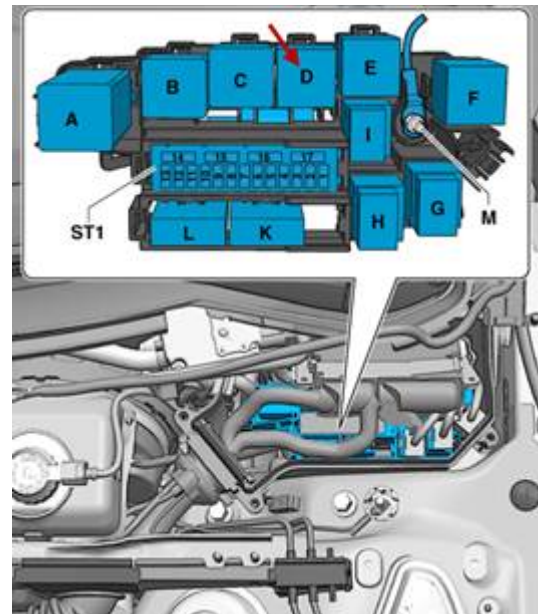
Figure 1. Location of J271 relay (D), as shown in Elsa.

2. Check Elsa for the location of the J271 relay (*Wiring diagrams >> Component locations >> Component Locations: Relays*) (Figure 1).

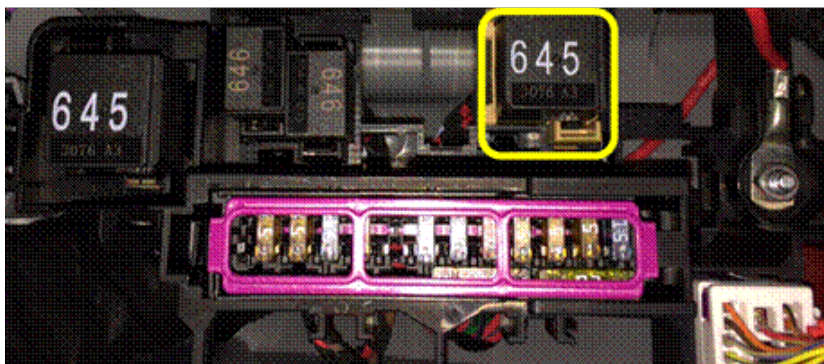
The motronic engine control module power supply relay, J271, is not functioning properly. Because the J271 relay controls battery voltage (Terminal 30) via a ground signal sent from the ECM, numerous faults can occur in multiple control modules when it is not functioning properly.

Figure 6. J271 relay (outlined).

7. The J271 relay is now accessible (Figure 6).

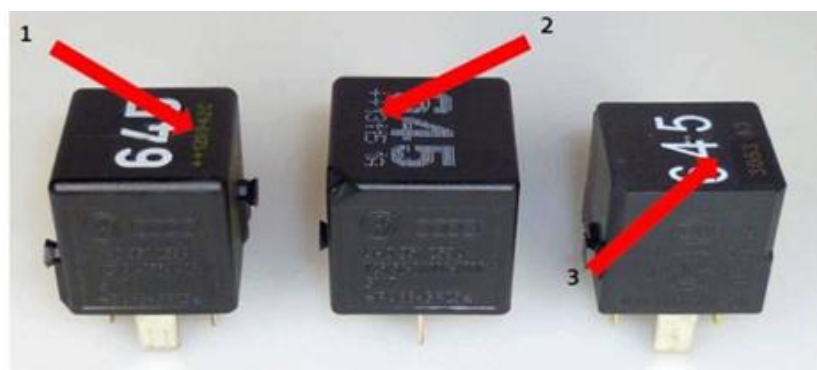
Figure 7. Relay manufacture data: Tyco Electronics relay with a yellow label (1), Tyco Electronics relay with a white label (2), Hella relay with a white label (3).

8. Check the relay manufacture build information on the relay. This information is printed under "645" on the relay:

- If the relay is from Tyco Electronics and has a yellow label (Figure 7, 1), replace the relay and proceed to step 10.
- If the relay is from Tyco Electronics and has a white label (Figure 7, 2) or from Hella and has a white label (Figure 7, 3), do not replace the relay. Proceed to step 9.

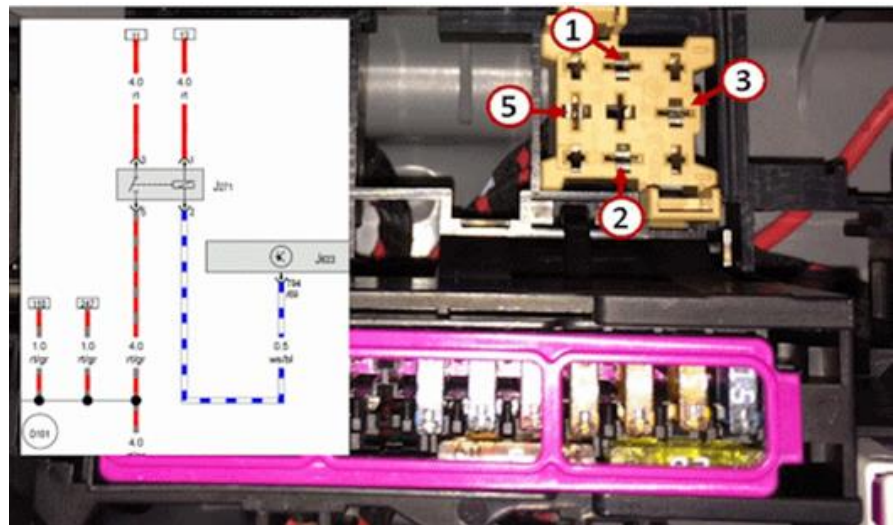
Figure 8. J271 relay pins. Terminal 1: 30 power from SA2, Terminal 2: switched ground from J623, Terminal 3: 30 power from SA2, and Terminal 5: switched power from J271.

10. Check for battery voltage on J271 relay harness terminals 1 (85 power) and 3 (30 power) (Figure 8 and Figure 9).

If no voltage is found, do not proceed with this bulletin. Continue with diagnosis.

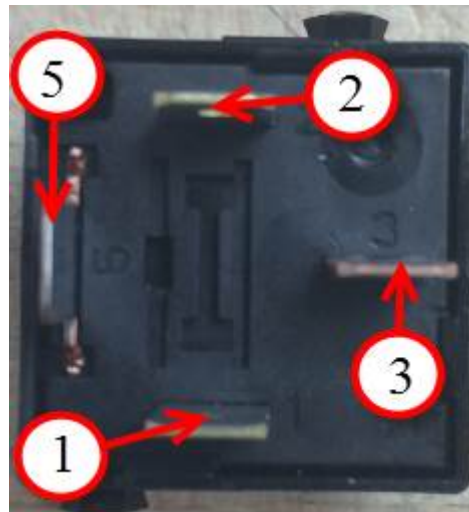
Figure 9. Relay terminal locations. Terminal 1: 85 Terminal 2: 86 Terminal 3: 30 Terminal 5: 87
