# Technical Service Bulletin

## 21 MIL on (DTC P0299 - negative pressure deviation); turbocharger excessive wastegate play

21 14 18 2031245/7 June 6, 2014. Supersedes Technical Service Bulletin Group 21 number 13-16 dated July 9, 2013 for reasons listed below.

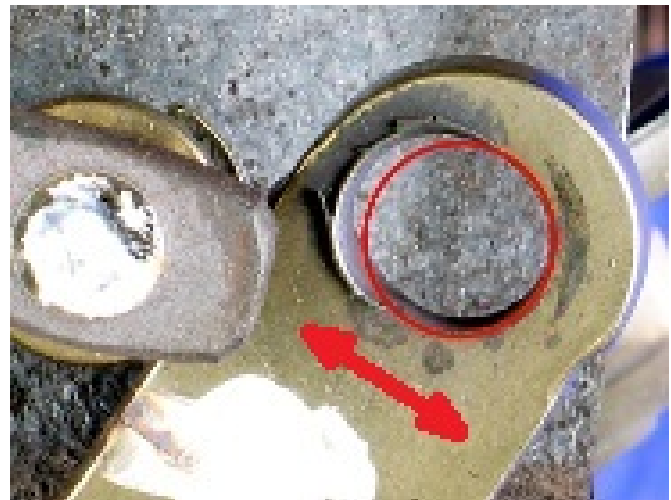
Under certain driving conditions, the linkage for the waste gate actuation can encounter excessive wear which leads to play at the waste gate flap. This leads to boost escaping through a loose flap, which sets **DTC P029900** (Negative Pressure Deviation).

- Verify the condition by confirming that **DTC P029900** is stored in the ECM, and that the wastegate link plate has visible play in the direction of the actuating rod (Figure 1). Review the attached video clip for an example.

**Figure 1.** Worn eye on wastegate link plate allowing excessive play.

2. Remove turbocharger according to the instructions in ElsaWeb: *Repair Manual >> Engine / Engine Mechanical >> 21 Turbocharger, G-Charger >> Removal and Installation >> Turbocharger.*
3. Install clip **06J145220B** on a new, replacement turbocharger's link plate and actuating rod joint as illustrated (Figures 2 and 3).

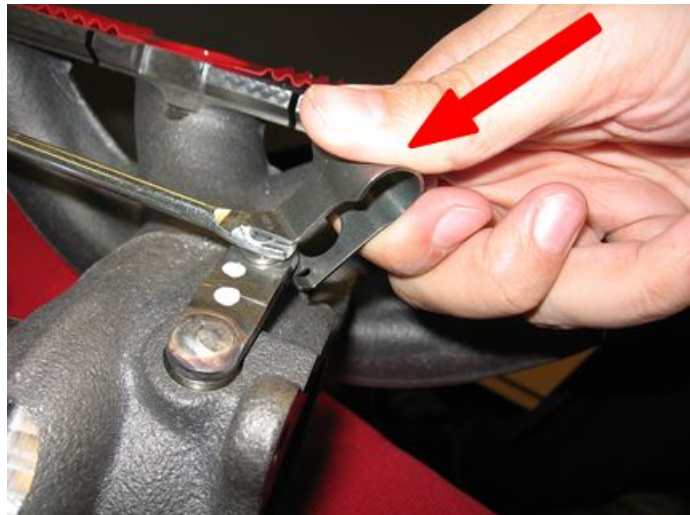
**Figure 2.** Fit the clip from the side.

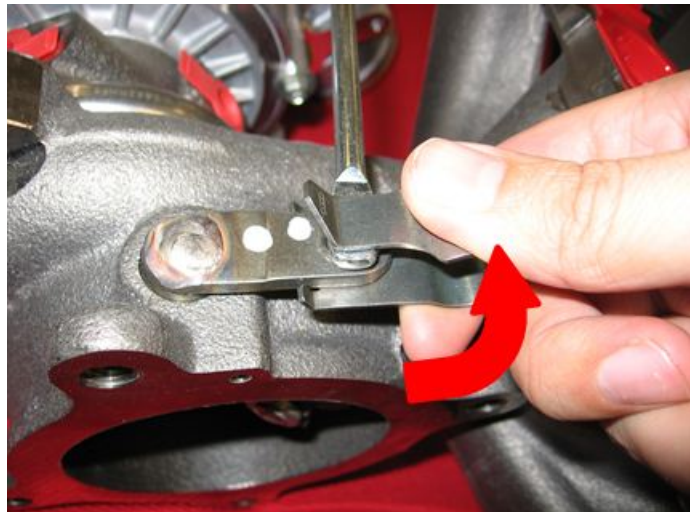
**Figure 3.** Turn the clip counter clockwise till the lugs slot in.

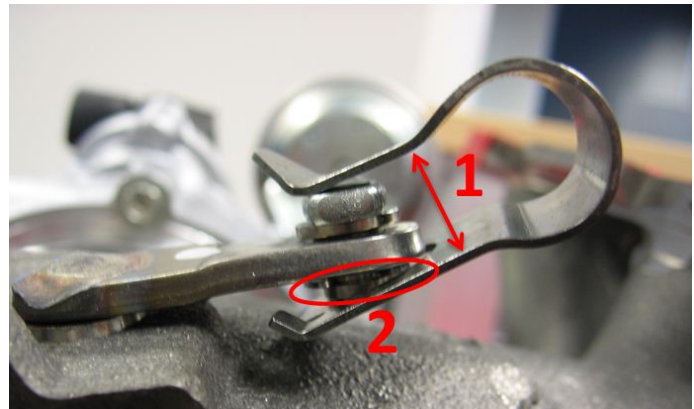
**Figure 4.** (1) Maximum opening of clip, (2) Position of original circlip

- The spring clip must not be overstretched. The maximum opening of the spring clip is 14 mm (Figure 4, 1).
- The spring clip must be replaced after every removal.

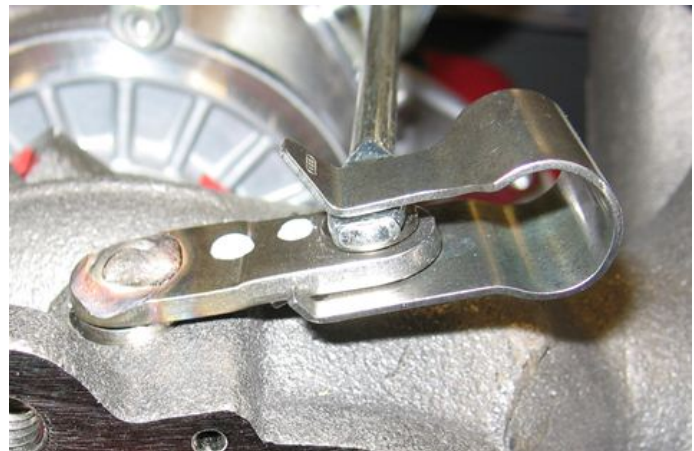
**Figure 5.** Correctly-fitted clip.

5. After fitting the spring clip, check for correct fit (Figure 5).

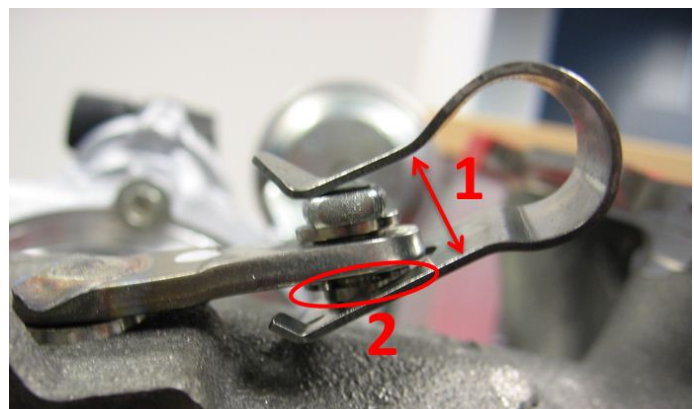
**Figure 6.** (1) Maximum opening of clip, (2) Position of original circlip

6. After fitting the spring clip, check the position of the original circlip (Figure 6, 2) and correct it if necessary.
