Technical Service Bulletin

94 Side mirror turn signal inoperative

94 12 90 2030956/2 October 8, 2012. Supersedes Technical Service Bulletin Group 94 number 12 – 88 dated September 25, 2012 for reasons listed below.

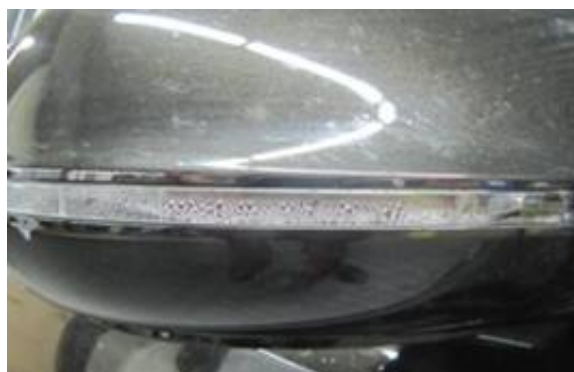
The turn signal indicator lens is inoperative without any damage from outside influence. Cracks have formed in the lens and as a result condensation can be seen behind the lens as shown in Figure 1.

Figure 1 Condensation in turn signal lens

The turn signal lens can crack due to the high amount of tension in the side mirror housing. The tension is due to improper installation of the mirror at the factory and is not a defect in the mirror housing. Replacing the mirror housing will not affect this condition.

1. Remove the side mirror as instructed by the ElsaWeb Repair manual.

2. Replace the damaged turn signal lens in the side mirror.

3. Test turn signals.
4. Clear DTCs in electrical system.
