Technical Service Bulletin

43 Self-leveling compressor inoperative

43 12 11 2018765/7 October 29, 2012. Supersedes Technical Service Bulletin Group 43 number 12-08 dated February 2, 2012 for reasons listed below.

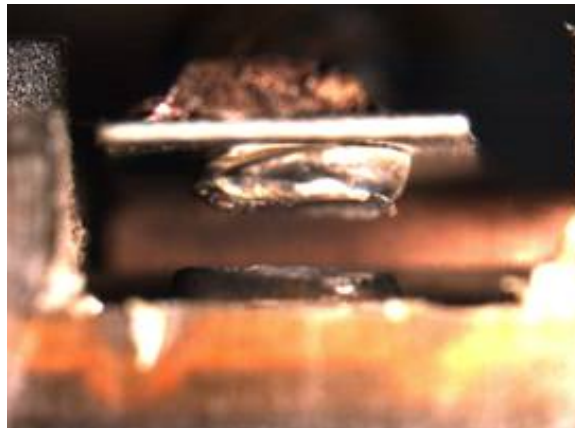
Figure 1. Strong erosion of both contacts.

If the relay resembles Figures 1 to 3, replace the compressor and relay J403 for the self-leveling system.

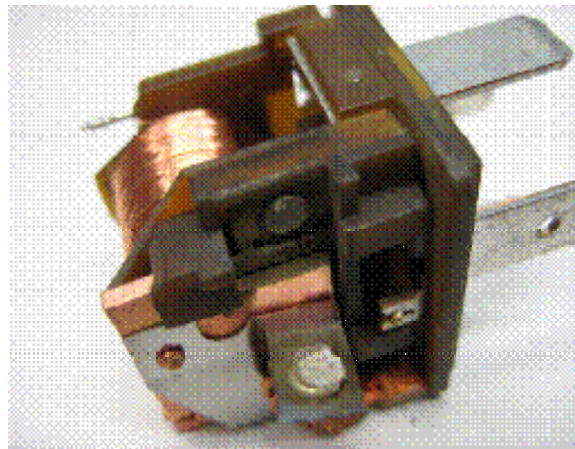
Figure 2. Strong erosion of both contacts.

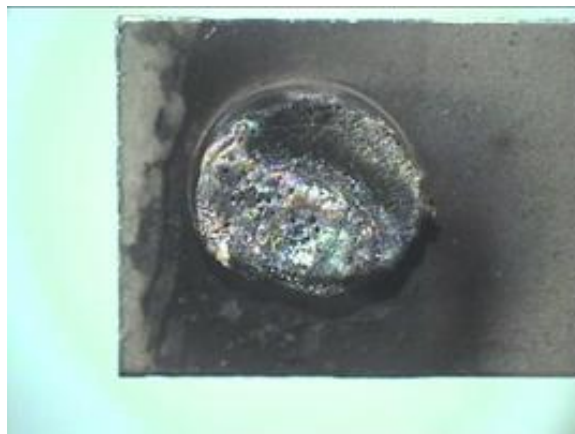
Figure 3. Strong erosion of the spring contact.

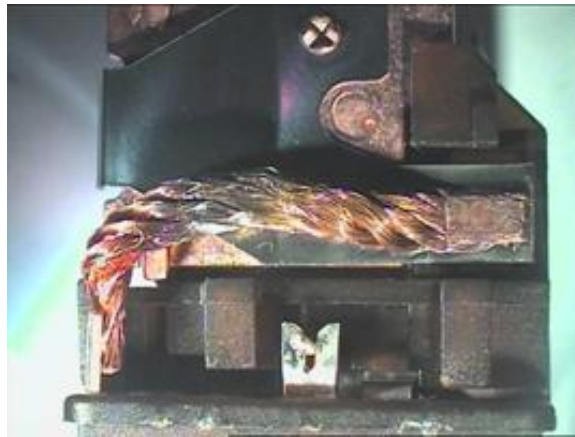
5. Discoloring of the strand is also a clear indication of permanent operation of the compressor (Figure 4).

Figure 4. Overheated strand.

Replace the compressor and relay J403 for the self-leveling system.

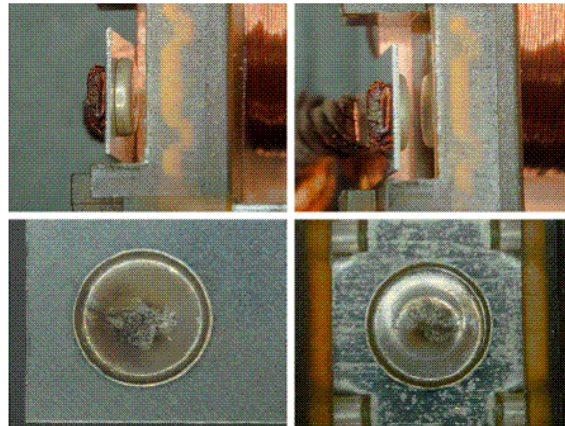
Figure 5. Contacts with minor marks; relay OK.

6. If the contacts resemble those in Figure 5 and the compressor has a working noise similar to a comparable vehicle, replace *only* the opened relay J403 for the self-leveling system.
