Technical Service Bulletin

42 Loud cracking or rubbing noises when steering (cars without Audi magnetic ride suspension)

42 12 16 2021724/4 November 13, 2012. Supersedes Technical Service Bulletin Group 40 number 12-24 dated June 6, 2012 for reasons listed below.

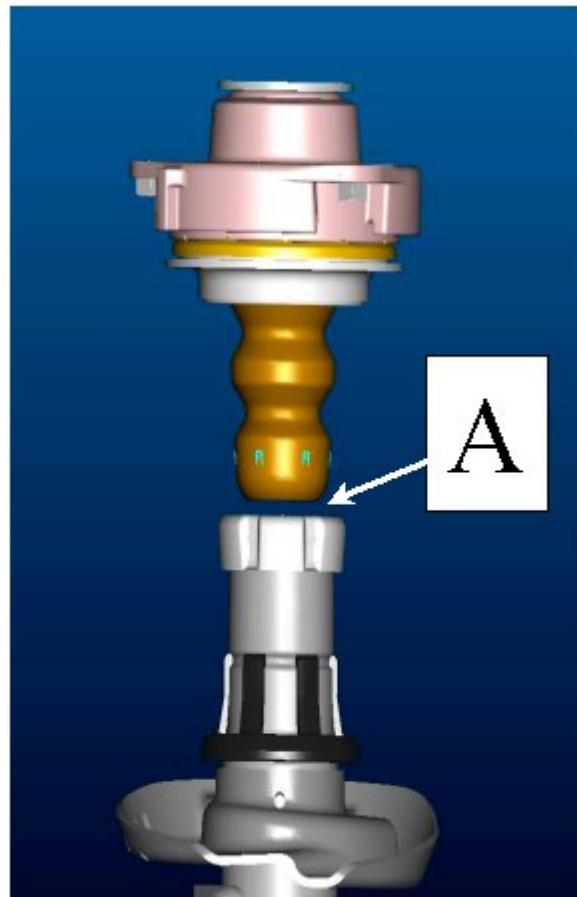
- While steering, the shock absorber stop can chafe on the plastic cap of the suspension strut.
- If the vehicle is lifted up, the noise disappears.
- The boot is not properly secured / installed, or is deformed.

Figure 1. The contact surface of the plastic cap of the suspension strut (A).

1. Brush silicon grease **G 000 405 A2** on the contact surface of the plastic cap of the suspension strut where it makes contact with the rubber stop (yellow).
