Technical Bulletin

26 15 04 April 30, 2015 2039436 Supersedes Technical Bulletin V261501 dated January 21, 2015 to change Golf vendor code from WWO to 3ME and update supply line front labor operation number.

Ad Blue Warning and or MIL ON - Ad Blue Leakage at Reductant Injector

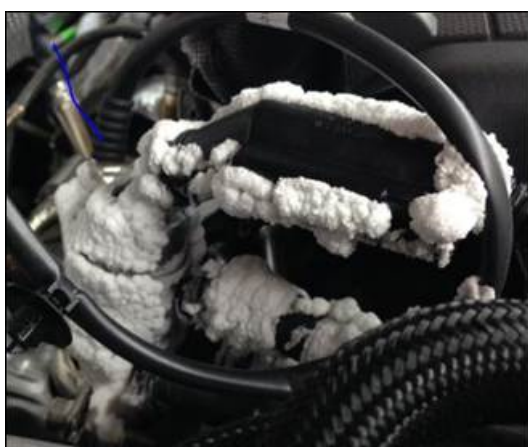
Welding process issues of the reductant line connector to the supply line may cause Ad Blue leakage at the reductant injector.

Inspect the connection of the reductant supply line connector at the reductant injector in the engine compartment. If white crystalized (dried) Ad Blue is found at the reductant injector (see Figure 1 & 2), it will be necessary to replace the reductant supply line.

Thoroughly clean the area of the reductant supply line connection with water to remove the crystalized Ad Blue. Replace the reductant supply line.
