Technical Bulletin

26 15 02 April 13, 2014 2038752

MIL ON, Exhaust Flap Faults P048B, P048E, P0475, P0478, P0477 stored in ECM Fault Memory

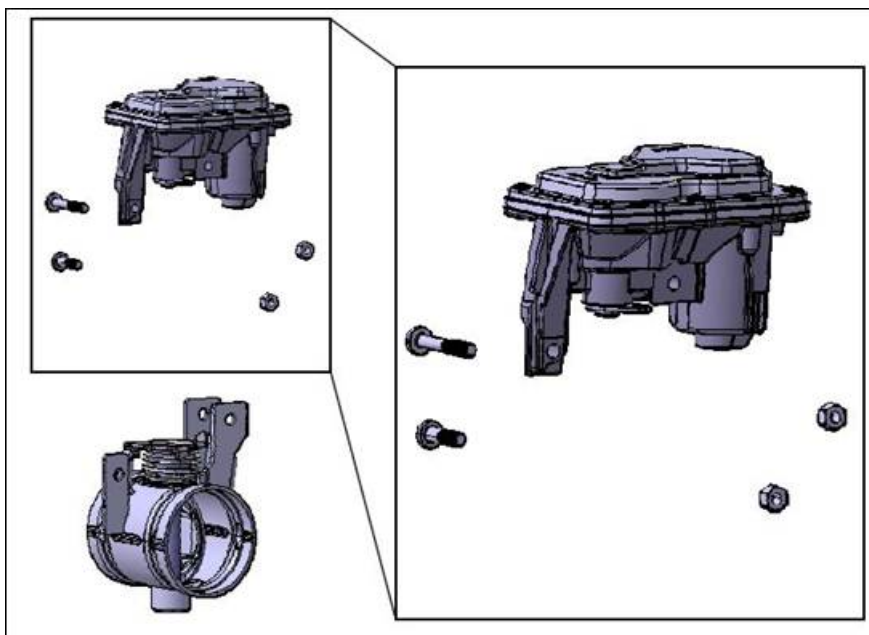
Figure 1

Contents of the package:

Actuator

2 screws

2 nuts

All contents of the package must be used. Re-use of the existing fasteners is not allowed.
