Technical Bulletin

26 15 03 April 24, 2015 2038752 Supersedes Technical Bulletin V261502 dated April 13, 2015 to correct Golf vendor code.

MIL ON, Exhaust Flap Faults P048B, P048E, P0475, P0478, P0477 stored in ECM Fault Memory

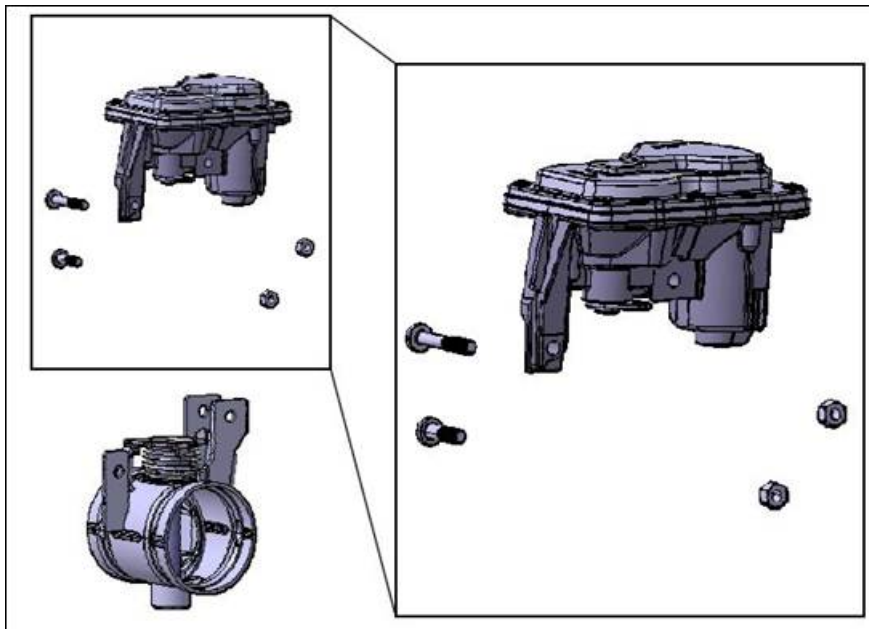
Figure 1

Contents of the package:

Actuator

2 screws

2 nuts

All contents of the package must be used. Re-use of the existing fasteners is not allowed.
