Technical Bulletin

Model(s)	Year	Eng. Code	Trans. Code	VIN Range From	VIN Range To
e-Golf	2015	All	All	All	All

91 15 04 April 29, 2015 2040330

Modular Infotainment System (MIB) Display Shows Fuel Pump Icon after J794 Module Replacement

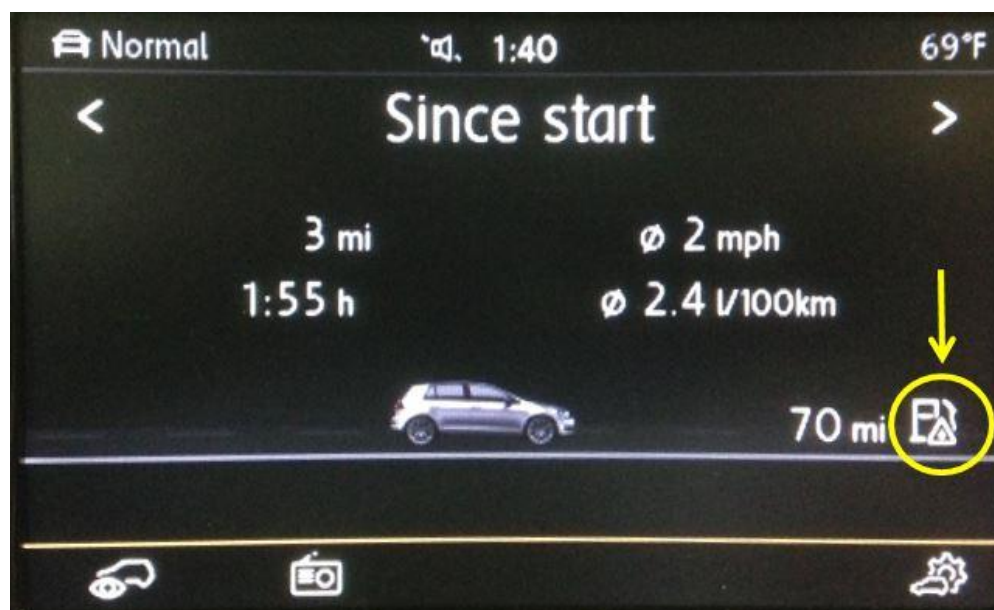
The customer may complain that after a repair involving replacement of the 5F Information Electronics Module J794, that the icon in the lower right hand side of the “Car” menu on the MIB display shows the image of a fuel pump instead of an electric charging station icon.

This procedure corrects the concern listed above by updating the 5F Information Electronics Module to software E4250.
