Technical Bulletin

Model(s)	Year	Eng. Code	Trans. Code	VIN Range From	VIN Range To
e-Golf	2015	All	All	All	All

87 15 04 May 13, 2015 **2040184** Supersedes Technical Bulletin V871503 dated March 26, 2015 due to new improvements with Thermal Management SW109.

Climatronic with Heat Pump - Sporadically Too Low Heating or Cooling Performance

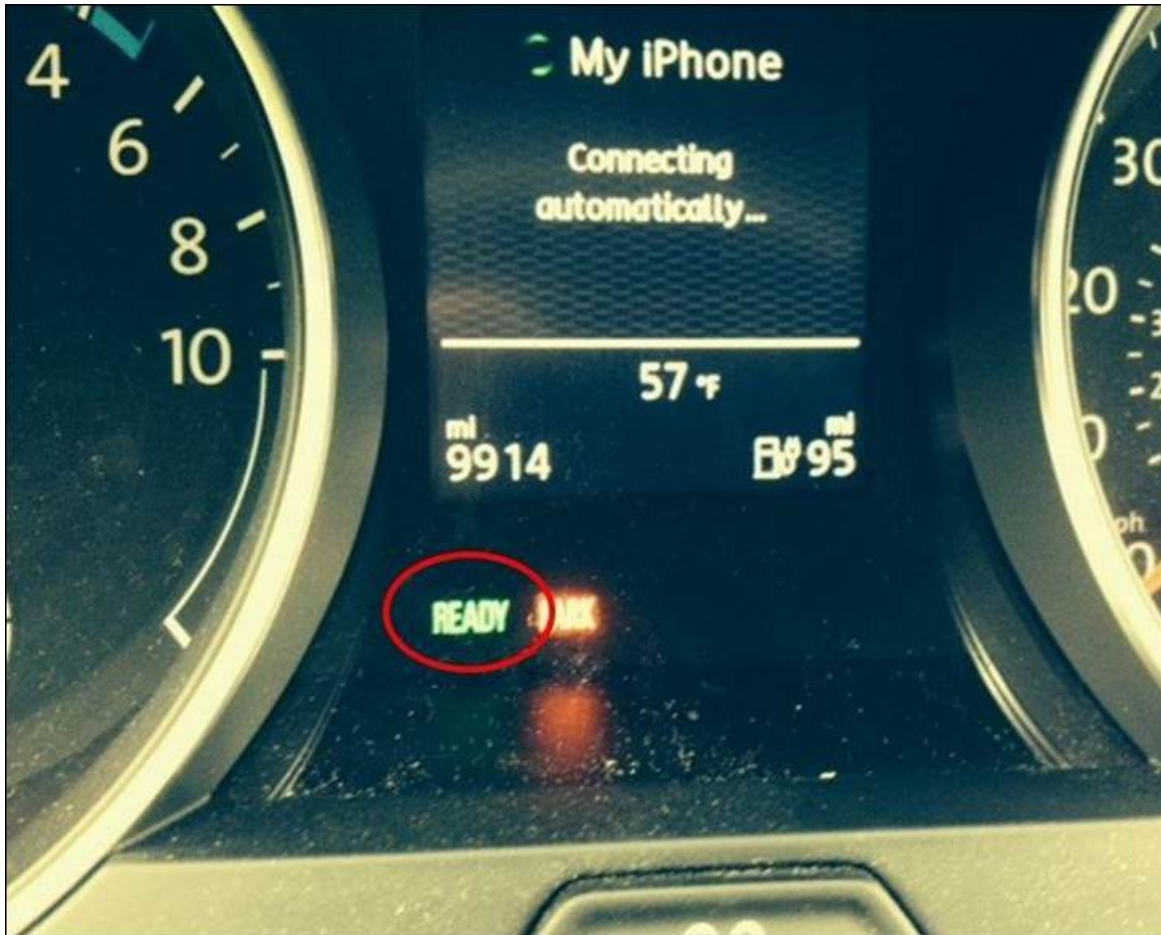
Figure 1

After the software update an initial run of the compressor must be carried out according to the Guided Functions. The start switch must be ON, brake pedal depressed and electric motor indicator in the instrument panel in READY status (Figure 1). The initial run of the compressor will not complete without READY status illuminated.
