Technical Bulletin

Model(s)	Year	Eng. Code	Trans. Code	VIN Range From	VIN Range To
Phaeton	2004 –2006	All	All	All	All

58 15 02 July 21, 2015 2039211 Supersedes technical bulletin V581404 dated December 18, 2014 to update service number.

Corrosion on Rear Doors (Multiple Locations)

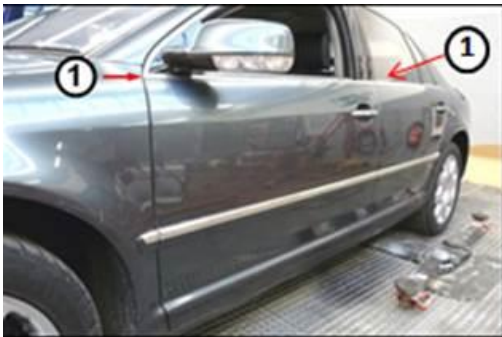
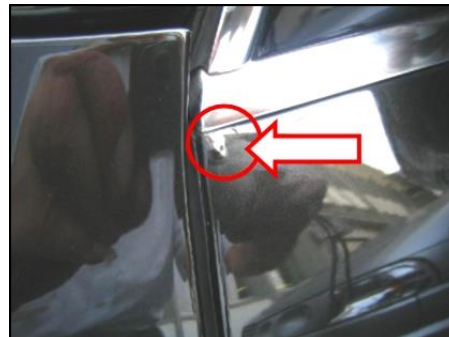
Figure 1 – Upper window channel strip

Figure 1.1

Alignments in production can lead to hairline cracks in the top coat and paint damage (edges on holes) on the already painted door. Humidity then penetrates paint and causes blistering and/or white corrosion.

- Inspect the inner edge area of the doors for cracks, particularly the fine seam sealing.
- Completely remove the corrosion in the damaged area.
- Apply a VOC compliant epoxy primer as an anti-corrosion treatment and primer to both sides of the door (locally sourced).
- Seal the edges/metal sheathings with adhesive (part number: AKD 476 KD505) before painting.
- Repaint door according to Volkswagen guidelines

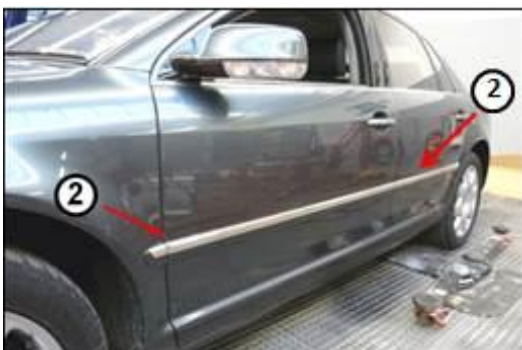
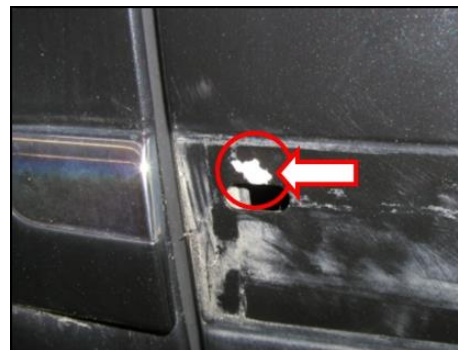
Figure 2 – Central protective strip

Figure 2.1

1. Central protective strip

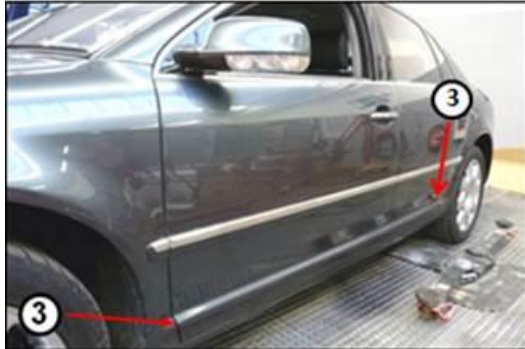
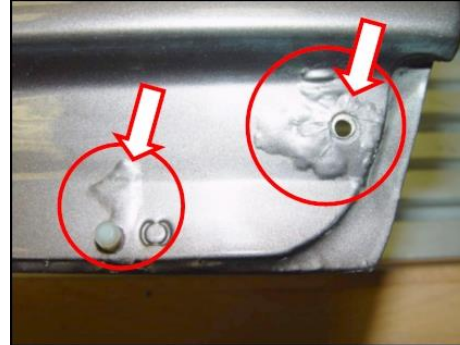
Figure 3 – Lower protective strip

Figure 3.1

2. Lower protective strip

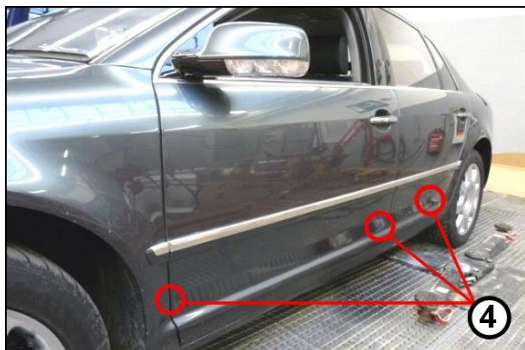
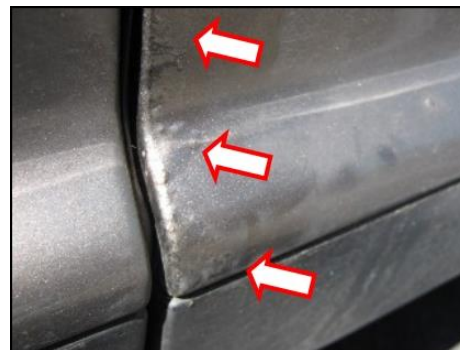
Figure 4 – Surface/edge corrosion

Figure 4.1

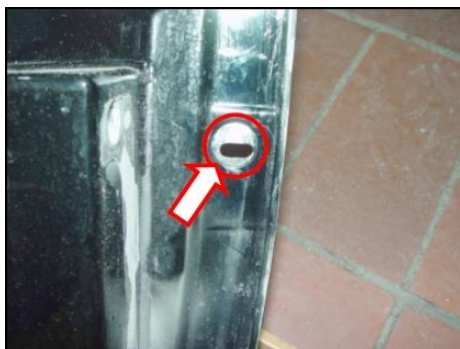
Figure 5

Holes and edges in the flange area
