# Technical Bulletin

Model(s)	Year	Eng. Code	Trans. Code	VIN Range From	VIN Range To
Touareg	2004 – 2010	All	All	7L_4D000001	7L_AD005286

**58 15 01** July 21, 2015 **2039001** Supersedes Technical Bulletin V581402 dated December 16, 2014 to update the service number.

### Corrosion, Rear Inner Doors in Door Fold Area

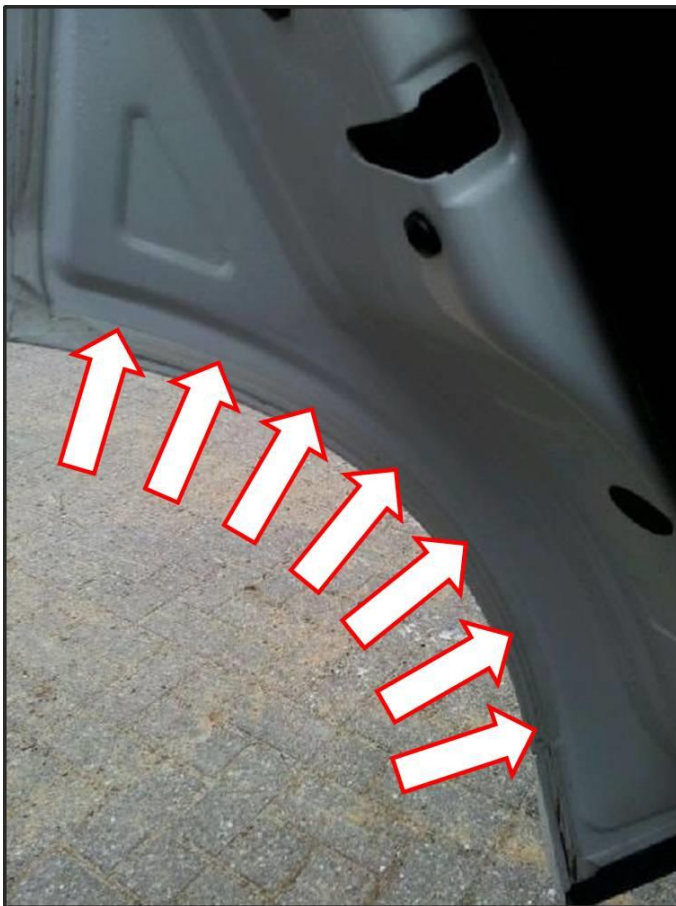
Corrosion in the fold of the rear door.

Figure 1) Arrows show the area affected by corrosion

1. Fine seam sealing in the area of the rear door fold not optimal.
2. Bonding of the rear door in the metal fold not optimal.
3. Incorrect or no cavity coating.

1. Repair the rear door fold **Only perform this operation if the total repair cost is 80% or less of the total replacement cost.**

**If the door fold is only lightly corroded (no through-corrosion), proceed as follows:**

- Protect the outer door area against damage by covering the door fold area with masking tape.
- Remove corrosion and fine seam sealing in the damaged area using a pneumatic brush grinder.

- Apply a VOC compliant epoxy primer as an anti-corrosion treatment and primer (locally sourced).
- Restore the fine seam sealing according to the repair manual.
- Restore the paint structure according to Volkswagen guidelines.

- Replace the door according to the repair manual. See Repair Manual Group 58 in Elsa.
