# Technical Bulletin

**40 15 02** August 14, 2015 **2033347** Supersedes V401401 dated March 4, 2014 to include additional model and model year applicability.

### CV Boot Replacement

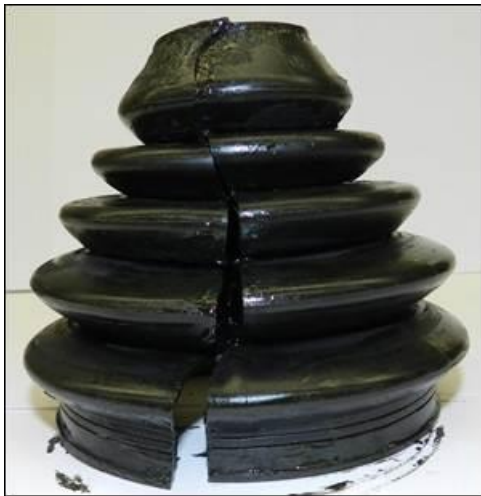
CV Boots should not be cut or sliced upon removal.

If it is determined that a CV boot needs to be replaced, the boot should be removed and replaced without cutting or slicing the boot open. Once the CV Joint is removed the boot will slide off the axle shaft. Refer to repair manual group 40, removal procedure for drive axle disassembly, in Elsa.
