Preliminary Information

PIP5495C Check Engine Light On With P0299 Or P0234

Models

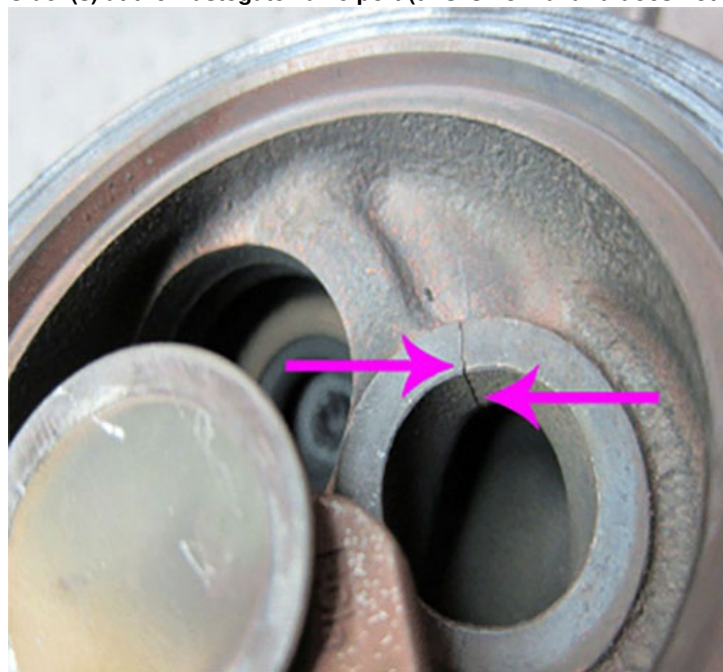
Crack(s) at the wastegate valve port (this is normal and does not affect performance)

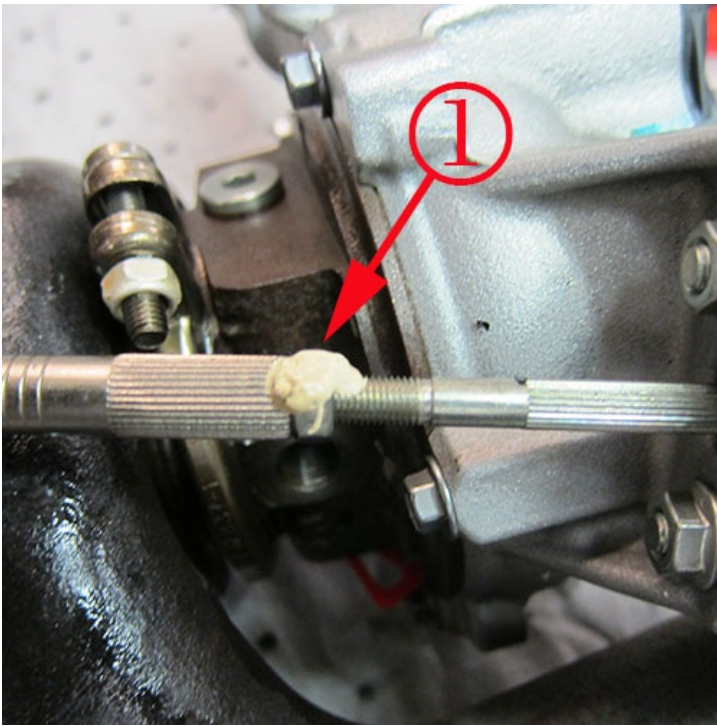
If the tamper paint seal is broken or missing, check the vehicle for any additional sign of modification to the induction, exhaust, or engine calibrations as this may indicate an attempt to adjust the wastegate arm to modify the powertrain operation.

If found, review the powertrain warranty status with your service manager prior to performing repairs.

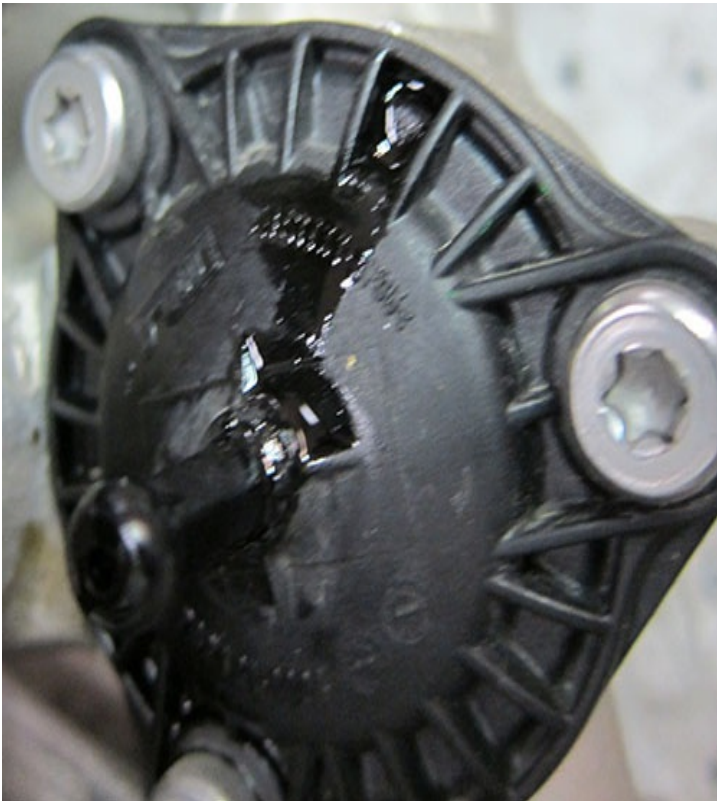
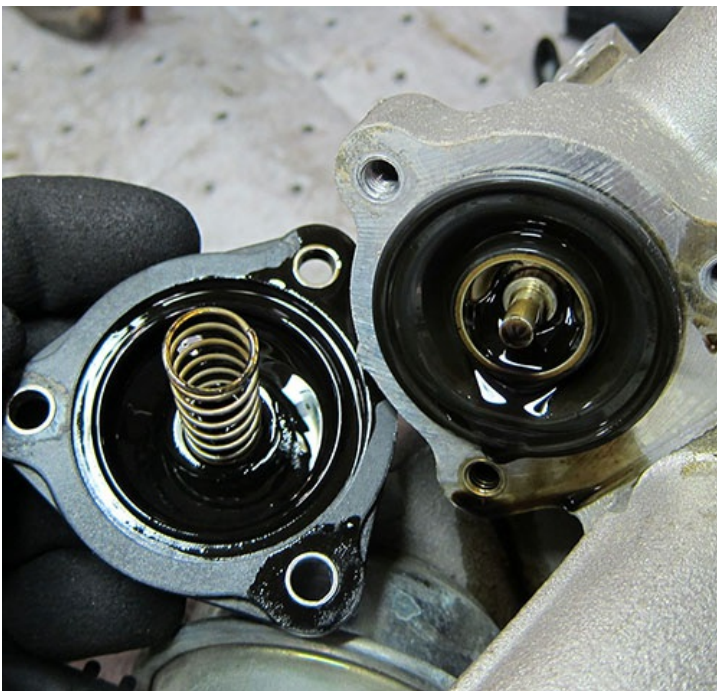
Bypass (recirculation) valve cover port broken or water/oil found inside the valve (clean the components, if necessary replace bypass (recirculation) valve assembly - released for service)

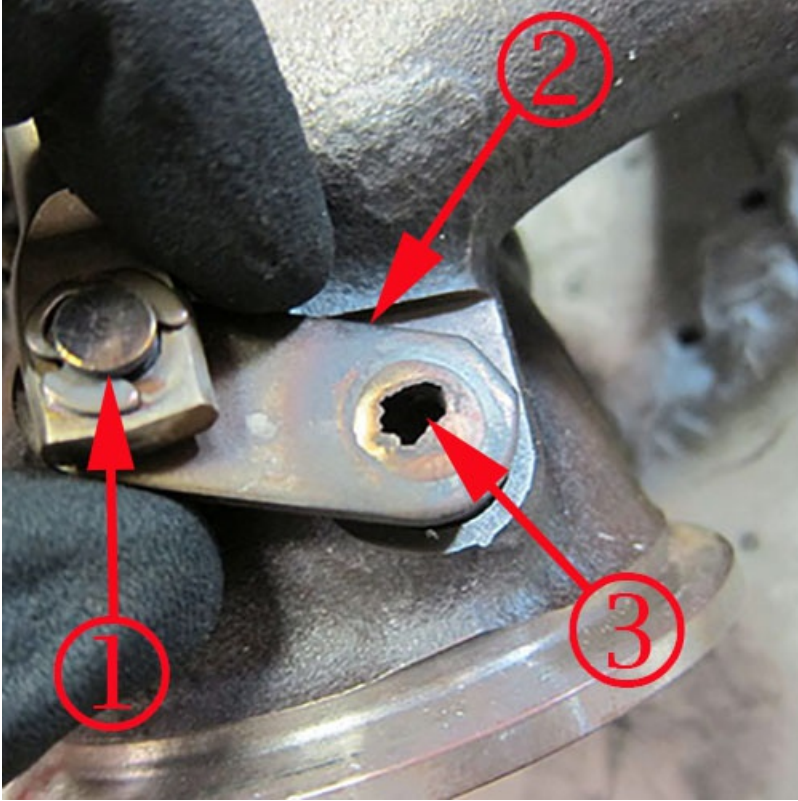
Disconnected wastegate lever arm (crank) (2) from the shaft (3).

Disconnected wastegate lever arm pin (1) from the lever arm (crank) (2).

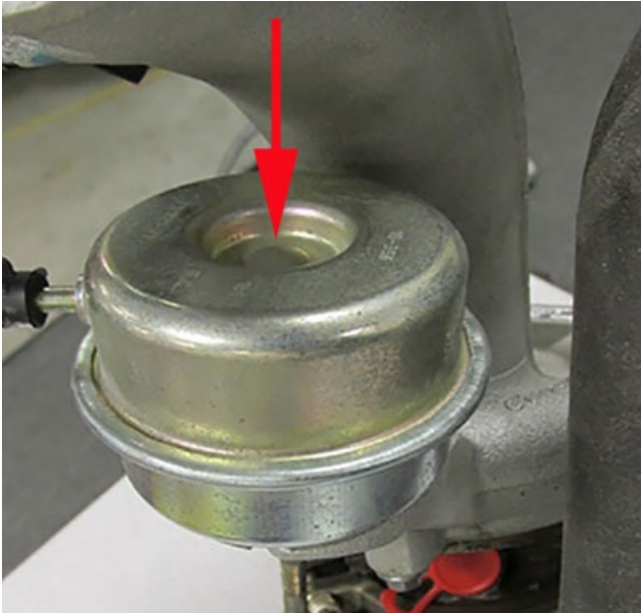
The original equipment wastegate actuator found on 2011 and 2012 model years shown below, has a recessed stop at the head of the actuator.

Original equipment actuator is found on 2011 and 2012 model years.

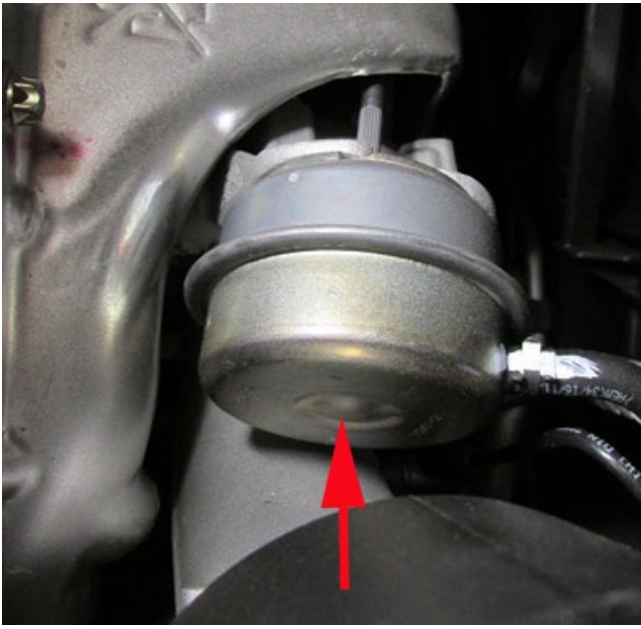
The updated design actuator shown below has a stop that is not recessed and allows 5mm more travel in the closed direction.

With this updated design, it is very unlikely that an insufficient preload issue exists.

Updated design.

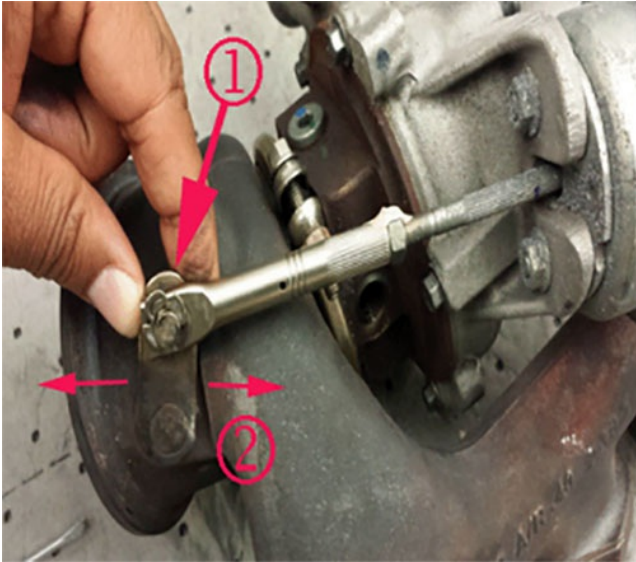
Wastegate Preload Inspection.

Wastegate lever arm (1) moves with little effort in the direction as shown (2) while the actuator rod remains static, see picture below "Wastegate Preload Inspection".

If the lever wiggles with little effort while the actuator rod remains static, the pre-load is insufficient and the turbocharger must be replaced.

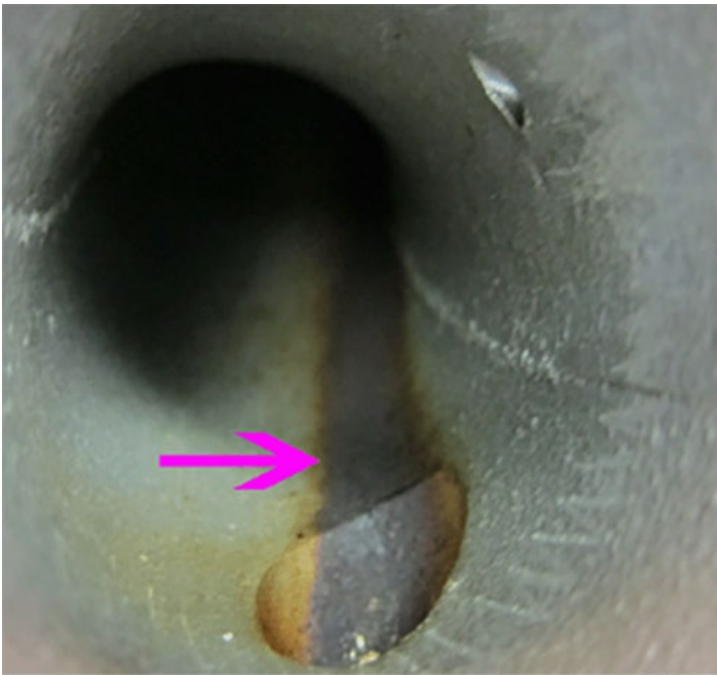
Notice: The view shown below indicates **NORMAL** oil staining in the turbocharger outside air inlet. This dry stain does not represent an oil leak.

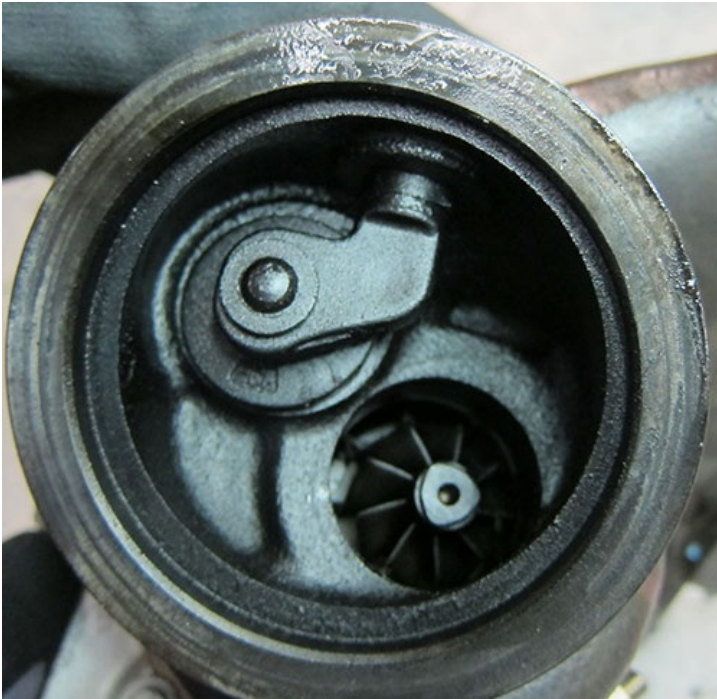
Inspect for the presence of oil in the exhaust system.

If oil is present in the exhaust system, then inspect the turbocharger turbine and compressor wheels to be sure that they are not broken off.

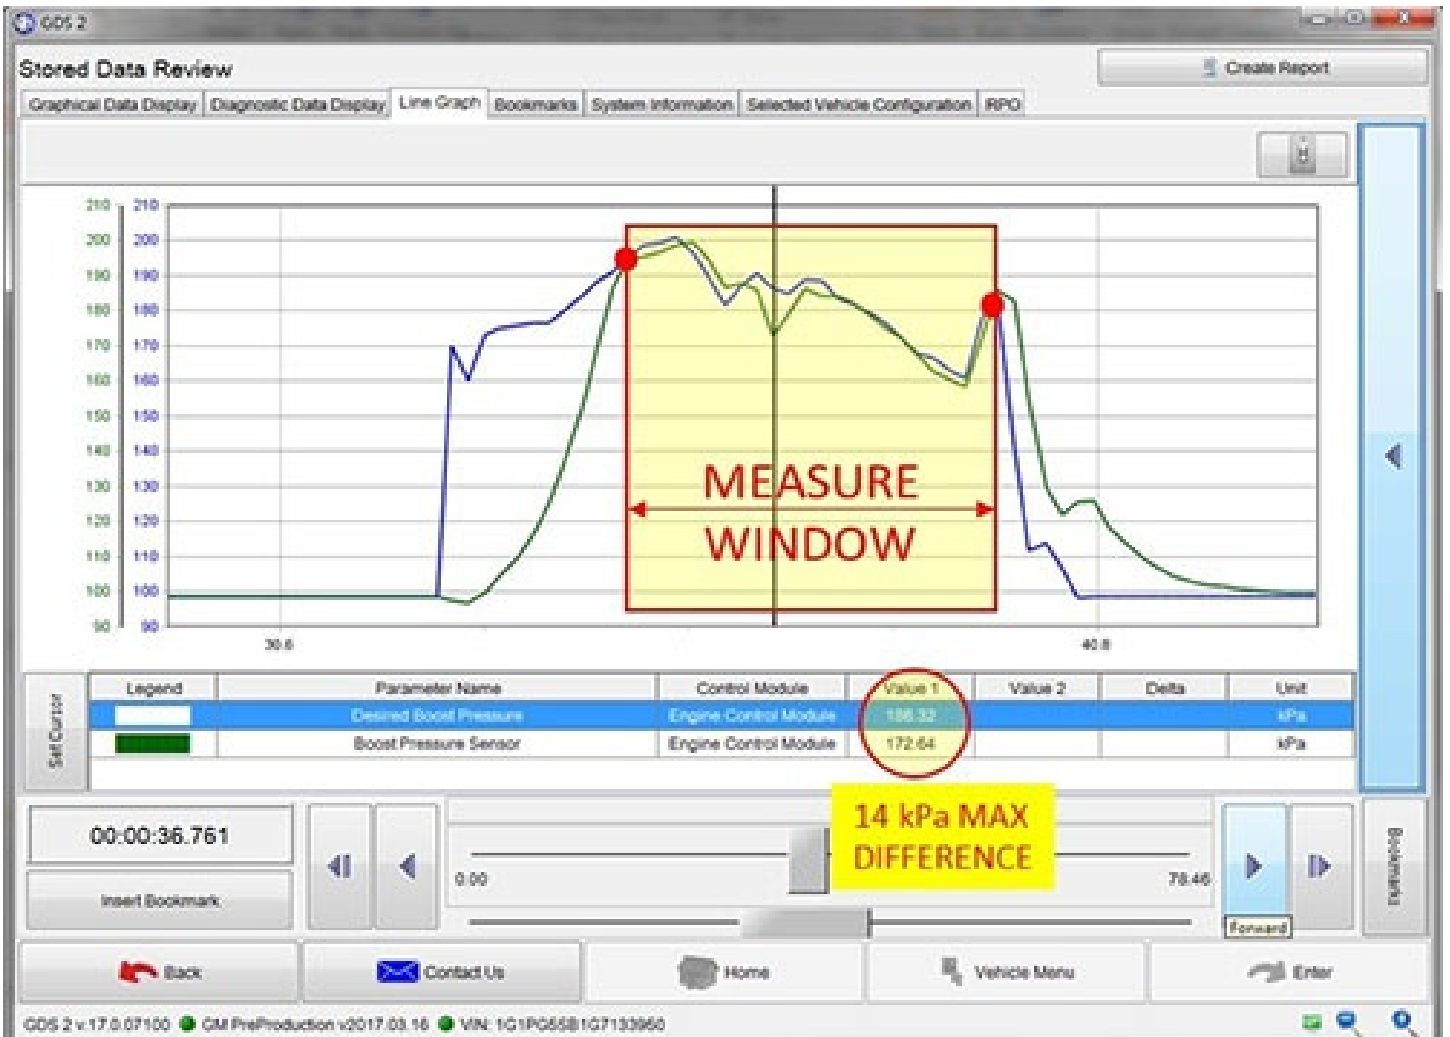
Example of normal turbocharger wastegate operation:

In this example, notice that the measure window begins once the Boost Pressure Sensor reading (Green) meets the Desired Boost Pressure reading (Blue) and ends when the APP is released per the testing instructions. The Boost Pressure Sensor reading (Green) closely tracks the Desired Boost Pressure reading (Blue) indicating normal Turbocharger operation.

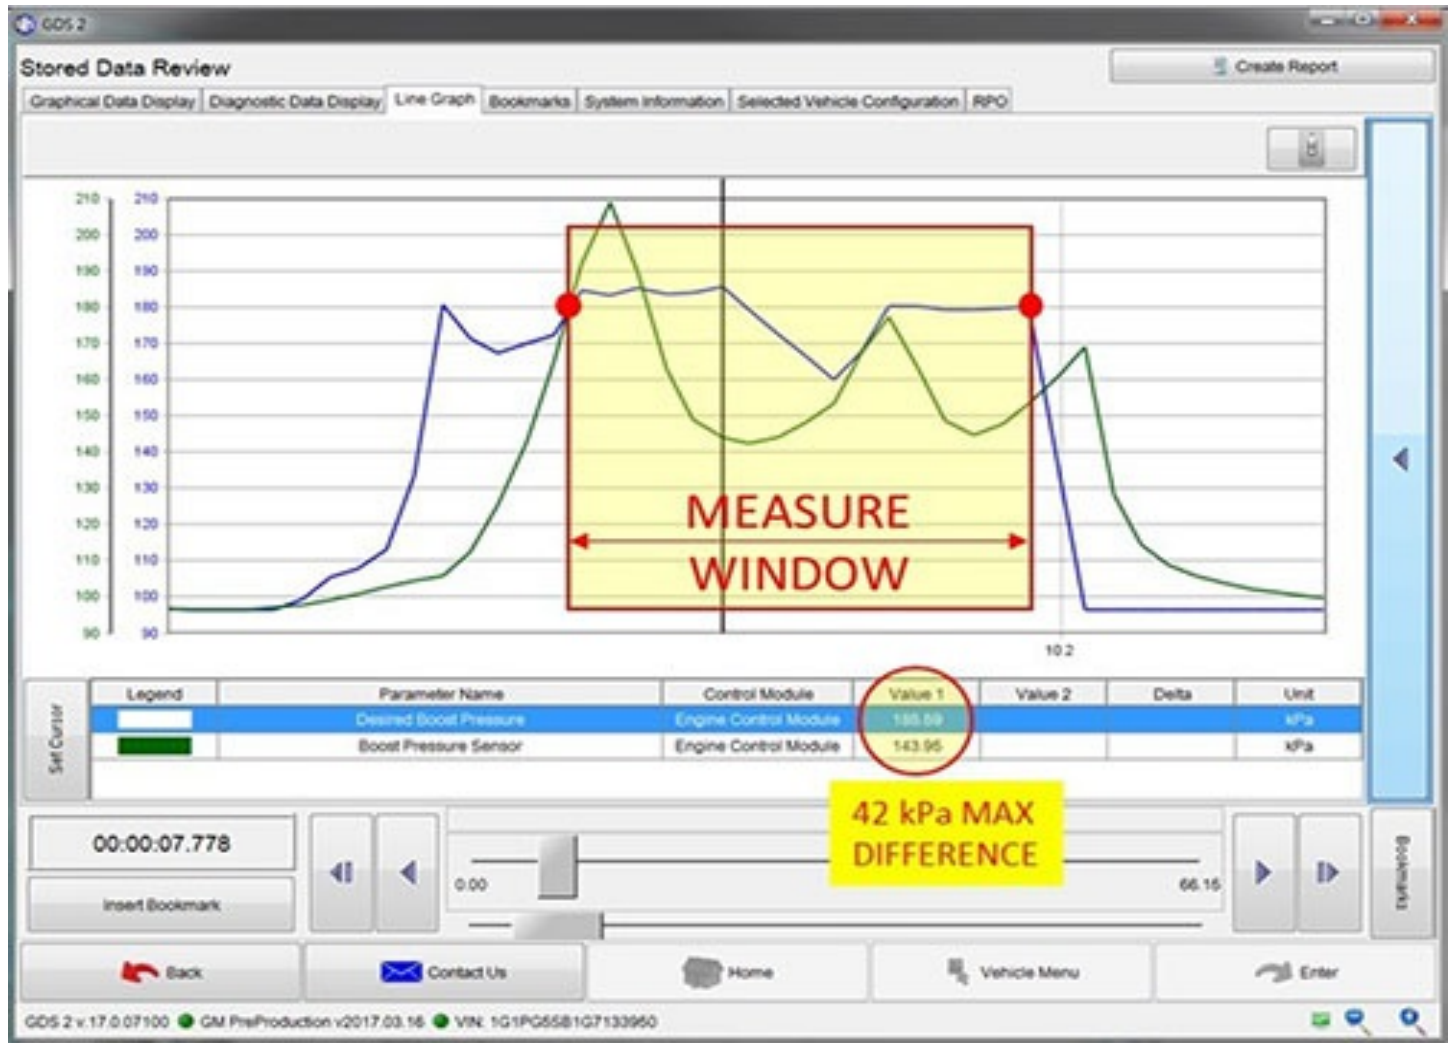
Example of a malfunctioning turbocharger wastegate:

In this example, notice that the Boost Pressure Sensor reading (Green) moves thru and well above the Desired Boost Pressure reading (Blue).

As the abnormally high pressure is corrected by the management system, the Boost Pressure Sensor reading (Green) over reacts and dips well below Desired Boost Pressure reading (Blue).

A difference of 14 KPA (2 PSI) between the Boost Pressure reading (Green) and the Desired Boost Pressure Sensor reading (Blue) indicates a Malfunctioning Turbocharger.
