| HYUNDAI NEW THINKING. NEW POSSIBILITIES. Technical Service Bulletin | GROUP CAMPAIGN | NUMBER 17-01-033-1 |
| | DATE OCTOBER 2017 | MODEL(S) SANTA FE SPORT (AN) SONATA (LF) |
| SUBJECT: | LOOSE ALTERNATOR REGULATOR B+ SCREW (SERVICE CAMPAIGN T1Y) | |

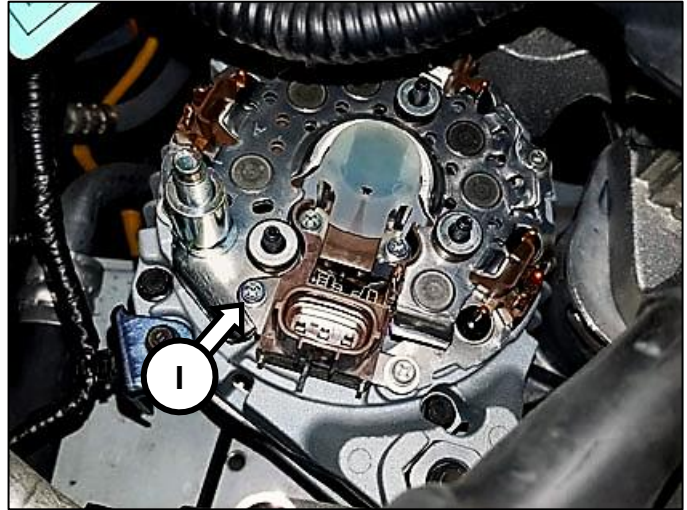
On certain 2017 MY Sonata (LF) and Santa Fe Sport (AN) vehicles, a screw securing the alternator's regulator may not have been properly torqued during assembly. If this condition exists, the interior and/or exterior lights may flicker, and the alternator's charging function may be affected illuminating the charging system warning light in the instrument cluster.

6. Torque the Regulator B+ screw **(I)**.
Tightening Torque:
20 kgf.cm (17 lb-in)

Install all removed parts in the reverse order of removal.
