JTB00592NAS1

**TECHNICAL BULLETIN**

211-05: Steering Column Multifunction Switch

Indicator / Wiper Stalks Inoperative or Intermittent Function

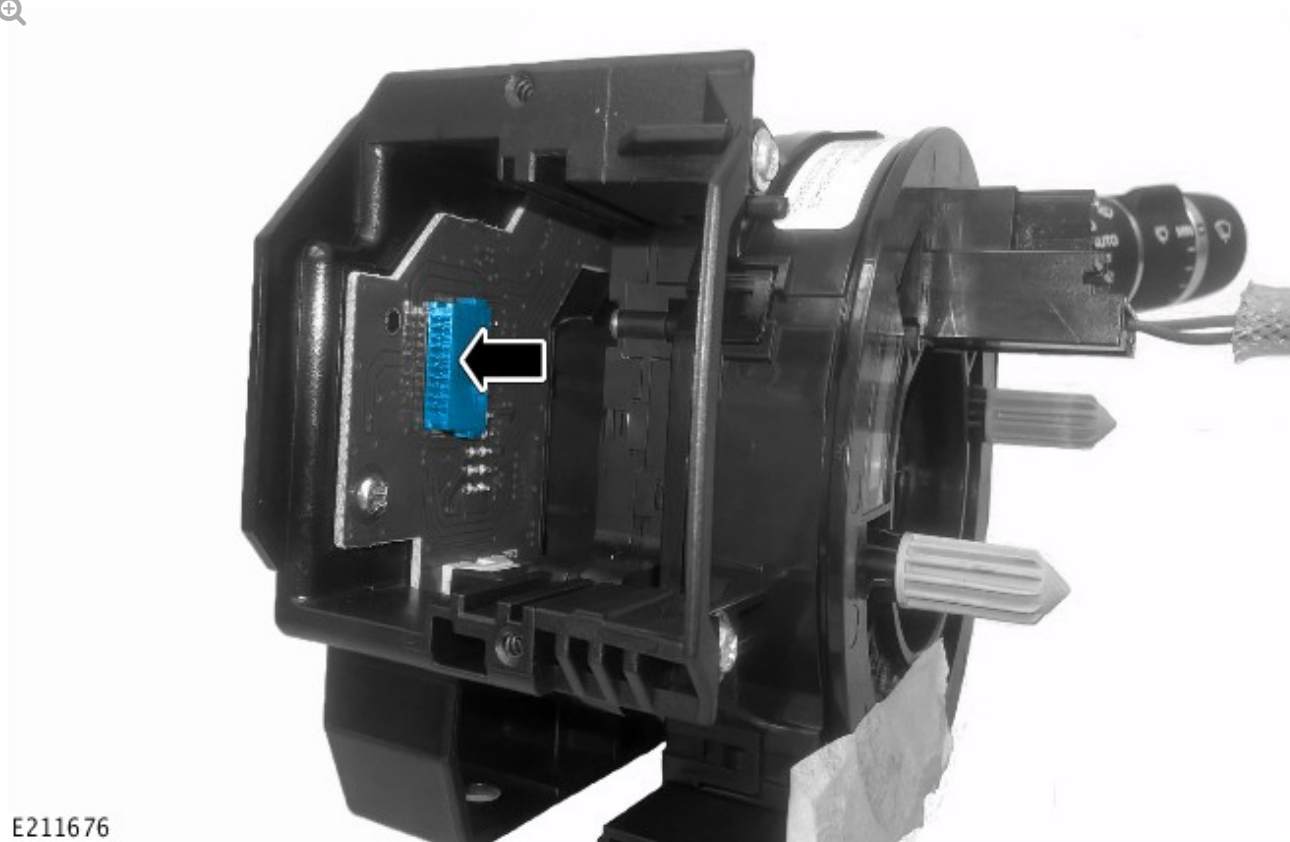
2

The lighting control switch and/or the wiper control switch may not operate or operates intermittently.

This may be caused by a poor electrical connection at the lighting control switch and/or the wiper control switch.

**NOTES:**

- Do not apply Nyogel to the lighting control switch connector.
- Make sure there is an even coating of Nyogel on the electrical contacts surface.
- Remove any excess Nyogel.

With the lighting control switch removed, apply the Nyogel to the electrical contacts surface.
