Technical Service Bulletin

91 Bluetooth call quality issues for caller on other end of call

91 13 86 2027718/4 June 11, 2013. Supersedes Technical Service Bulletin Group 91 number 12-68 dated November 12, 2012 for reasons listed below.

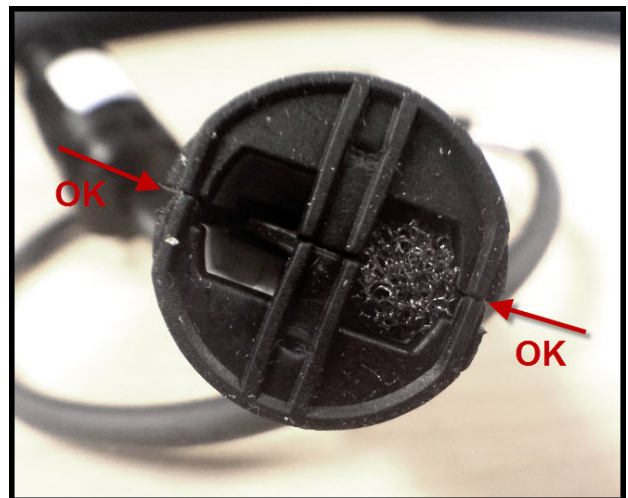
1. Inspect the seal of the microphone for damage:
 - There are two splits in the rubber seal. This is normal as long as the two halves of the seal are touching each other (Figure 5).

Figure 5. Undamaged seal

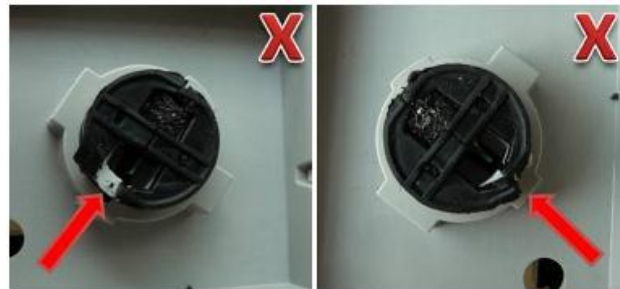
- If the two halves of the seal are loose and move freely, the seal is damaged (Figure 6).

Figure 6. Examples of damaged seals

If any of the seals are damaged:

- Replace the microphone set by installing the replacement microphone while the decorative trim is removed from the base plate. Take care when doing so to prevent damaging the new microphone's seal by slowly installing it perpendicular to the base plate (Figure 7). Do not install the microphone at an angle, as this may pinch the seal (Figures 8 and 9)

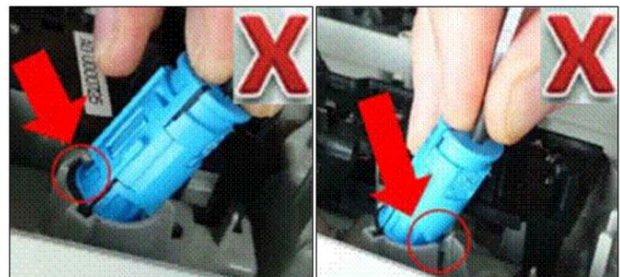
Figure 8. Incorrect installation at an angle, showing a pinched seal on the left.

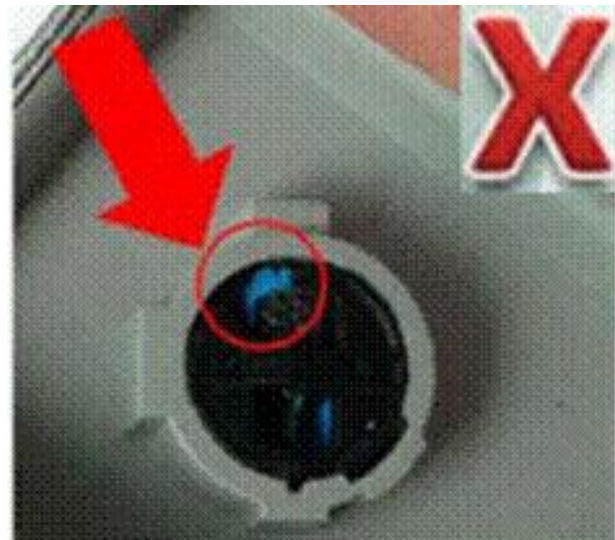
Figure 9. Damage caused by a pinched seal.

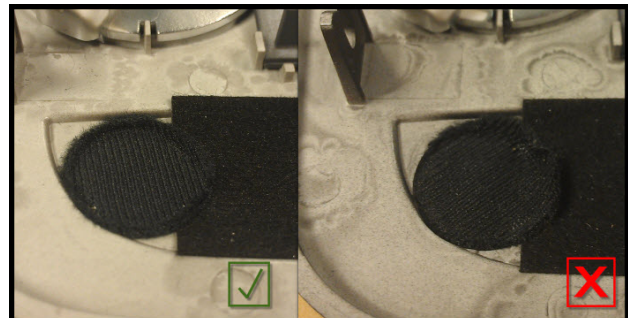
- Visually inspect the round felt material on the underside of the decorative trim (Figure 10). The felt material pushes against the microphone's rubber seal and forms a barrier. The decorative trim should be replaced (see ETKA) if the material is bunched up or not centered perfectly, as it can potentially affect the call quality.

Figure 10. Felt on backside of decorative trim.
