Technical Service Bulletin

87 Air conditioning inoperative

87 13 42 2020124/9 June 11, 2013. Supersedes Technical Service Bulletin Group 87 number 12-37 dated November 16, 2012 for reasons listed below.

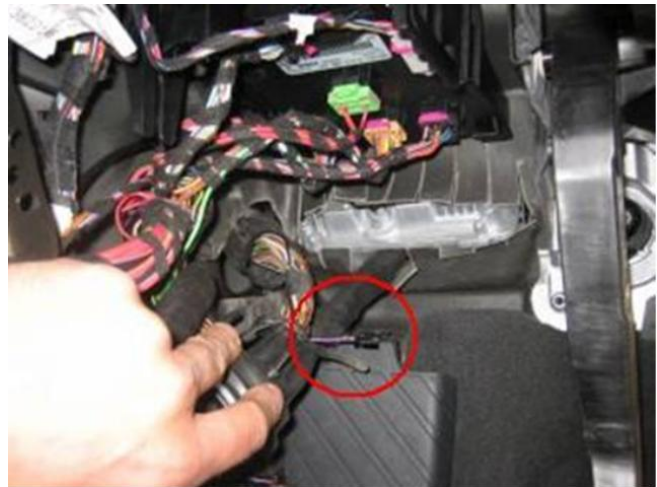
There are two known sections in the wiring harness that can be affected, but the potentially affected areas are not limited to these two known sections. One of the known sections is in the driver's footwell area where the wire harness enters the interior of the car from the engine bay (Figure 1).

Figure 1. Wire harness in driver footwell area.

6. If a cut wire is found, install an overlay wire for the LIN bus signal. Do *not* attempt to repair the existing wire harness.

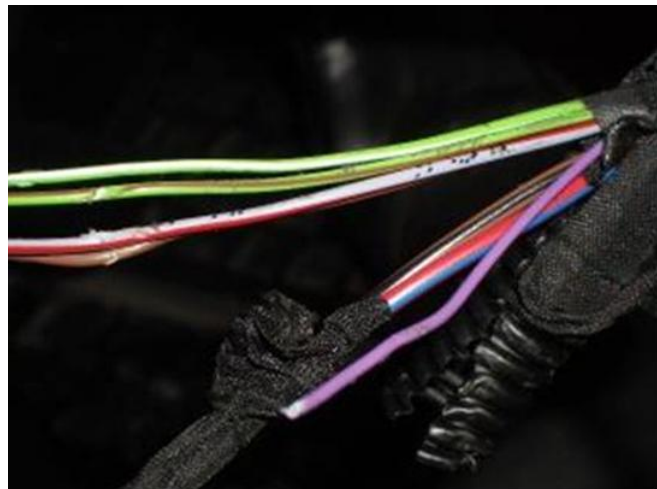
The second known section is in the wire harness located under the driver's side headlight (Figure 2).

Figure 2. Wire harness under driver's side headlight.

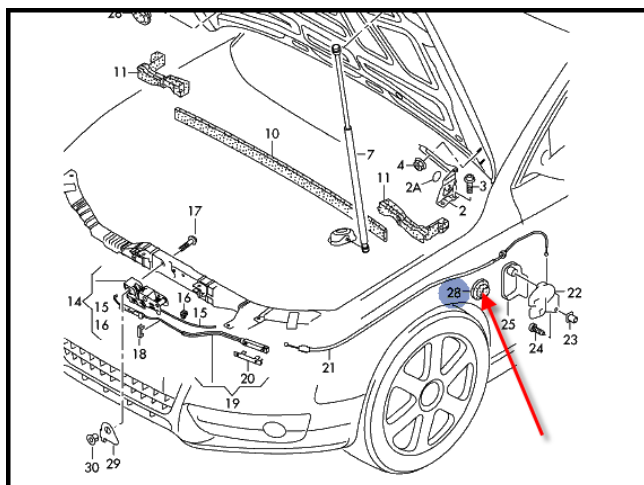
Figure 3. Grommet in driver's side fender/lower A-pillar area used for pass-through for new overlay wire.

- a. Route the new LIN bus wire from the vehicle electrical system control module, J519, to the sender for sensor G395 so that it enters the interior of the vehicle through the driver's side fender/lower A-pillar area through the grommet indicated in the images at right (Figures 3 and 4).

Tip: Do *not* route the wire through the same opening used by the existing wire harness.

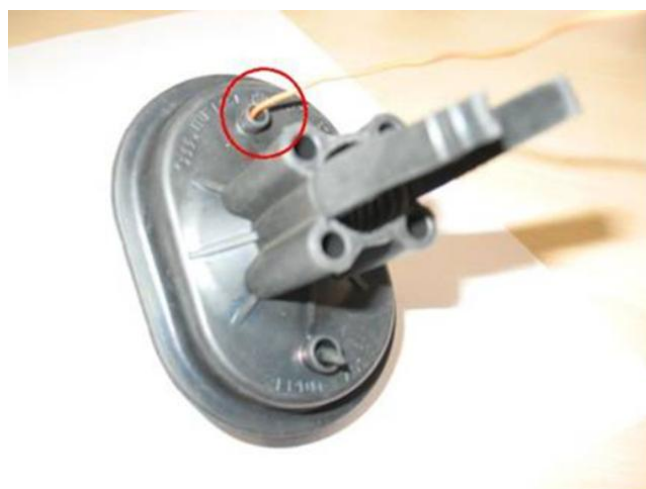
Figure 4. Access hole in grommet.

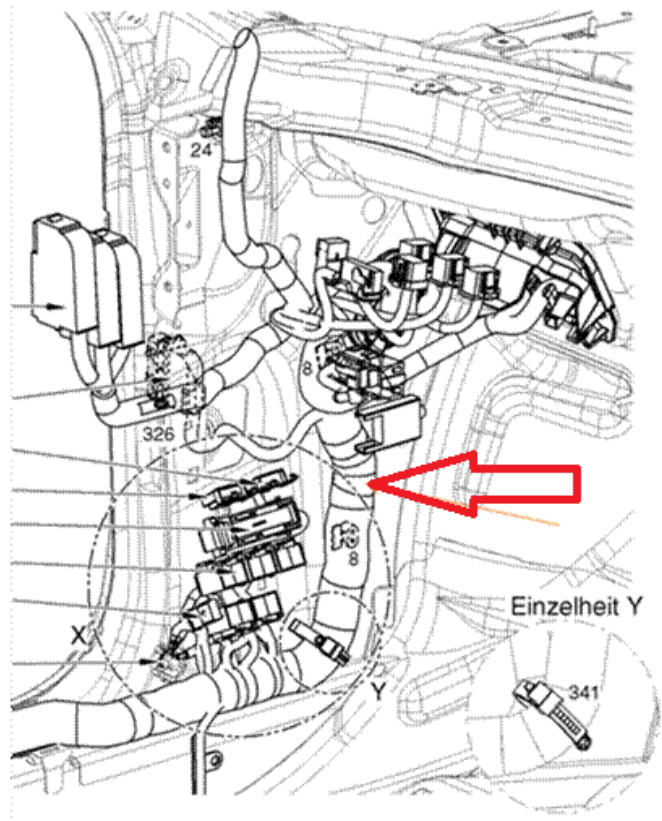
Figure 5. Cable routing with charisma switch option.

On vehicles with a charisma switch (ride selection switch located on the instrument panel) route the new cable of the sender for sensor G395 to junction B549 (Figure 5, red arrow).

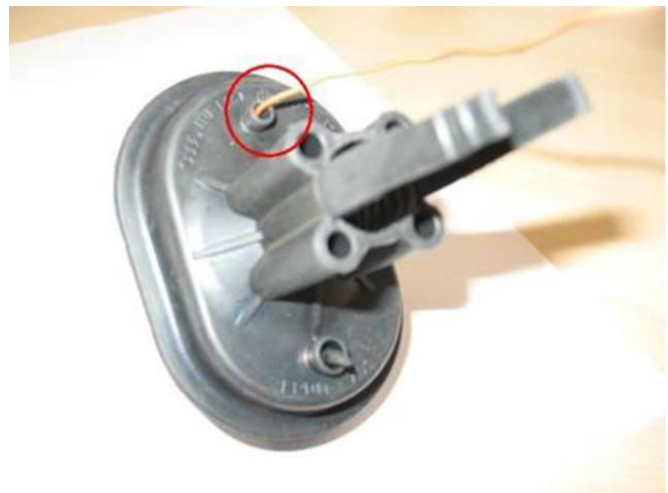
Figure 6. Access hole in grommet to be sealed with Butyl sealant.

- b. Seal off the opening around the wire with Butyl sealant to prevent water intrusion (Figure 6).
