Technical Service Bulletin

46 A4, A5, A5 Cabrio, & A6 squealing from front brakes (PR-1LA or 1LB)

46 13 45 2033674/2 June 12, 2013. Supersedes Technical Service Bulletin Group 46 number 13-42 dated June 11, 2013 for reasons listed below.

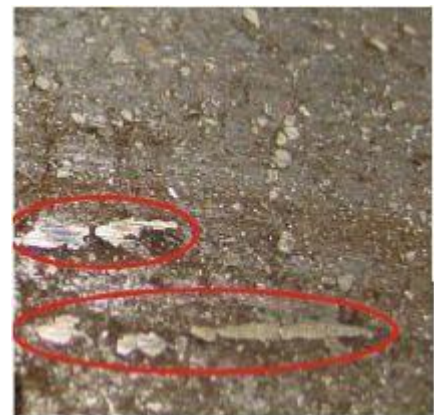
- Foreign bodies between brake disc and brake pad, such as small stones, grit, or sand.
- Un-ground or corroded friction materials.
- Brake discs or brake pads are close to their wear limit. (Front brake disc wear limit: 28mm. Front brake pads wear limit with backing plate and dampening sheet: 7mm.)
- Metallic deposits from disc material in brake pad (Figure1).

Figure 1. Metallic deposits.

- Deposits in brake pad.

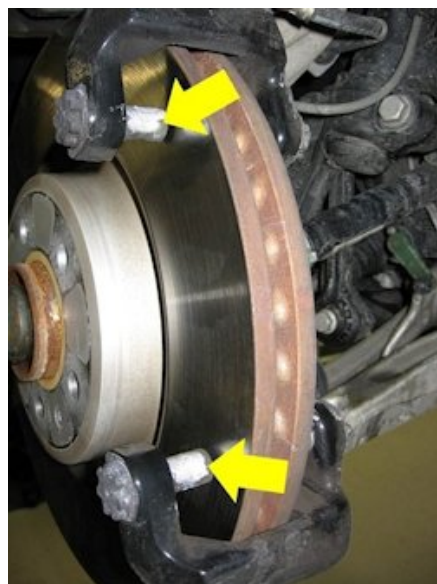
Figure 2. Caliper carrier guide pins with anti-seize (**G 052560A2**) lubricant applied where the pads make contact.

2. Remove the front brake caliper with the brake pads still attached and apply a thin coat of anti-seize (**G 052560A2**) lubricant to the guide pins of the caliper carrier (Figure 2). Only apply this lubricant to the section of the guide pins that will be contacted by the brake pads.
