Technical Service Bulletin

42 Light cracking or rubbing noises from suspension strut when steering

42 13 18 2021771/3 June 10, 2013. Supersedes Technical Service Bulletin Group 40 number 10-10 dated September 10, 2010 for reasons listed below.

Model(s)	Year	VIN Range	Vehicle-Specific Equipment
A3	2006 - 2011	All	Not Applicable
TT	2008 - 2011	All	Not Applicable

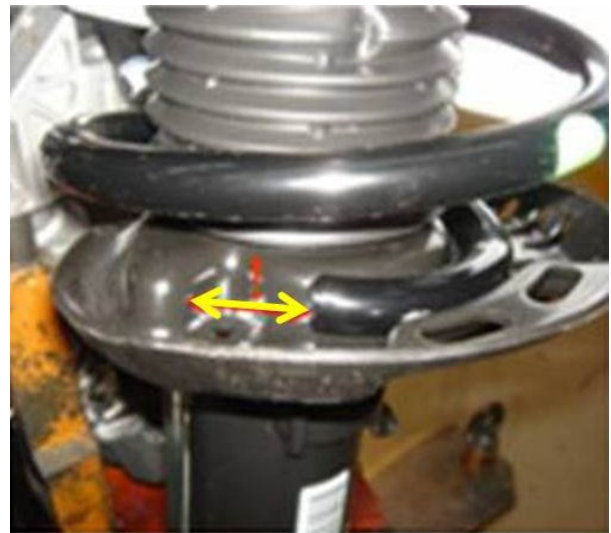
- A) The shock absorber buffer can chafe the cap of the suspension strut tube when steering. This is the most frequent cause.
- B) The boot is incorrectly fastened, or it is deformed.
- C) The coil spring is not correctly positioned on the stop of the spring retainer.

Figure 1. An incorrectly positioned coil spring.

To determine if the noise is from cause C:

- Turn the spring so that the end of the spring rests against the stop:
 - First, remove the affected strut assembly from the vehicle: Chassis >> Suspension, Wheels, Steering >> 40 Front Suspension >> Removal and Installation >> Suspension Strut.
 - Next, compress the spring and rotate it to the correct position. It is not necessary to remove the spring for this procedure: Chassis >> Suspension, Wheels, Steering >> 40 Front Suspension >> Disassembly and Assembly >> Suspension Strut.

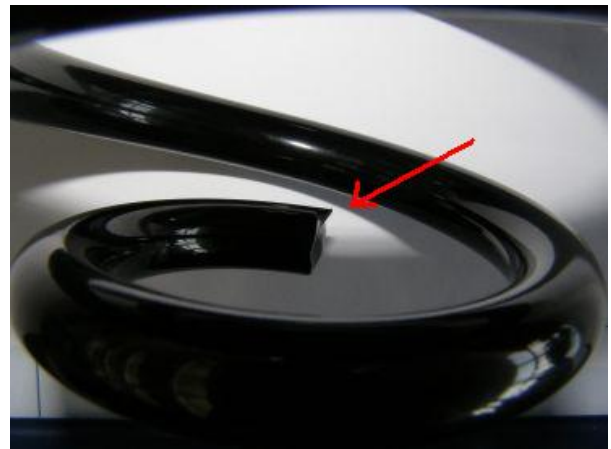
- D) There is a burr on the lower end of the coil spring, which can cause noises in the lower spring retainer (Figure 2).

Figure 2. A burr on the end of the coil spring.

To determine if the noise is from cause D:

- Remove the burr(s) at the end of the spring(s):
 - First, remove the affected strut assembly from the vehicle: Chassis >> Suspension, Wheels, Steering >> 40 Front Suspension >> Removal and Installation >> Suspension Strut.
 - Disassemble the strut assembly, remove the burr at the end of the spring, and paint any exposed metal on the spring and spring plate: Chassis >> Suspension, Wheels, Steering >> 40 Front Suspension >> Disassembly and Assembly >> Suspension Strut.

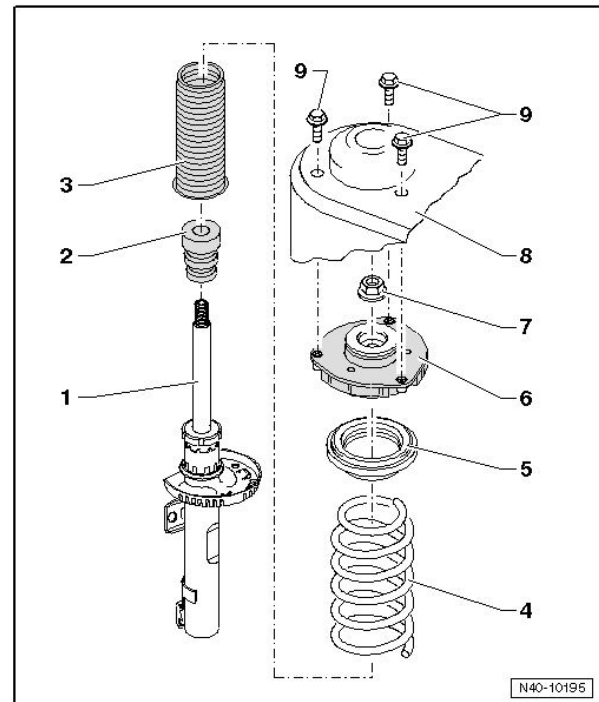
Figure 4. Front strut assembly overview.

- F) Unfavorable tolerances increase forces on the axial grooved ball bearing (Figure 4, 5). An indication for this cause is that the suspension strut bearing (Figure 4, 6) cannot be turned against the suspension strut assembly. This check must be performed with the strut assembly removed.
