Technical Service Bulletin

91 Audi drive select, cruise control, navigation, Bluetooth, or voice recognition is not available

91 15 25 2042506/1 November 17, 2015.

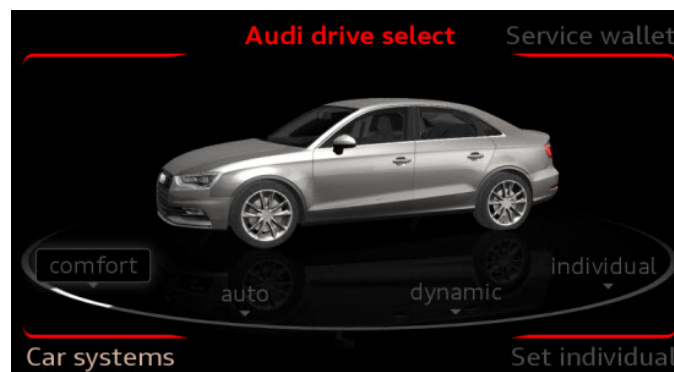
- Audi drive select functions cannot be selected (Figure 1).
- Cruise control does not work (in A3 or TT only)
- Navigation is not activated (Figure 2).
- Bluetooth is unavailable.
- Voice recognition is unavailable (in all cars except A3 cabriolet. For A3 cabriolet, see TSB 2038136).

Figure 1. Audi drive select functions unavailable and greyed-out.

Audi drive select, cruise control, navigation, Bluetooth, and voice recognition are functions controlled by activation keys, which are obtained through the SVM Recovery Activation test plan.

- Replacement of the data bus diagnostic interface (Gateway), J533 (address word 19), without running the SVM Recovery Activation test plan, or if the test plan fails.
- Replacement of the information electronics control module 1 (MMI), J794 (address word 5F), without running the SVM Recovery Activation test plan, or if the test plan fails.
- Replacement of the complete lock set in the vehicle without running the SVM Recovery Activation test plan, or if the test plan fails.

In ODIS, run the SVM Activations test at *FLASH >> START FLASH >> SVM Activations >> PERFORM TEST >> -2- Obtain existing activations from server for replacement control module* (Figure 3). When prompted, select “restore existing activations.”

If the complaint persists, reset terminal 30 (for five minutes), then disconnect ODIS, roll the windows up, and lock the car to allow the vehicle systems to go to sleep. Allow the vehicle to sit for at least two minutes before turning on the ignition.

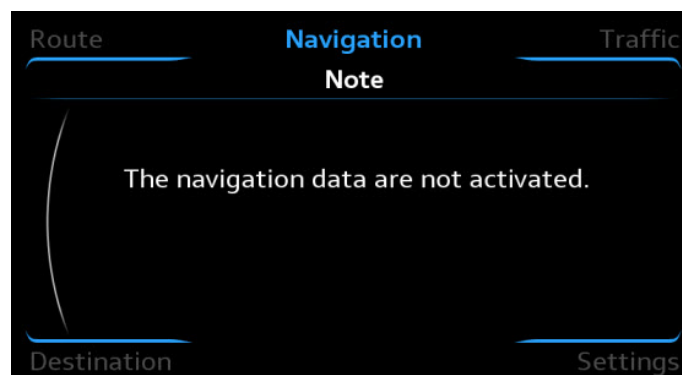
Figure 2. Navigation not activated message.

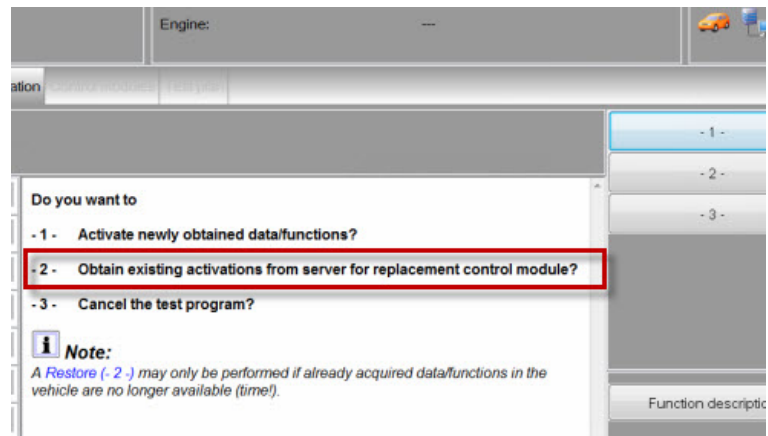
Figure 3. Obtain existing activations from server for replacement control module?
