Technical Service Bulletin

96 Warning message in DIS: "Key not In vehicle" or "Remote key not recognized"

96 15 03 2039108/3 November 9, 2015. Supersedes Technical Service Bulletin Group 96 number 14-90 dated December 5, 2014 for reasons listed below.

Model(s)	Year	VIN Range	Vehicle-Specific Equipment
Q3	2015 - 2016	All	Not Applicable

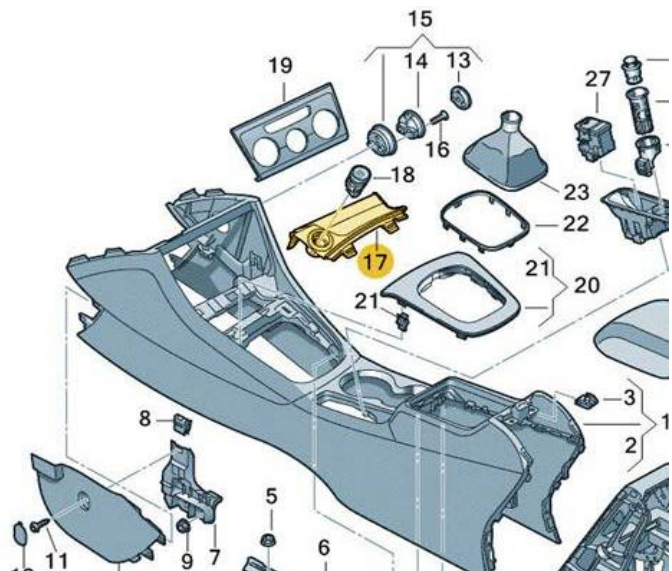
Figure 1. The front storage compartment in the center console (Number 17).

1. Remove the front storage compartment according to the Elsa Repair Manual (Figure 1).

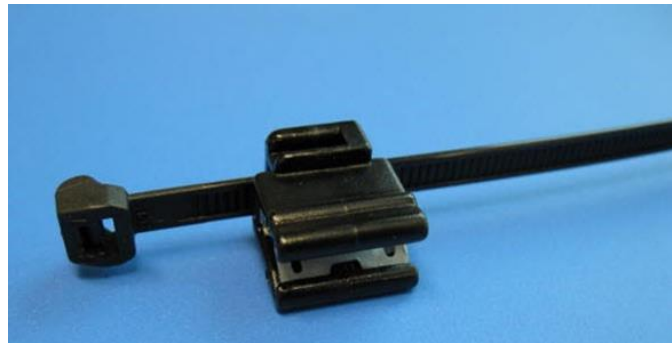
Figure 2. Zip tie with holder.

2. Remove the climate control module according to the Elsa Repair Manual.
3. Remove Aerial 1 for Access and Start Authorization (R138).
4. Change the routing of the cable for the Access and Start Authorization button and for Aerial 1. The routing of the wiring harness for the shift gate must also be modified.
5. Using a zip tie with holder (**3D0 971 838 M**) (Figure 2), turn the zip tie by 90° (Figure 3).

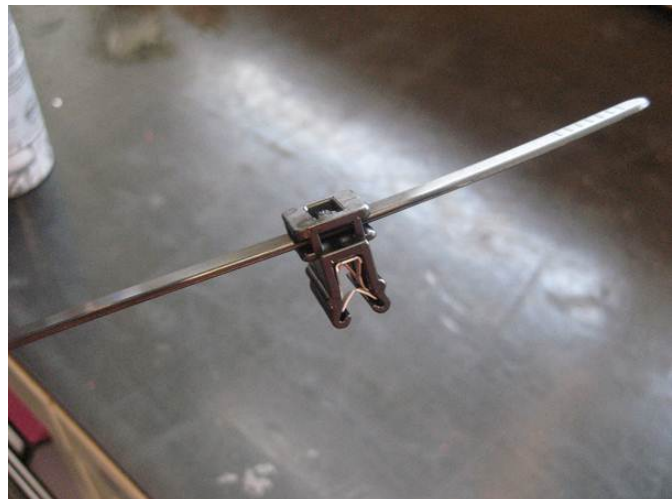
Figure 3. Zip tie turned by 90°.

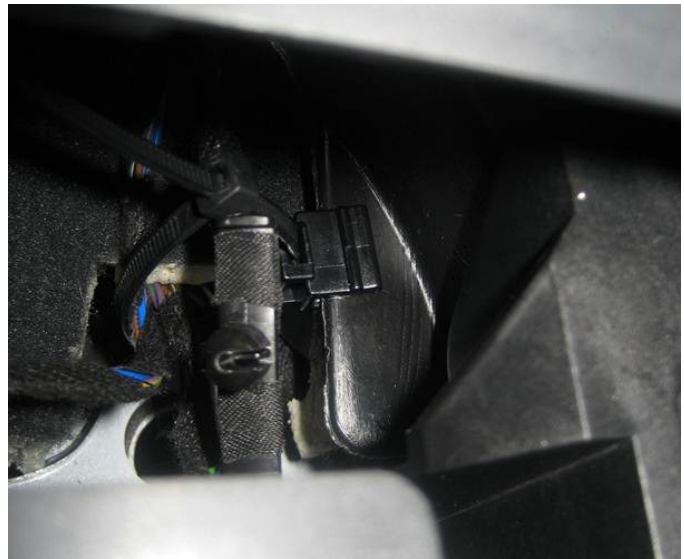
Figure 4. The zip tie with holder is installed but not tightened.

6. Attach the zip tie with holder as shown (Figure 4). Do not tighten the zip tie.

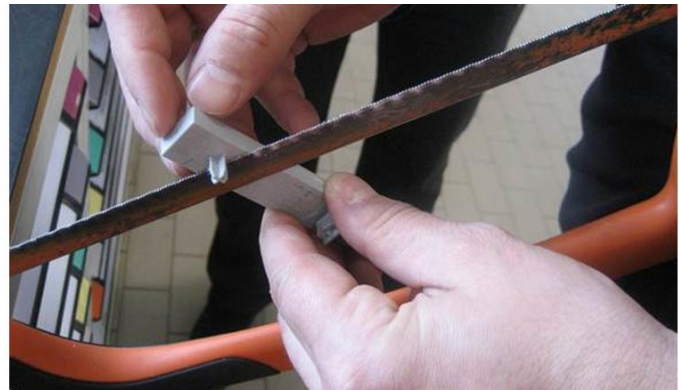
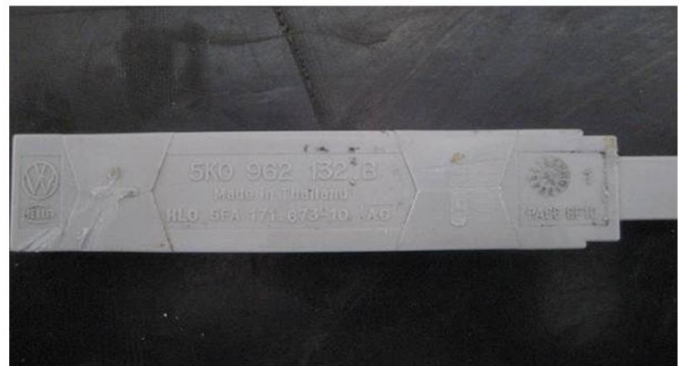
Figure 5. Removing the plastic locating pins from Aerial 1 (top image), and Aerial 1 with locating pins removed (bottom image).

7. Remove the two plastic locating pins on Aerial 1 so that no cables can chafe any components (Figure 5).

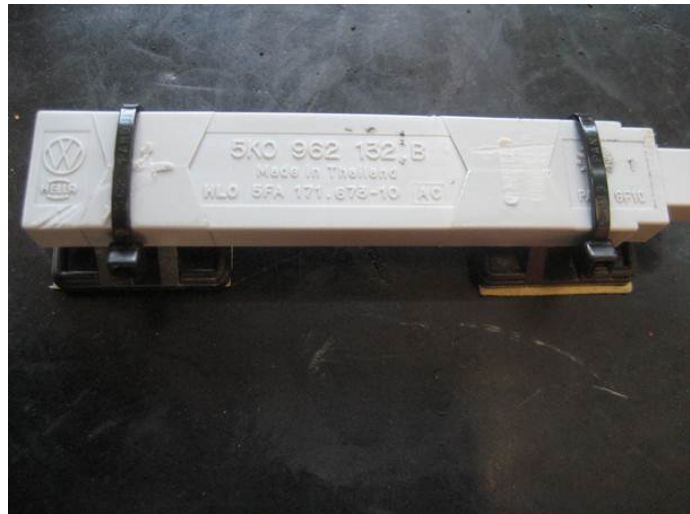
Figure 6. Zip ties with adhesive retaining plates installed on Aerial 1.

8. Attach zip ties (N 020 904 8) and the retaining plates for zip ties (000 971 010 A) as shown (Figure 6).

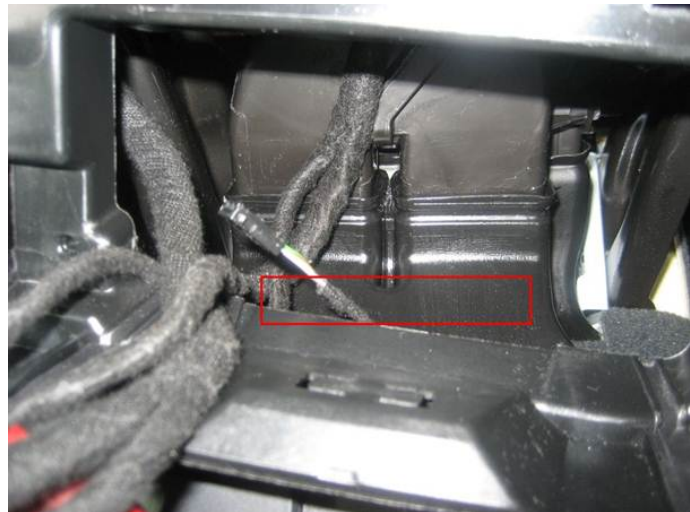
Figure 7. Mounting surface on HVAC ducting to be cleaned.

9. Prepare the mounting surface by cleaning the marked area with cleaning solution (D 009 401 04) (Figure 7).

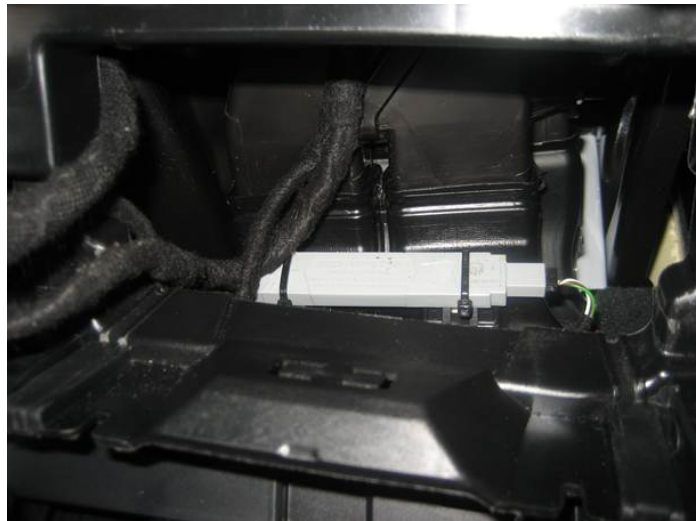
Figure 8. Aerial 1 mounted on HVAC ducting.

10. Once the area is dry, attach Aerial 1 to the HVAC ducting (Figure 8).
