Technical Service Bulletin

91 Bluetooth phone cannot be paired to vehicle

91 15 29 2013422/11 December 11, 2015. Supersedes Technical Service Bulletin Group 91 number 13-04 dated September 11, 2013 for reasons listed below.

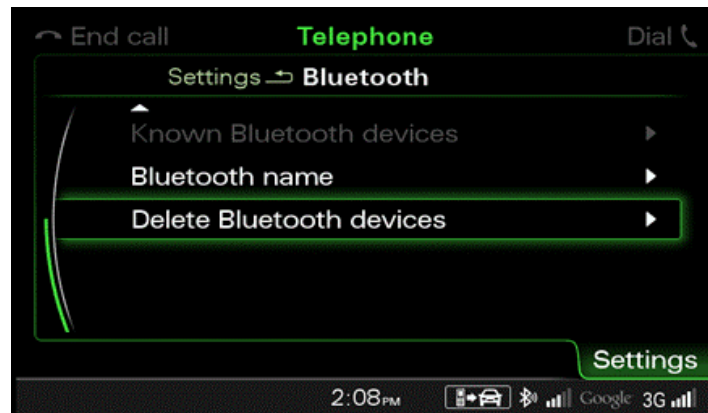
Figure 1. Select “Delete Bluetooth devices”.

If the phone still will not connect in MMI3G+, delete all Bluetooth devices in the MMI menu (Figure 1 and Figure 2).

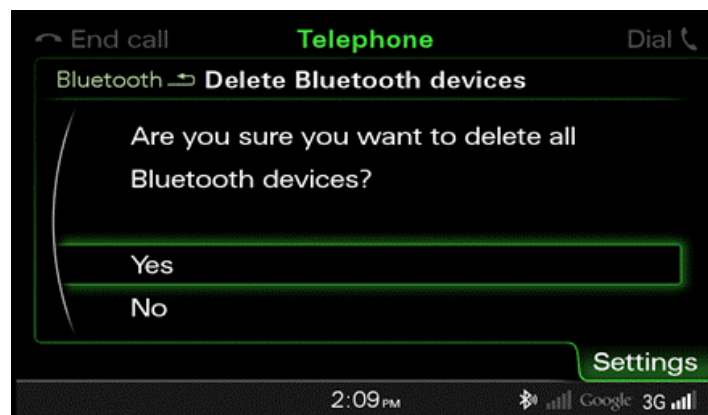
Figure 2. Confirm deletion of Bluetooth devices.

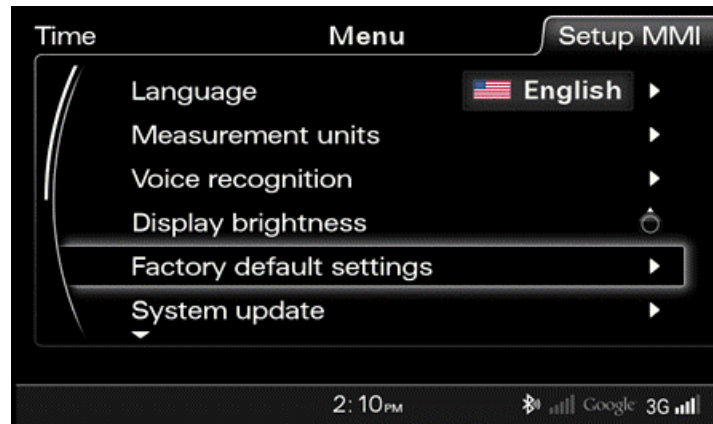
Figure 3. Open default settings menu.

Reset phone and Bluetooth settings in the MMI menu to default (Figure 3 - Figure 6).

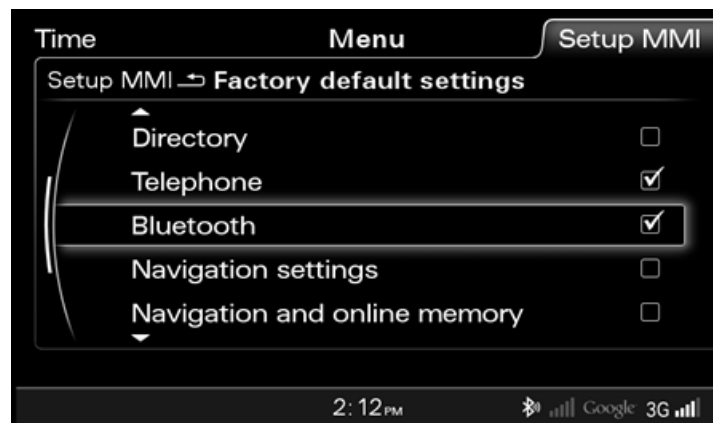
Figure 4. Select Telephone and Bluetooth options for factory defaults.

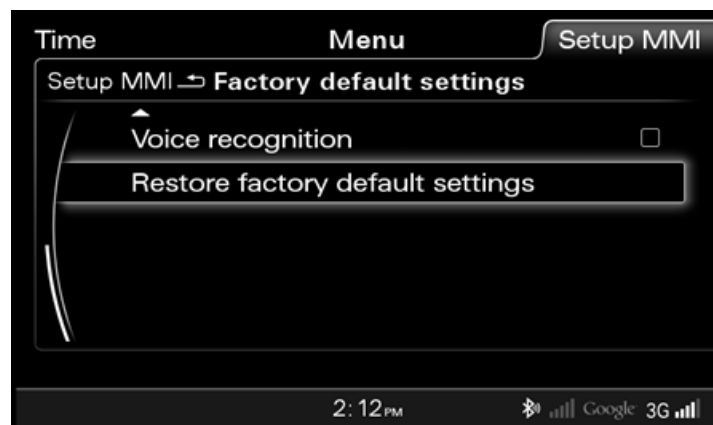
Figure 5. Restore factory default settings.

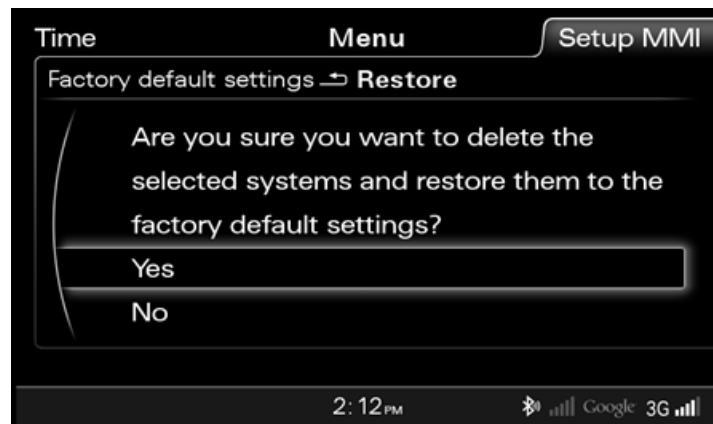
Figure 6. Confirm restoration of factory default settings.
