Technical Service Bulletin

70 Noises from doors when playing music tuned with heavy bass

70 15 49 2037104/2 October 27, 2015. Supersedes Technical Service Bulletin Group 70 number 14-38 dated April 30, 2014 for reasons listed below.

Model(s)	Year	VIN Range	Vehicle-Specific Equipment
Q7	2011 - 2015	All	Not Applicable

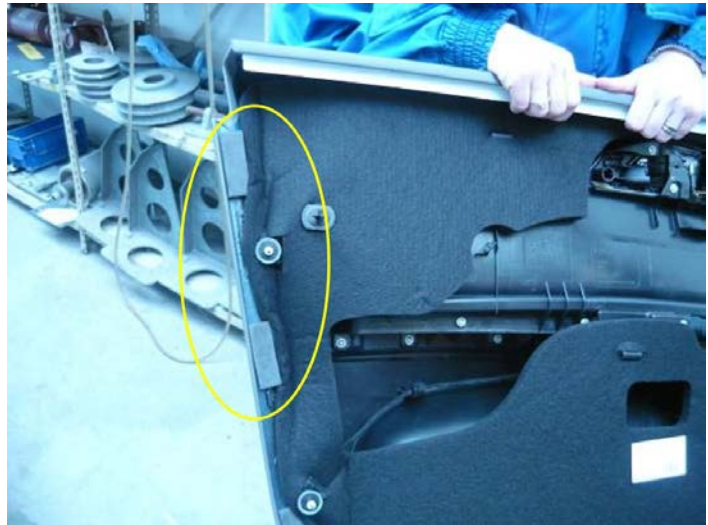
The noises are likely due to contact between the foam isolation blocks on the door front door panels and the door structure or vibration in the door wiring harness bundle or connectors.

1. Remove the right and left door panels. Inspect the insulation mat. The insulation mat will likely be mounted around the foam pads (Figure 1).

Figure 1. Insulation mat installed around the foam pads.

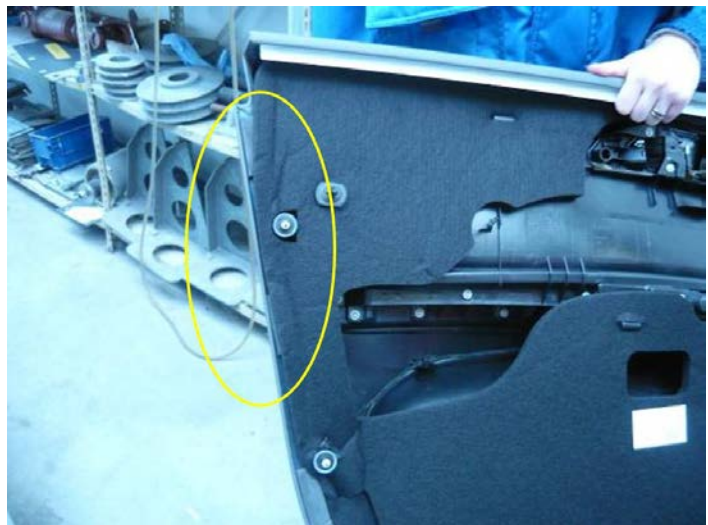
Figure 2. Insulation mat properly installed.

2. Adjust the insulation mat. The insulation mat should be installed in such a way that it covers the foam pads and should now be between the foam pads and the door structure (Figure 2).

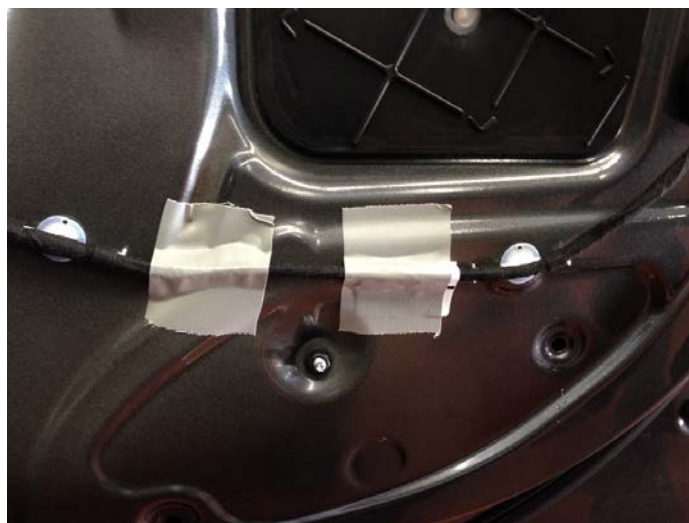
Figure 3. Tape applied to door wiring harness.

3. Check the wiring harness of the door. Any loose sections of harness or connectors should be secured with tape to eliminate the possibility of harness or connector movement against the door panel or door structure.
