Technical Service Bulletin

91 MMI3G+ GPS navigation location inaccurate or navigation takes a very long time to acquire location

91 15 22 2040406/4 October 16, 2015. Supersedes Technical Service Bulletin Group 91 number 15-10 dated August 25, 2015 for reasons listed below.

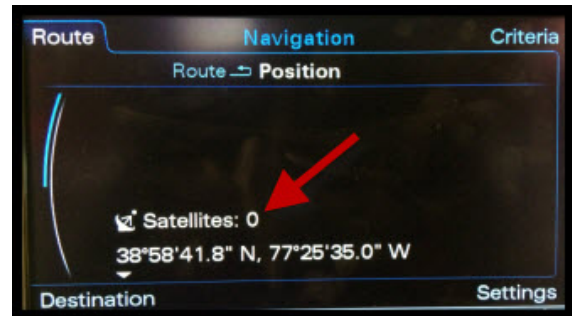
Figure 1. No satellite reception.

- When the issue occurs, the GPS navigation system satellite reception shows 0 satellites. Due to the infrequency of the issue, this might not be verifiable. (To view the number of satellites being received, go to *Nav >> Route >> Select Current Position* (first item in list) and scroll up (Figure 1)).

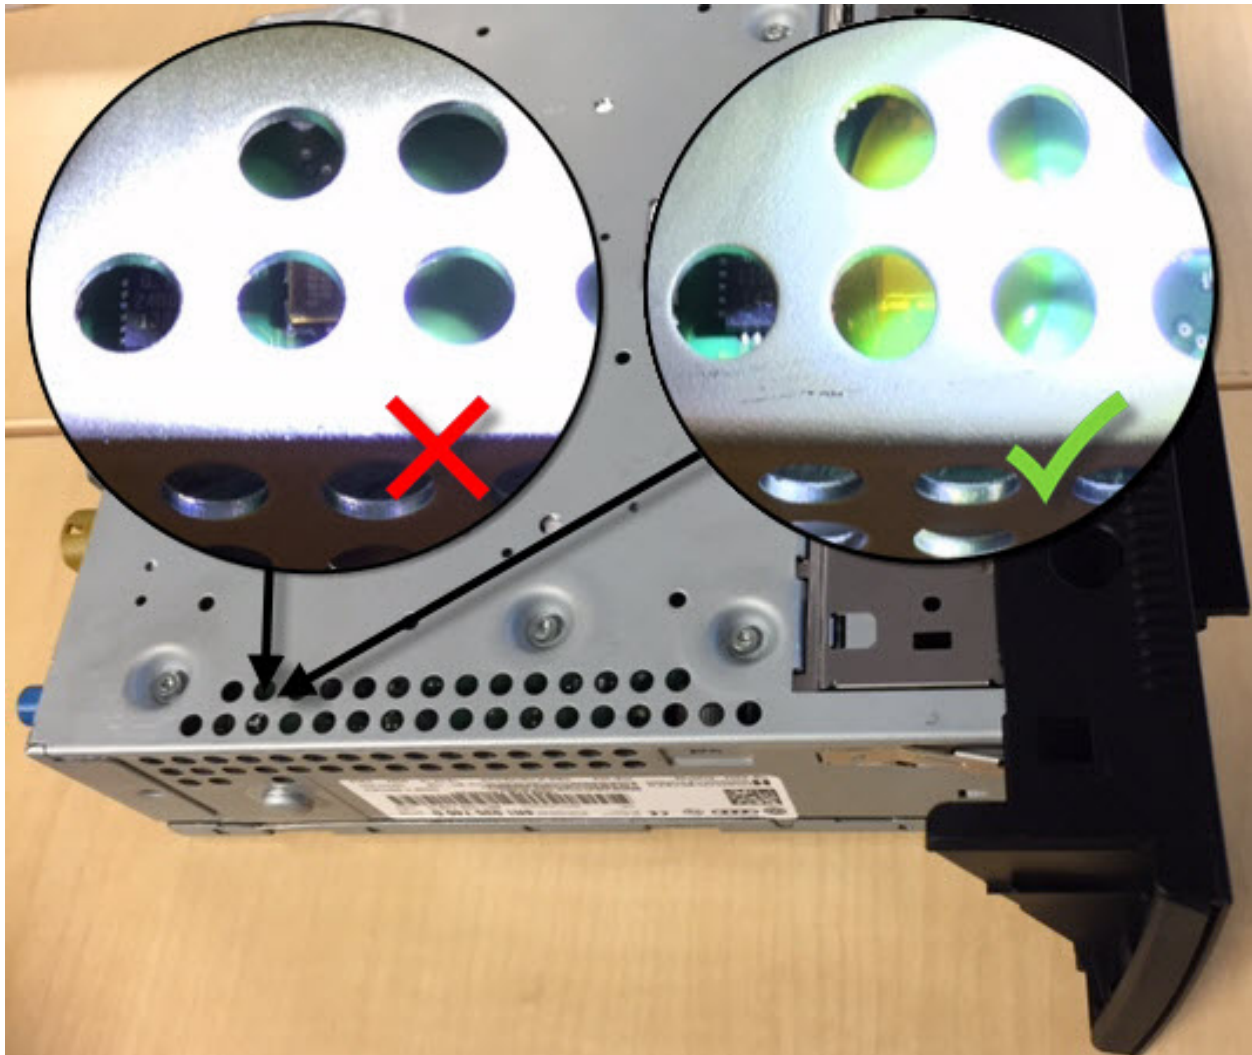
Figure 2. Example of integrated circuit chip without coating (left) and with coating (right). Parts without the coating over the integrated circuit chip are not okay and should be replaced.

3. Order a replacement MMI main unit using the applicable part number listed in the parts table below. There are different variants of main units that have support for a SIM card slot and some variants that do not. Once the new part arrives, check the integrated circuit chip of the GPS oscillator on the internal circuit board. The chip should have a translucent yellow coating (Figure 2).

Some early service parts did not have the coating despite the updated hardware part number (G suffix) and build date. All parts built after November 08, 2014 should have the coating over the integrated circuit chip. If the part does not have the coating over the integrated circuit chip, return the part and order a replacement.

If the parts department has problems getting updated parts with the integrated circuit chip coating, contact TAC. A small amount of specially modified parts are available for shipping directly from Audi of America.

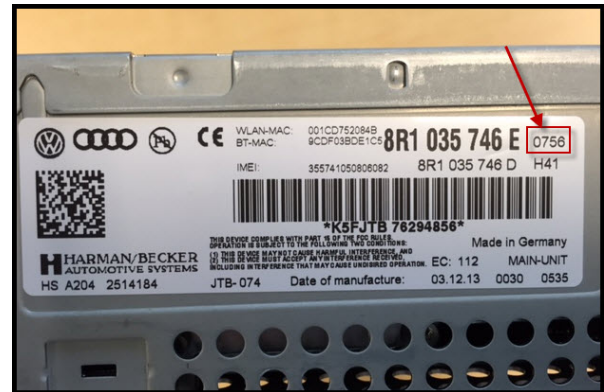
4. Check the label (Figure 3) on the side of the new part to verify that it contains software at level 0901 or higher. Install the replacement MMI main unit (information electronics control module 1, J794 (address word 5F)).

Figure 3. Main unit part label.

5.
 - If the software level is less than 0901, perform component protection removal, **repeat steps 1 and 2** and then move to step 6.
 - If the software is at 0901 or above (A6, A7, and A8 can have 0902), perform component protection removal and **repeat step 2**, then move to Step 6. Repeating step 2 will allow SVM to accept the new control unit with the updated part number.
