Technical Service Bulletin

70 Noises from headliner / sunroof area

70 15 47 2038029/3 September 21, 2015. Supersedes Technical Service Bulletin Group 70 number 15-44 dated February 25, 2015 for reasons listed below.

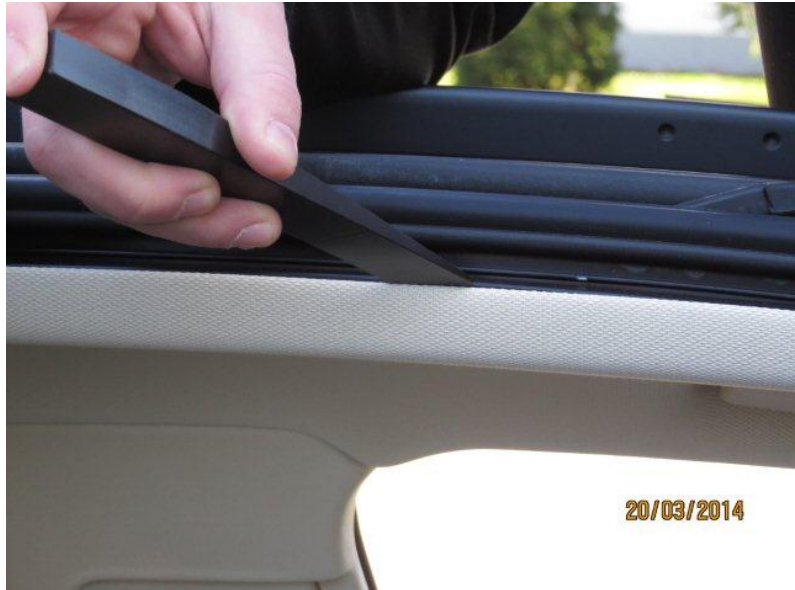
Figure 1: Unclipping the sunroof cover trim frame.

1. Remove the glass sliding roof panel(s). Remove the beam for the sunroof rollershade. Carefully unclip and remove the sunroof cover trim frame (Figure 1).

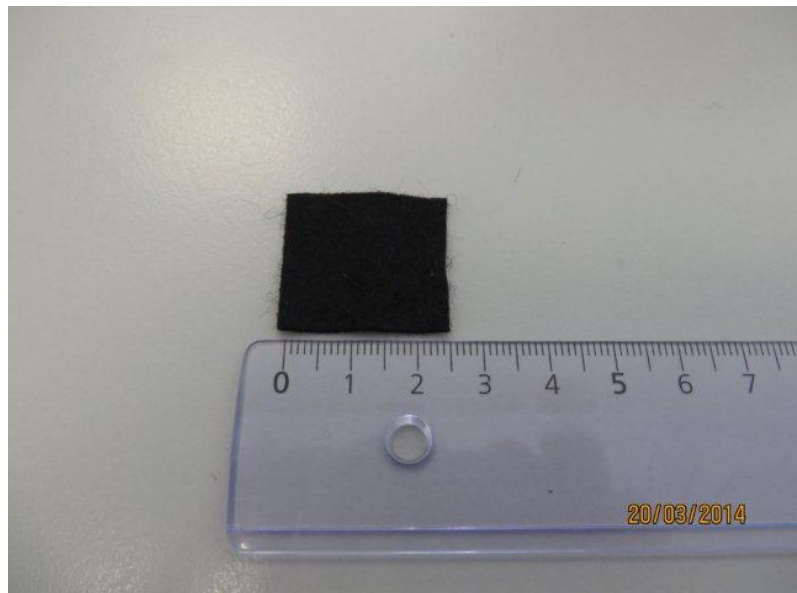
Figure 2: A 25mm section of fleece adhesive tape 533867910A.

2. The number of retaining clips will vary by model. A piece of dampening tape (fleece adhesive tape 533867910A) will be applied to each clipping point. Cut pieces of the tape 25mm long (Figure 2).

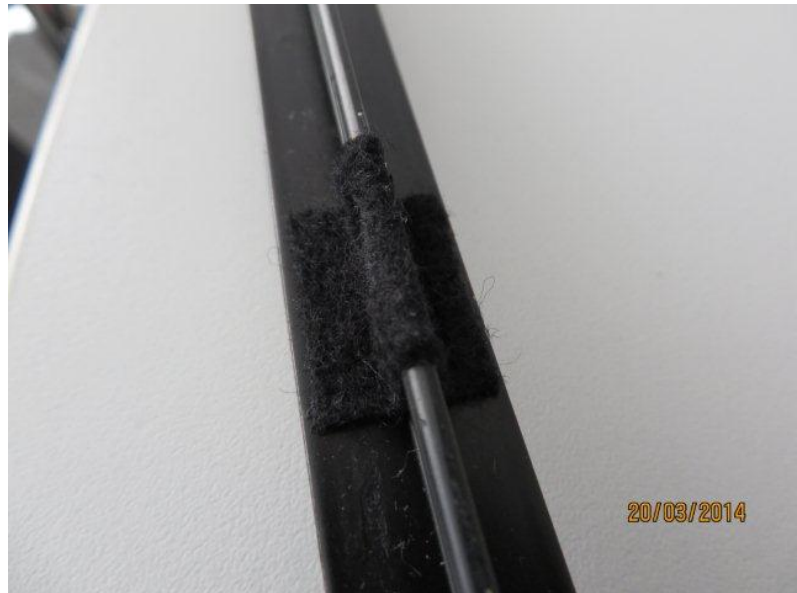
Figure 3: Fleece tape section applied.

3. Apply the sections of fleece tape to the sunroof cover trim frame to each clipping point as shown (Figure 3 and Figure 4).

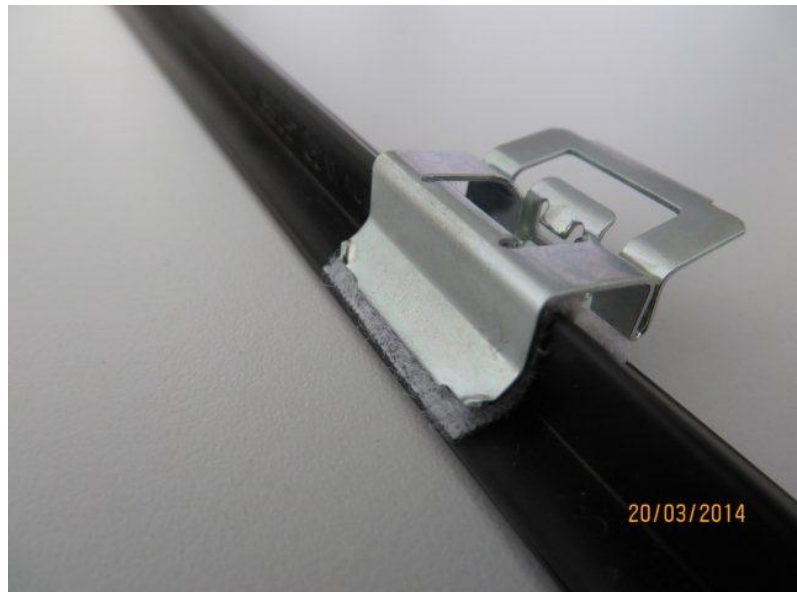
These noises can be created by the points of contact between the sunroof cover trim frame and the clips that retain it to the headliner.

Figure 4: Retaining clip isolated with the fleece tape.
