# Technical Service Bulletin

## 91 Audi connect online destination search or Google Earth navigation view is not available

91 15 17 2042013/1 September 29, 2015.

Model(s)	Year	VIN Range	Vehicle-Specific Equipment
All	2012 - 2016	All	Audi connect

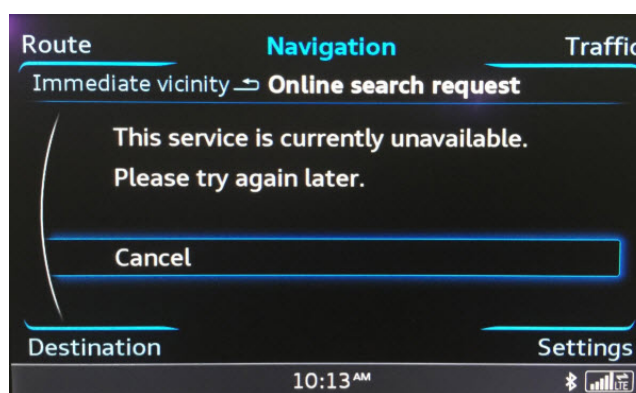
- While using Audi connect, the customer cannot access the online destination search and/or the Google Earth navigation view.
- The following message appears in the MMI (Figure 1): "This service is currently unavailable. Please try again later."
- The customer may also see an error message in the myAudi portal indicating that one or multiple licenses are expired and must be renewed.

Figure 1. Message in MMI.

1. Contact TAC and return the vehicle to the customer. No additional analysis is required. When a solution is provided, the dealer will be notified.
