Technical Service Bulletin

55 Oil warning in DIS or MMI

55 13 27 2023967/4 February 14, 2013. Supersedes Technical Service Bulletin Group 55 number 12-24 dated August 7, 2012 for reasons listed below.

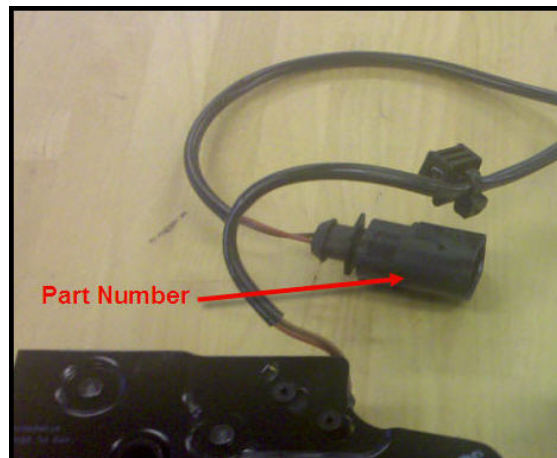
There are two suppliers for B8 hood latches. Check the part number on the current contact switch connector to determine which part number must be ordered: **8T0953236B** or **8K0953236A** (Figure 1).

Figure 1. Part number location on connector.

- If the value does not change, then replace only the contact switch. Follow the applicable work instructions listed in ElsaWeb for replacing the hood contact switch.

Tip: Do *not* replace the complete hood latch assembly. Replace only the micro-switch.

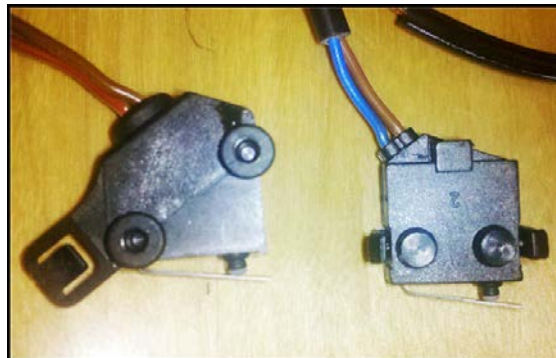
The two suppliers use different designs for the contact switch (Figure 2). Therefore, the mounting location is slightly different on the different hood latches (Figure 3). The contact switches are not cross-compatible between the different latches. However, the latches can be swapped between vehicles as long as the correct contact switch is installed.

Figure 2. Design differences between the two contact switches.

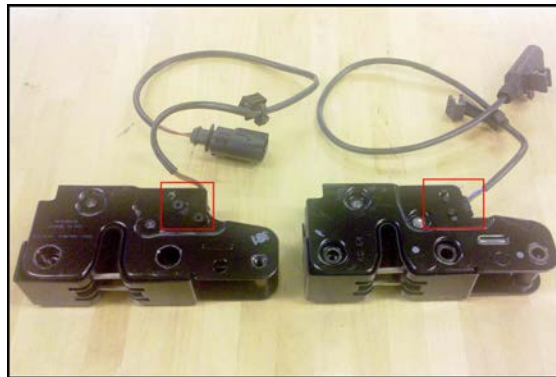
Figure 3. The mounting locations for the contact switches are different; thus, they are not cross compatible.
