> 122SD and Coronado
> Business Class M2
> Cascadia
> 108SD/114SD

**Freightliner
Service Bulletin**

General Information

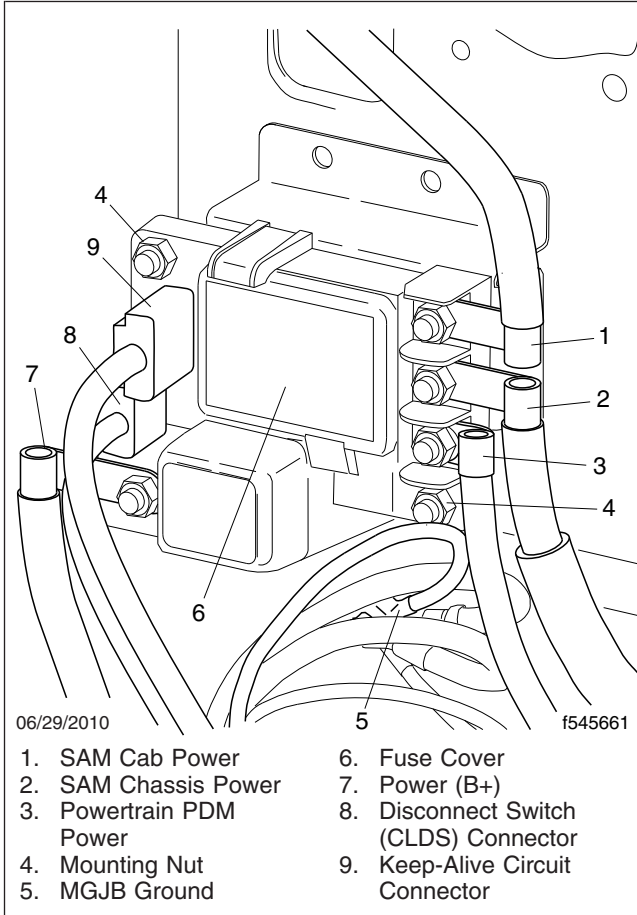
Fig. 1, Powernet Distribution Box

Some powernet distribution box (PNDB) modules may experience poor fuse retention on the keep-alive circuits. This could cause intermittent operation of any devices supplied by these circuits. On units equipped with remote sense, it could result in the alternator overcharging, even on alternators capable of self-regulating.

NOTE: The powernet distribution box (PNDB) is located on the cab frontwall, above the main ground junction block. See [Fig. 1](#).

If the fuses are not seating properly on the keep-alive circuits, or are falling out, use the instructions in this bulletin to replace the PNDB.
