Service Information Bulletin

SUBJECT	DATE
SPN 4364 (ACM) (EPA10)	August 2014

2 SPN 4364/FMI 1 - EPA10

Selective Catalyst Reduction NOx Conversion Very Low

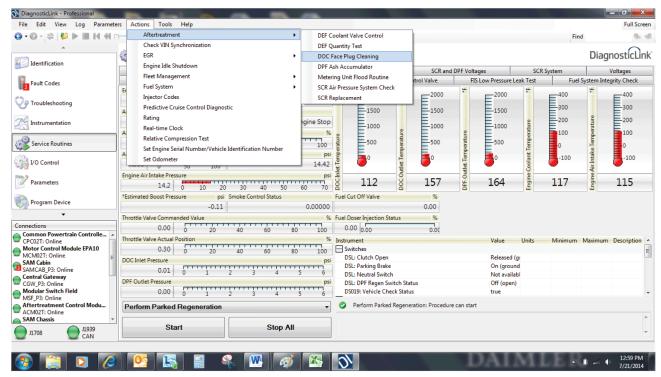
d500223

- **a.** Yes; this fault was likely caused by the DEF build-up in the exhaust which was cleared by the parked regeneration procedures. Release the vehicle.
- b. No; Use DiagnosticLink to perform the DOC face plug routine to clear the DEF build-up in the exhaust.

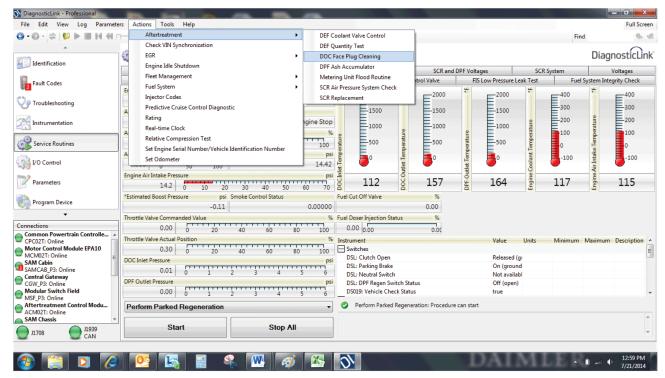
d500223

- **a.** Yes; this fault was likely caused by the DEF build-up in the exhaust which was cleared by the parked regeneration procedures. Release the vehicle.
- b. No; Use DiagnosticLink to perform the DOC face plug routine to clear the DEF build-up in the exhaust.
