Technical Service Bulletin

46 Squealing from front brakes (PR-1LA or 1LB)

46 13 51 2033674/4 July 30, 2013. Supersedes Technical Service Bulletin Group 46 number 13-46 dated June 27, 2013 for reasons listed below.

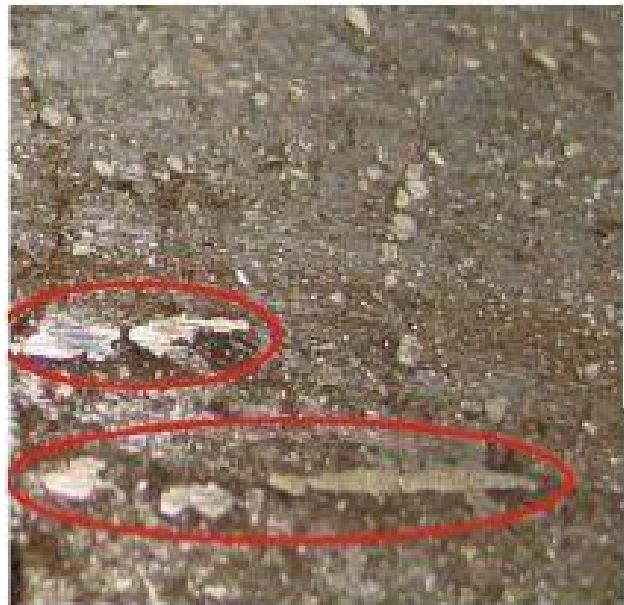
- Foreign bodies between brake disc and brake pad, such as small stones, grit, or sand.
- Un-ground or corroded friction materials.
- Brake discs or brake pads are close to their wear limit. (Front brake disc wear limit: 28mm. Front brake pads wear limit with backing plate and dampening sheet: 7mm.)
- Metallic deposits from disc material in brake pad (Figure1).

Figure 1. Metallic deposits.

- Deposits in brake pad.

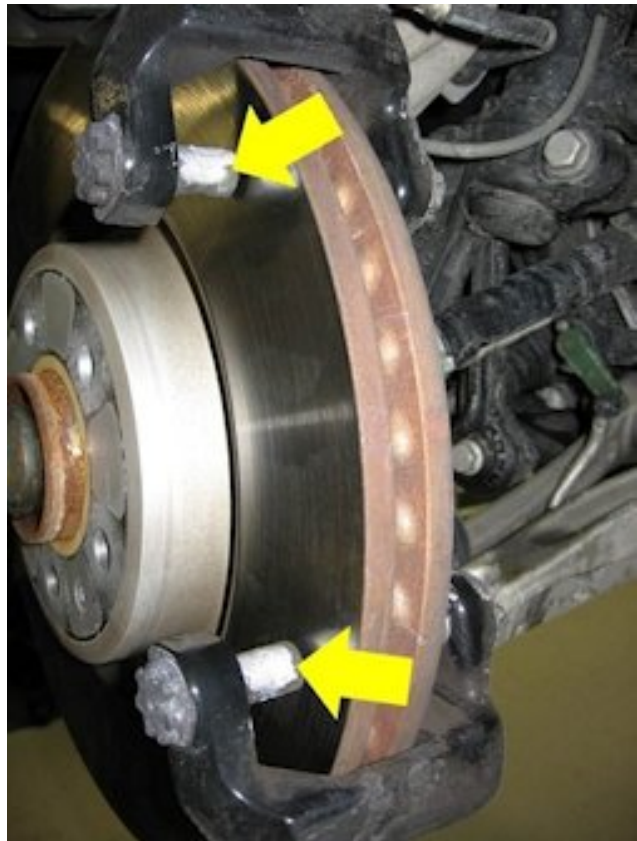
Brakes on vehicles produced before September 3, 2012 (calendar week 36 of 2012), squeak or squeal when used with light to moderate force.

Figure 2. Caliper carrier guide pins with anti-seize (**G 052560A2**) lubricant applied where the pads make contact.

2. Remove the front brake caliper with the brake pads still attached and apply a thin coat of anti-seize (**G 052560A2**) lubricant to the guide pins of the caliper carrier (Figure 2). Only apply this lubricant to the section of the guide pins that will be contacted by the brake pads.
