Technical Service Bulletin

94 Moisture accumulation in headlamps

94 13 28 2028277/9 August 13, 2013. Supersedes Technical Service Bulletin Group 94 number 13-24 dated July 18, 2013 for reasons listed below.

Model(s)	Year	VIN Range	Vehicle-Specific Equipment
Q7	2010 - 2014	All	Not Applicable

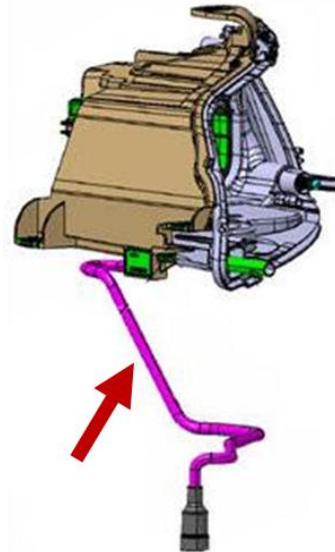
Figure 3. Mounting of updated ventilation hose.

i Tip: The updated ventilation hose is not connected directly to the headlamp housing. The hose routes downward from the headlamp carrier and between the radiator and bumper (Figure 3, arrow).

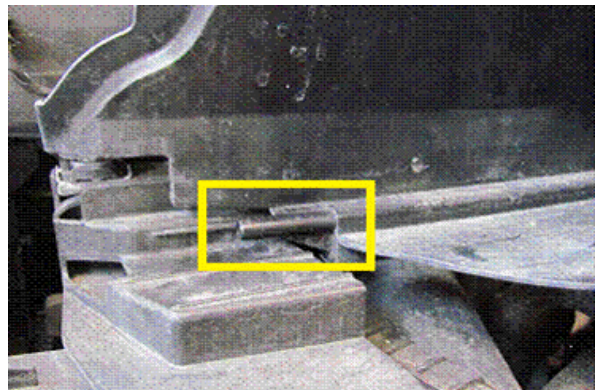
Figure 4. Headlamp ventilation guide tube.

3. Each headlamp air ventilation tube must be sealed to protect against further moisture ingress (Figure 4).

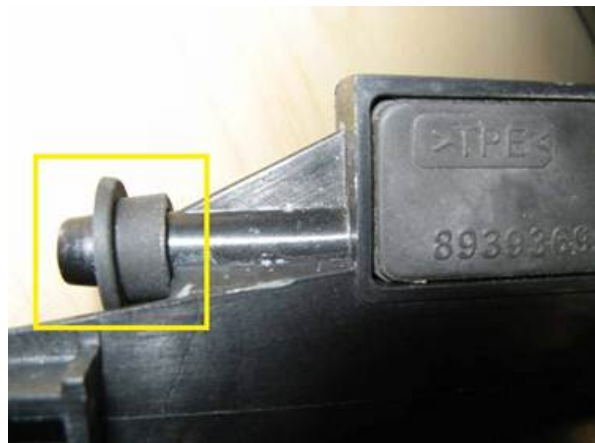
Figure 5. Ring seal installed on headlamp air tube.

4. Install ring seal on headlamp air ventilation tube (Figure 5). The larger diameter of the seal faces the headlamp.

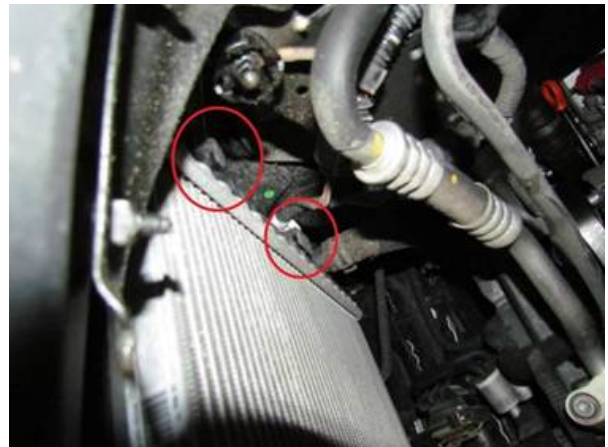
Figure 7. Lower exit air duct attachment point to charge air cooler.

Figure 8. Upper exit air duct attachment points to charge a cooler.

8. Locate exit air duct attachment hooks on the left and right air charge coolers (Figures 7 and 8).

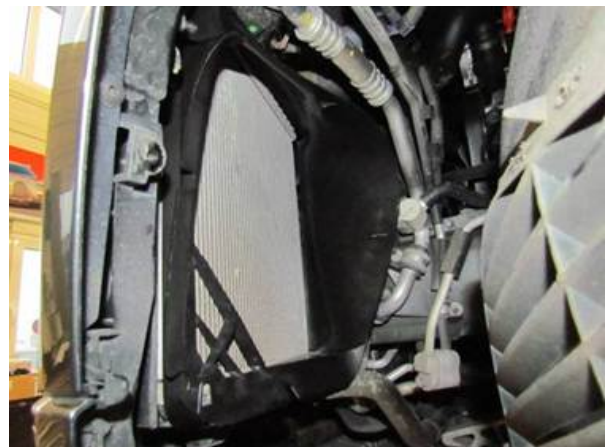
Figure 9. Charge air cooler exit air duct installed.

9. Affix left and right exit air ducts over the rear of the charge air coolers (Figure 9).

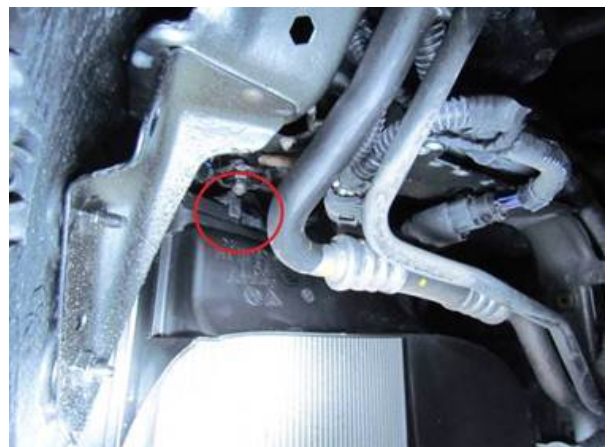
Figure 10. View of exit air duct affixed to mounting hook.

10. Inspect exit air duct attachment points to be sure that ducts are engaged properly over charge air cooler hooks (Figure 10).
