Technical Service Bulletin

80 Coolant loss from coolant valve, engine warning light on, "Limp Home" mode active

80 13 04 2033806/3 August 9, 2013. Supersedes Technical Service Bulletin Group 80 number 13-03 dated May 13, 2013 for reasons listed below.

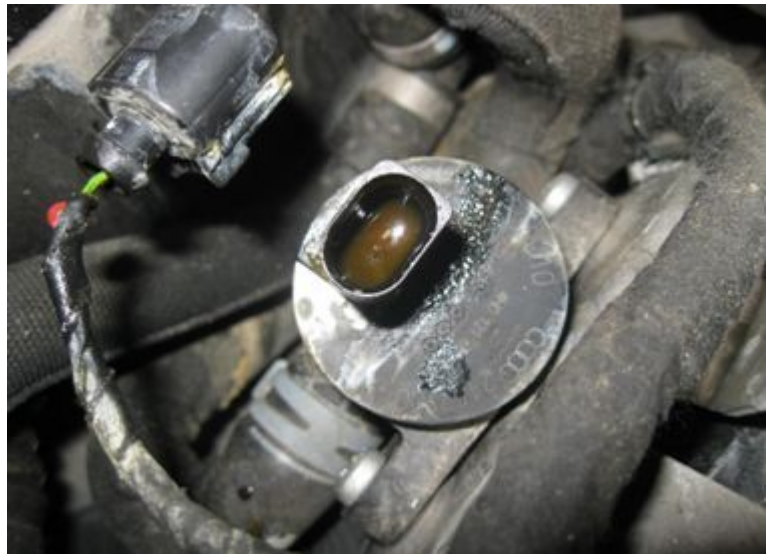
Inspection of the coolant control valves N82, N509, or N488 reveals the presence of coolant inside the electrical connector as shown in the illustration (Figure 1).

Figure 1. Coolant residue in the connector housing of the coolant regulating valve.

1. Diagnose the defective coolant valve (N82, N509, or N488) using Guided Fault Finding where stored DTCs are found.
2. Replace the defective coolant valve.

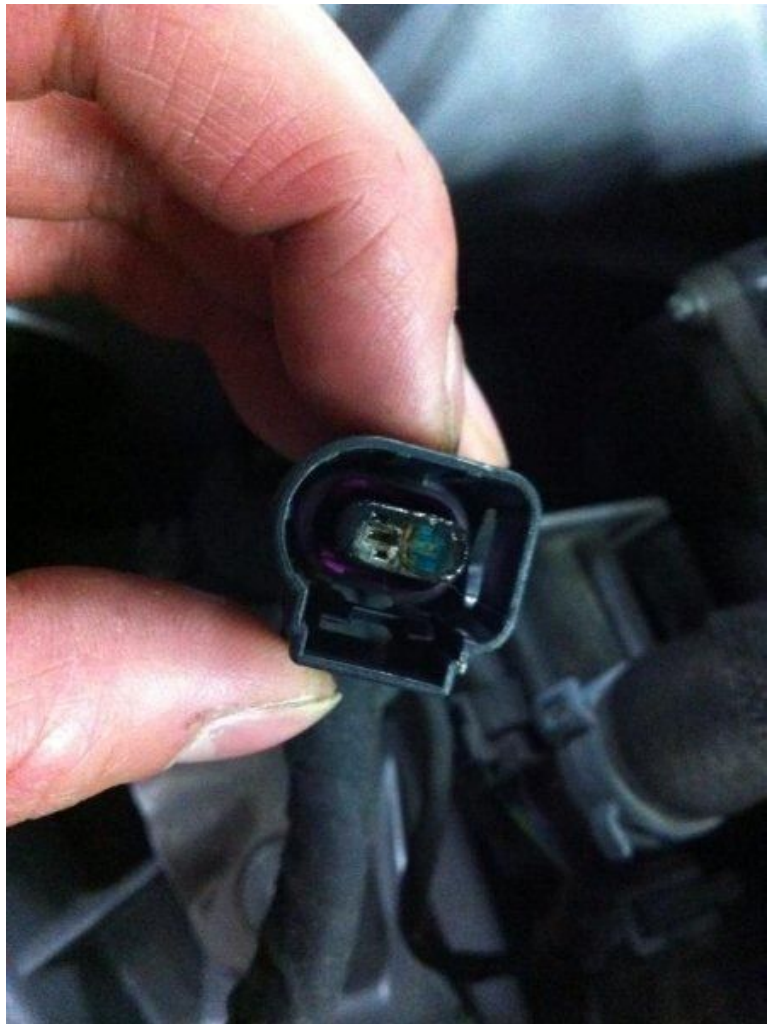
The connectors, wiring harness, and/or connected control units may have been damaged from exposure to coolant (Figure 2).

Figure 2. Corrosion formation on the connector pins.

Tip: Check the connectors, wiring harness, and connected control units for coolant damage. Perform repairs as necessary.
