# Technical Service Bulletin

## 01 MIL on (DTC P2293, P0087)

01 13 18 2013147/12 August 1, 2013. Supersedes Technical Service Bulletin Group 15 number 11-22 dated May 31, 2011 for reasons listed below.

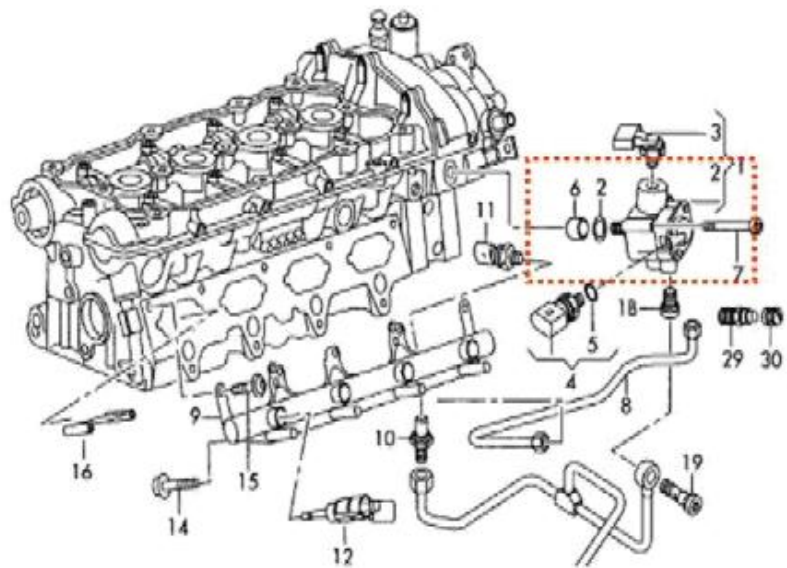
1. Remove the high pressure fuel pump and visually inspect:
  - The base surface of the cam follower (Figure 1, 6) in contact with the camshaft lobe.
  - The tip of the high pressure fuel pump plunger.
  - The high pressure fuel pump camshaft lobe.

**Figure 1.** The high pressure fuel pump.

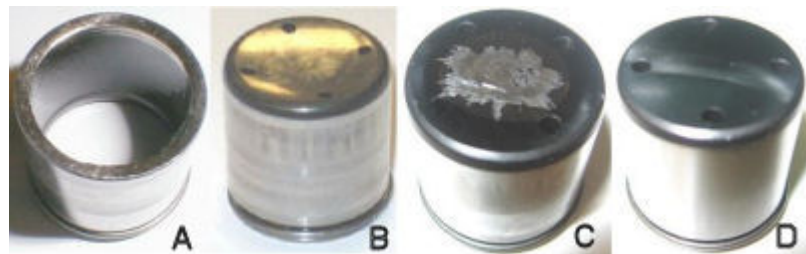
Excessive wear of the cam lobe (in the intake camshaft) that drives the high pressure fuel pump limits the maximum pump piston lift, causing fuel rail pressure fluctuations. The wear on the cam lobe also leads to wear in the base of the high pressure fuel pump cam follower.

2. If the base of the cam follower shows normal wear (Figure 2, C) or is a new part (Figure 2, D), the cam follower and cam shaft should not be replaced because excessive wear is not present.

**Figure 2.** Cam followers in various stages of wear: holed base (A), excessive wear (B), normal wear (C), and new part (D).

3. If the cam follower base surface is excessively worn so that its surface is concave (Figure 2, B) or missing (Figure 2, A), or if the high pressure fuel pump camshaft lobe shows excessive wear (Figure 3), replace the intake camshaft and the cam follower.

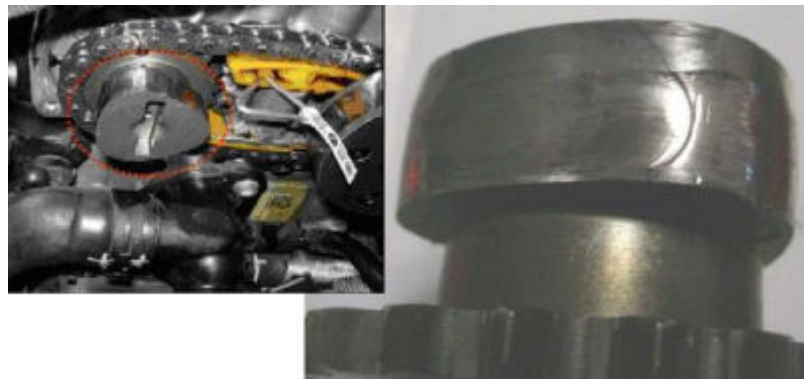
**Figure 3.** Excessive wear on the lobe for high pressure fuel pump in the intake camshaft.

5. If the intake camshaft is replaced because of excessive wear, also replace the engine oil and the oil filter.

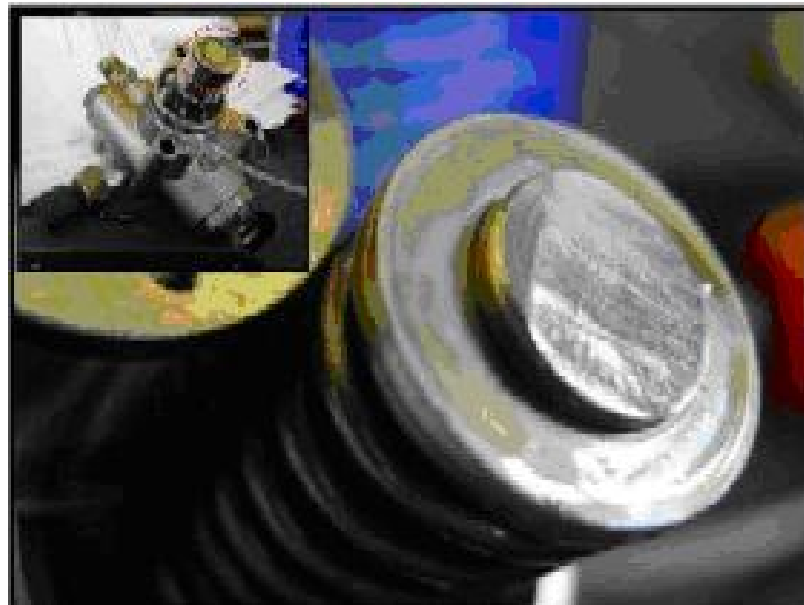
**Figure 4.** Excessive wear marks on the tip of the high pressure fuel pump plunger.

4. The high pressure fuel pump must be replaced only if the tip of the plunger shows excessive wear (Figure 4). This condition is only possible if the cam follower base is holed and the plunger tip has come in direct contact with the camshaft lobe.
