Technical Service Bulletin

01 MIL on (DTC P2293, P0087)

01 13 23 2013147/13 August 16, 2013. Supersedes Technical Service Bulletin Group 01 number 13-18 dated August 1, 2013 for reasons listed below.

Model(s)	Year	VIN Range	Vehicle-Specific Equipment
A4	2005-2006	all	2.0TFSI engine, engine code BPG
A3	2006-2007	all	2.0TFSI engine, engine code BPY
A4	2007	all	2.0TFSI engine, engine code BWT
Cabriolet	2007	all	2.0TFSI engine, engine code BWT

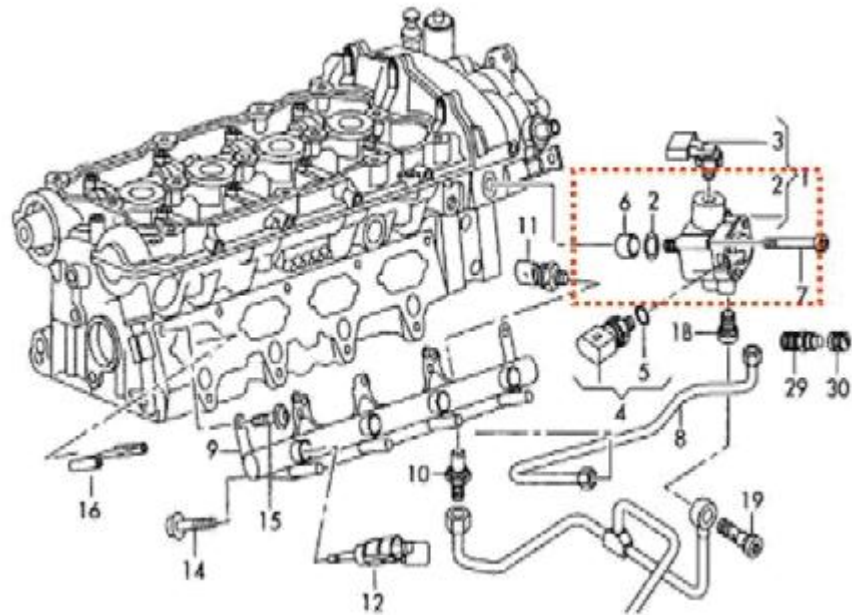
1. Remove the high pressure fuel pump and visually inspect:
 - The base surface of the cam follower (Figure 1, 6) in contact with the camshaft lobe.
 - The tip of the high pressure fuel pump plunger.
 - The high pressure fuel pump camshaft lobe.

Figure 1. The high pressure fuel pump.

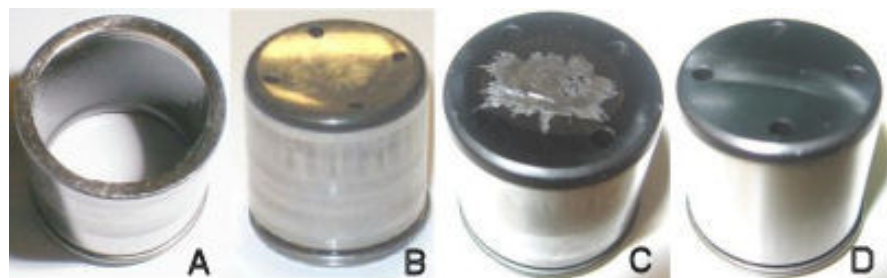
2. If the base of the cam follower shows normal wear (Figure 2, C) or is a new part (Figure 2, D), the cam follower and cam shaft should not be replaced because excessive wear is not present.

Figure 2. Cam followers in various stages of wear: holed base (A), excessive wear (B), normal wear (C), and new part (D).

3. If the cam follower base surface is excessively worn so that its surface is concave (Figure 2, B) or missing (Figure 2, A), or if the high pressure fuel pump camshaft lobe shows excessive wear (Figure 3), replace the intake camshaft and the cam follower.

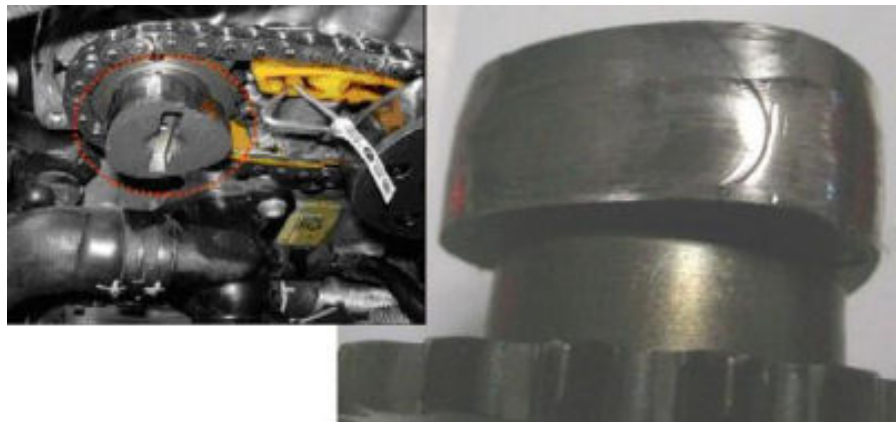
Excessive wear of the cam lobe (in the intake camshaft) that drives the high pressure fuel pump limits the maximum pump piston lift, causing fuel rail pressure fluctuations. The wear on the cam lobe also leads to wear in the base of the high pressure fuel pump cam follower.

Figure 3. Excessive wear on the lobe for high pressure fuel pump in the intake camshaft.

5. If the intake camshaft is replaced because of excessive wear, also replace the engine oil and the oil filter.

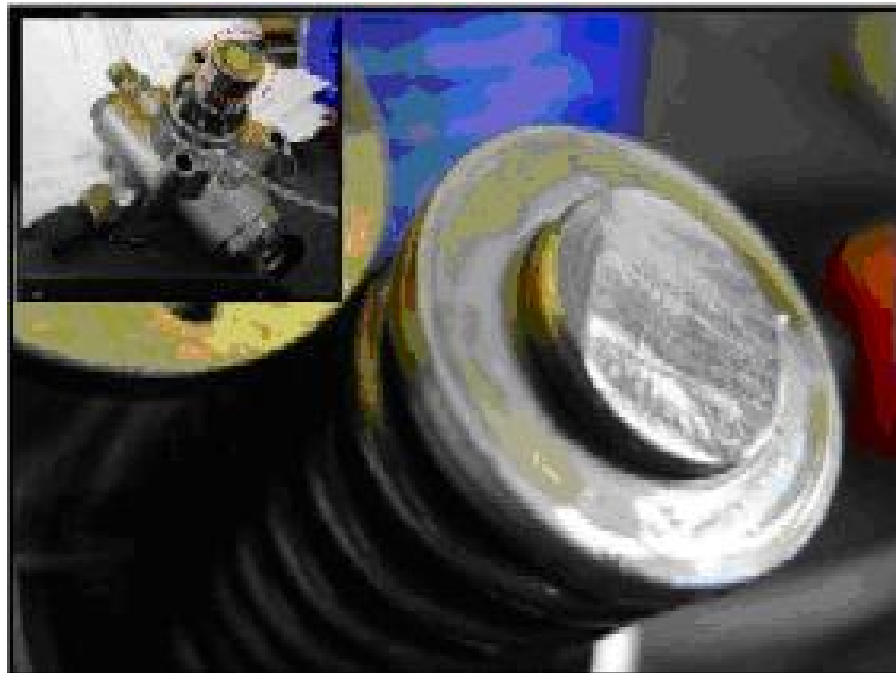
4. The high pressure fuel pump must be replaced only if the tip of the plunger shows excessive wear (Figure 4). This condition is only possible if the cam follower base is holed and the plunger tip has come in direct contact with the camshaft lobe.

Figure 4. Excessive wear marks on the tip of the high pressure fuel pump plunger.
